Locomotive Collision Test #3
**Grade Crossing Collision of a Freight Locomotive with
a Steel Coil on a Flat Bed Truck**

Test #3: Set-Up

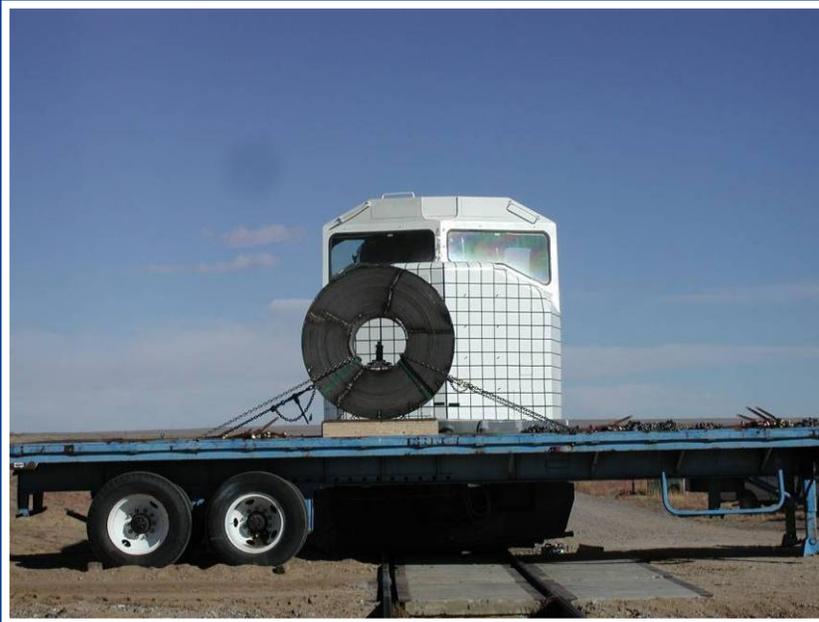
Steel coil aligned with engineer's side collision post

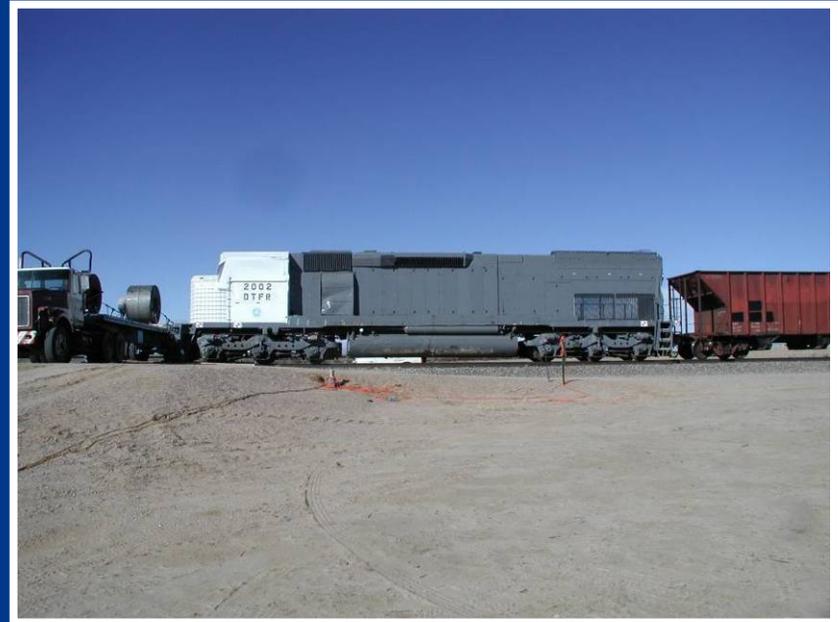
Steel coil trailer alignment with locomotive

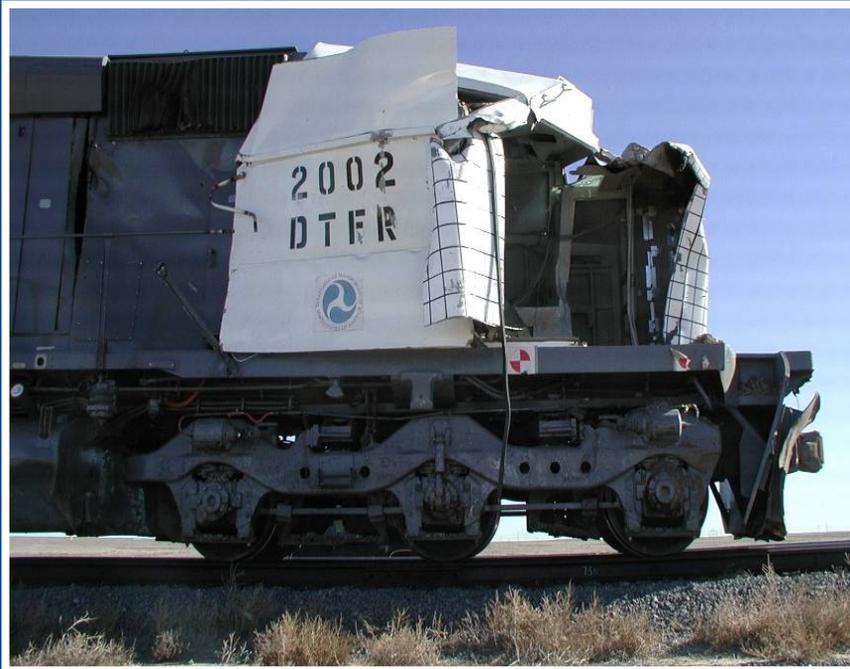
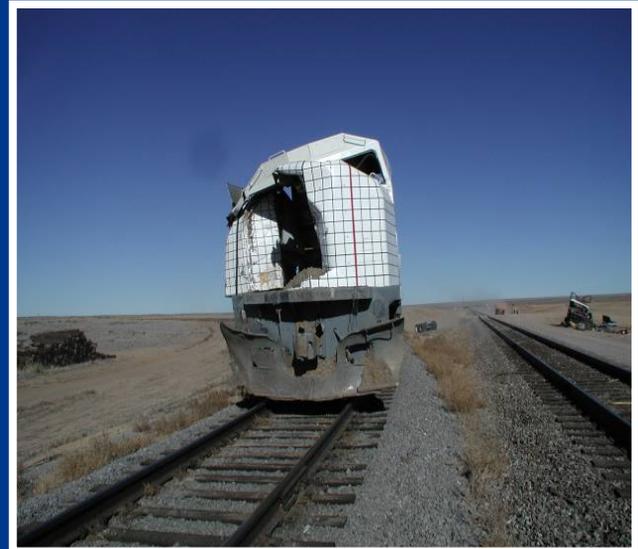
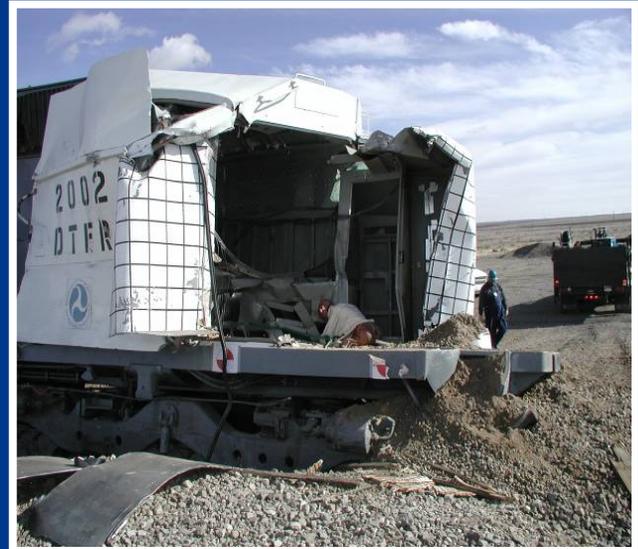
- Locomotive cabin experienced significant damage
- Anticlimber and endplate not significantly damaged

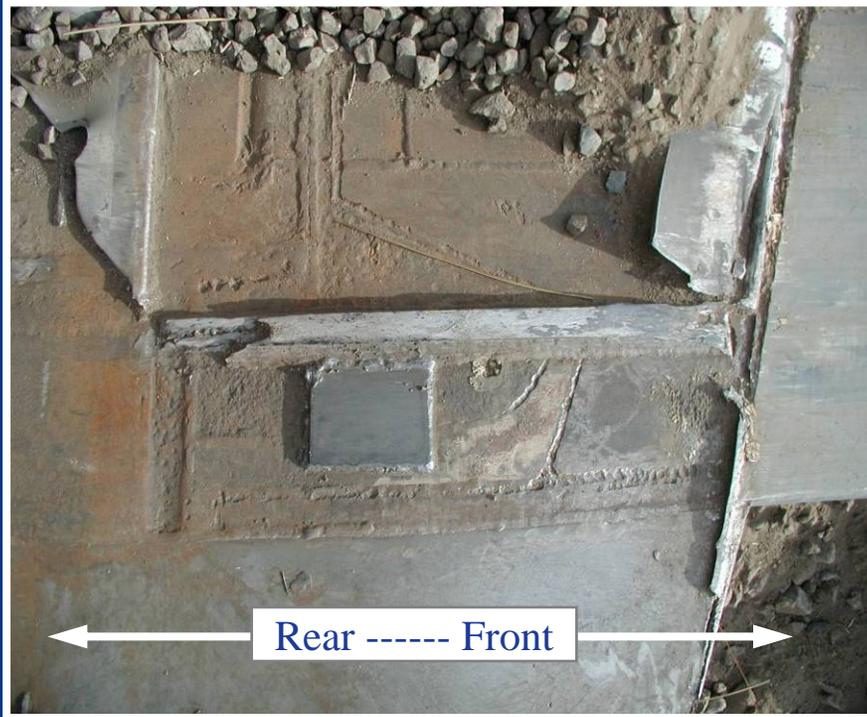
- Remainder of collision post including post base and weld bead

- What did we learn from this test?
 - The alignment of a steel coil at the moment of impact can place a significant load on a single collision post
 - The collision post struck by the massive coil was sheared off just above its weld to the underframe
 - The elevation of the coil just prior to locomotive impact was just above the anticlimber and underframe structure
 - A substantial portion of the hood and cabin was also damaged
 - Crew safety would be affected in this type of collision
