**Locomotive Collision Test #4**  
**Oblique, Offset Collision of a Freight Locomotive with a Loaded,  
Covered Hopper Car**

# Test #4: Set-Up

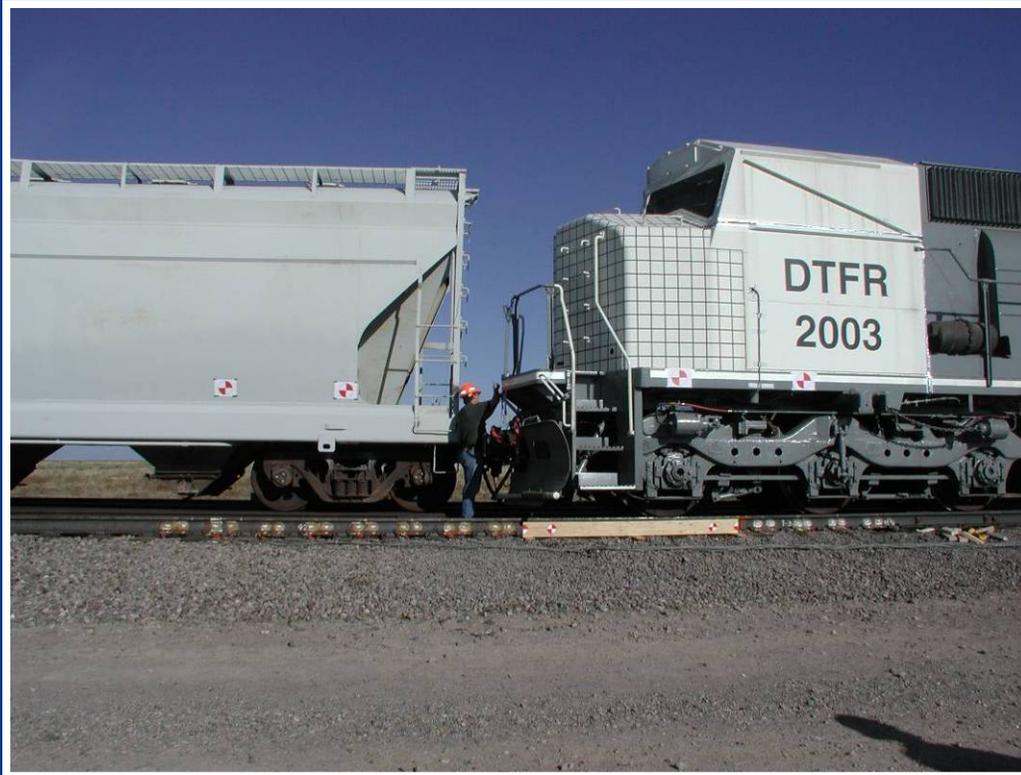
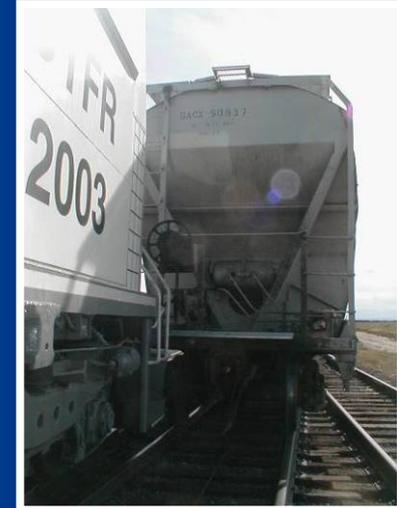
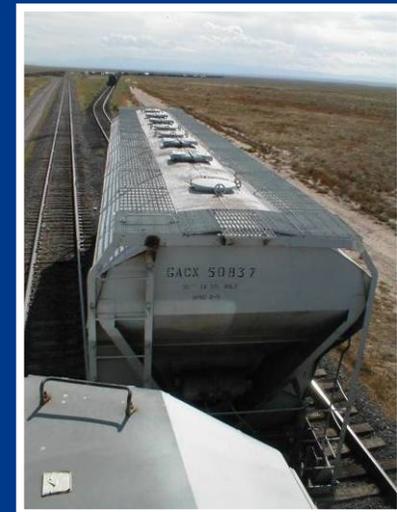
- Covered hopper overlaps locomotive by about 3 feet, but does not overlap the engineer's side collision post

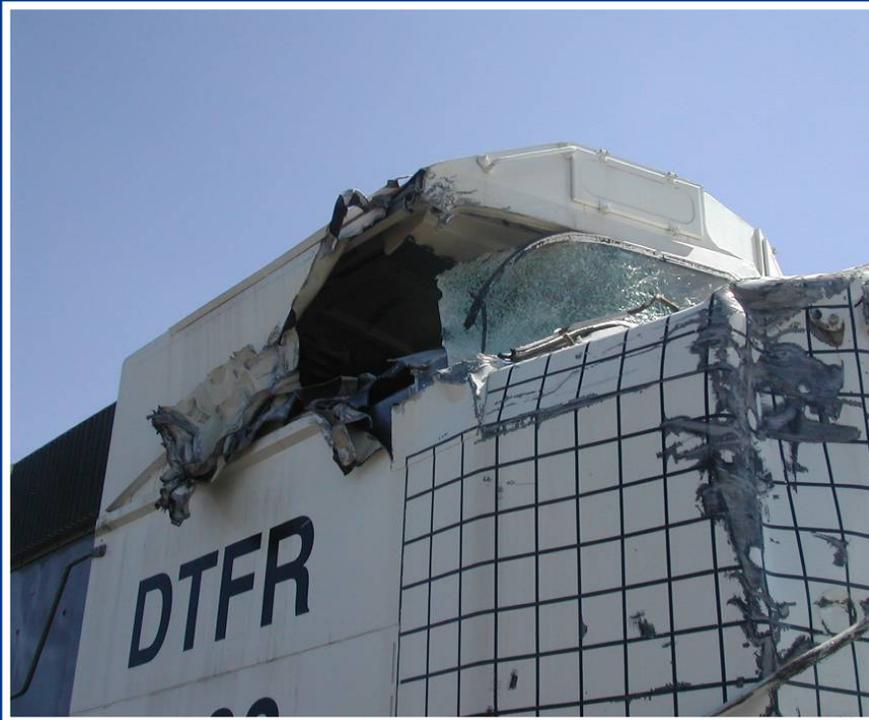
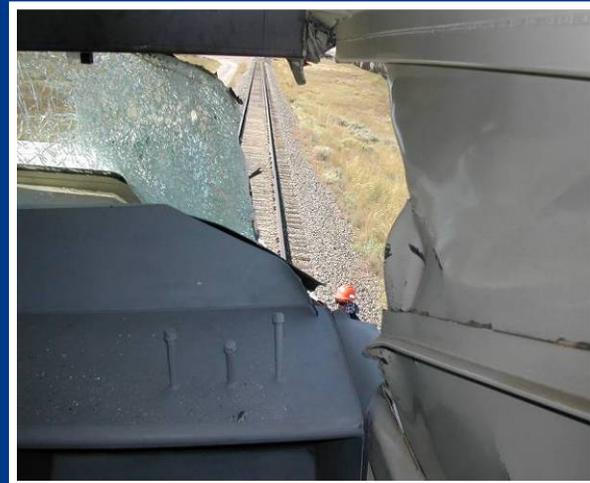
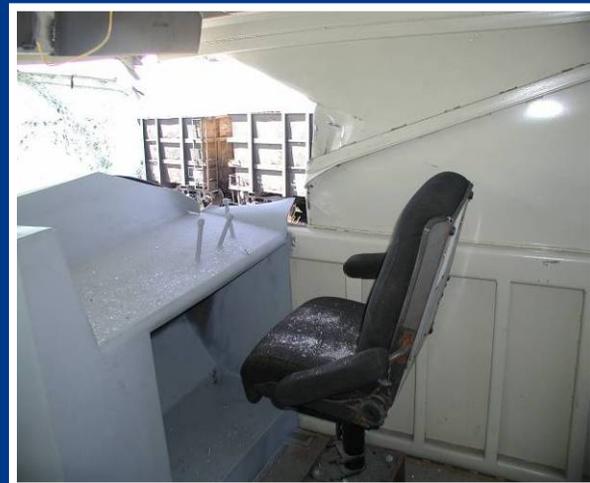
- Engineer's side windshield corner post significantly damaged during the impact event

- What did we learn from this test?
  - Significant damage occurred to the windshield corner post area
  - This damage would be greater with a larger hopper to locomotive overlap or impact speed
  - Some hood and endplate damage also occurred
  - The locomotive's front truck derailed, while the rear truck remained on the track
  - Crew safety would be affected in this type of collision

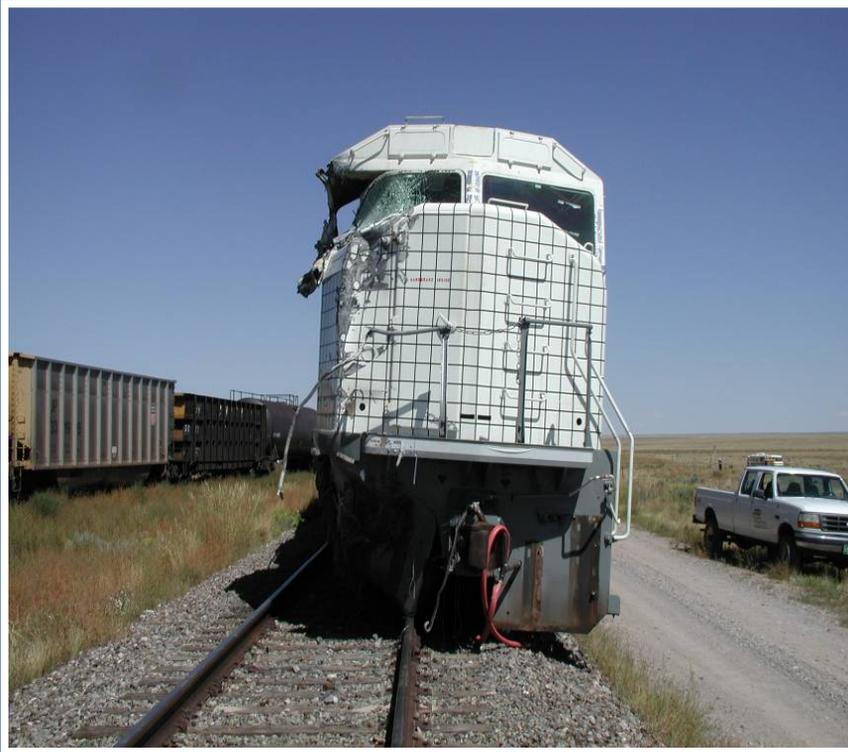
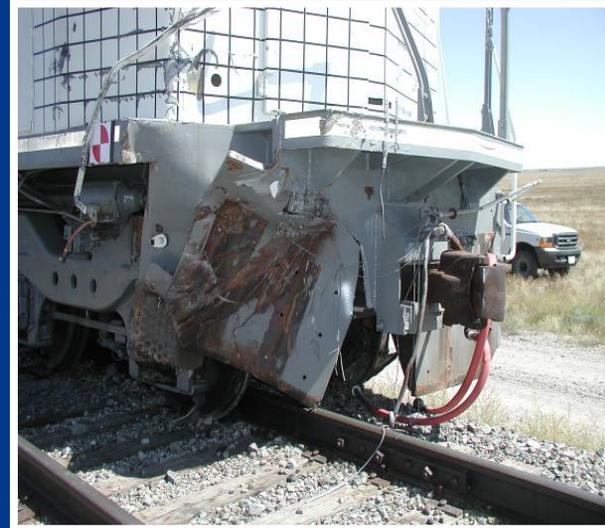
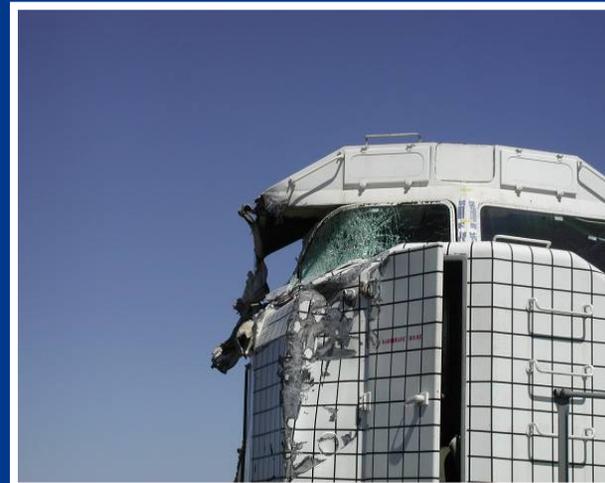
- Locomotive front truck derailed
- Hood and end plate damaged
