Locomotive Collision Test #6
**Elevated, Offset Collision of a Freight Locomotive with
a Loaded 40 ft Container**

Test #6: Set-Up

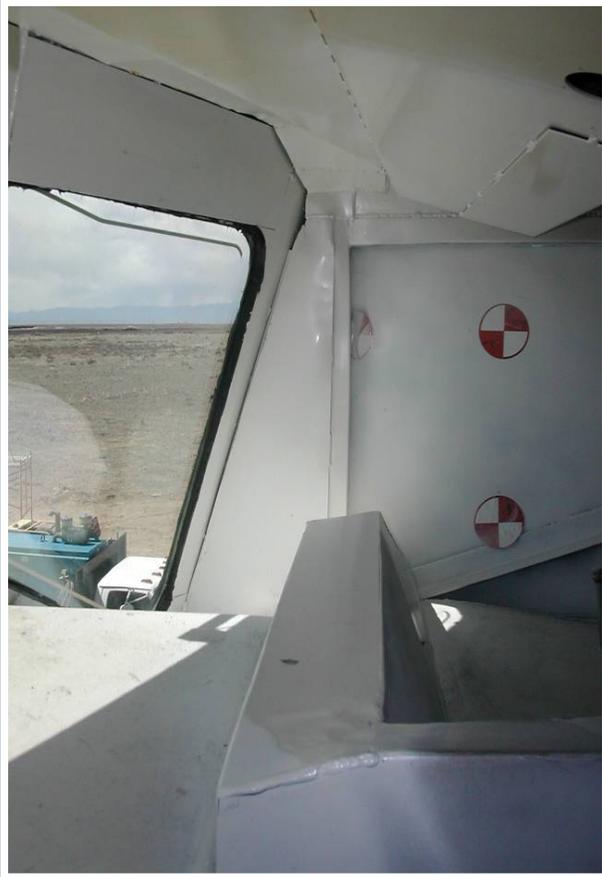
Windshield corner post prior to collision test

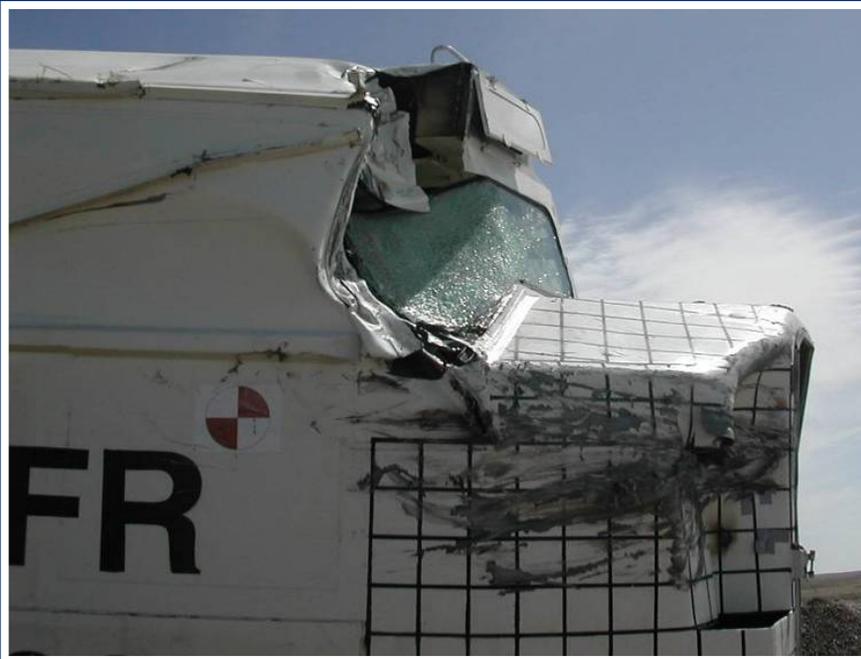
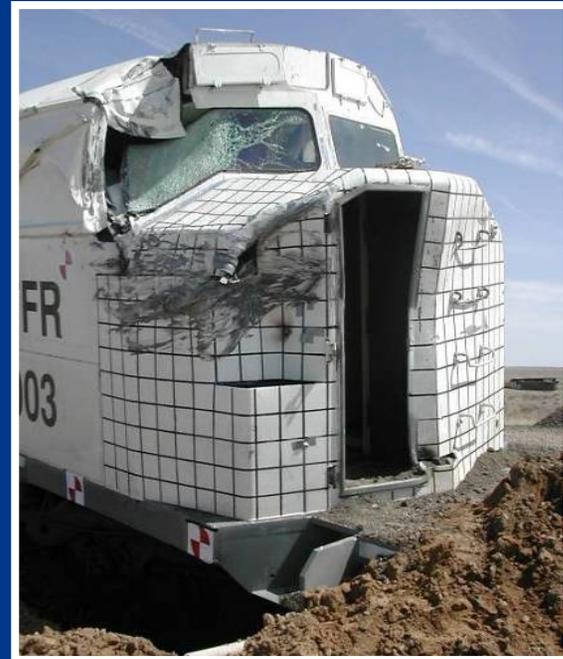
- Heavy damage to windshield corner post and frame, roof corner, and hood
- Separation of corner post and windshield structure

- Significant damage occurred to windshield corner post and roof, with separation of upper corner post
 - Results suggest that strengthening of windshield and corner post structure could be beneficial
- This collision could result in severe crew injuries
 - Debris ejected toward crewmembers (primary injuries)
 - Unrestrained crew member head and chest injuries striking interior (secondary injuries)
- Container structure destroyed and heavily distorted with loss of internal cargo material
 - “Wrapped around” windshield, hood and side window areas

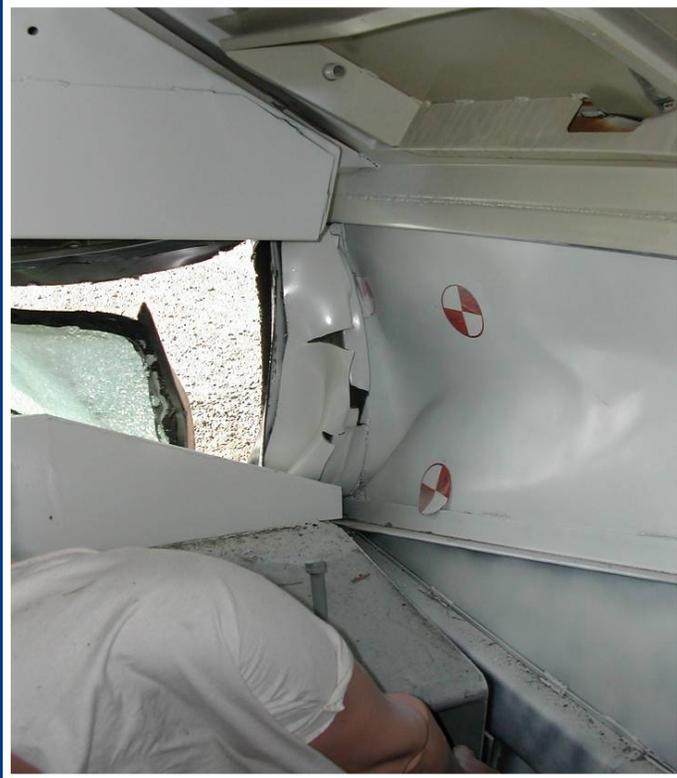
Windshield corner post and side window front portion with ~3 in. of intrusion

Roof above engineer's seat with ~2 in. of intrusion

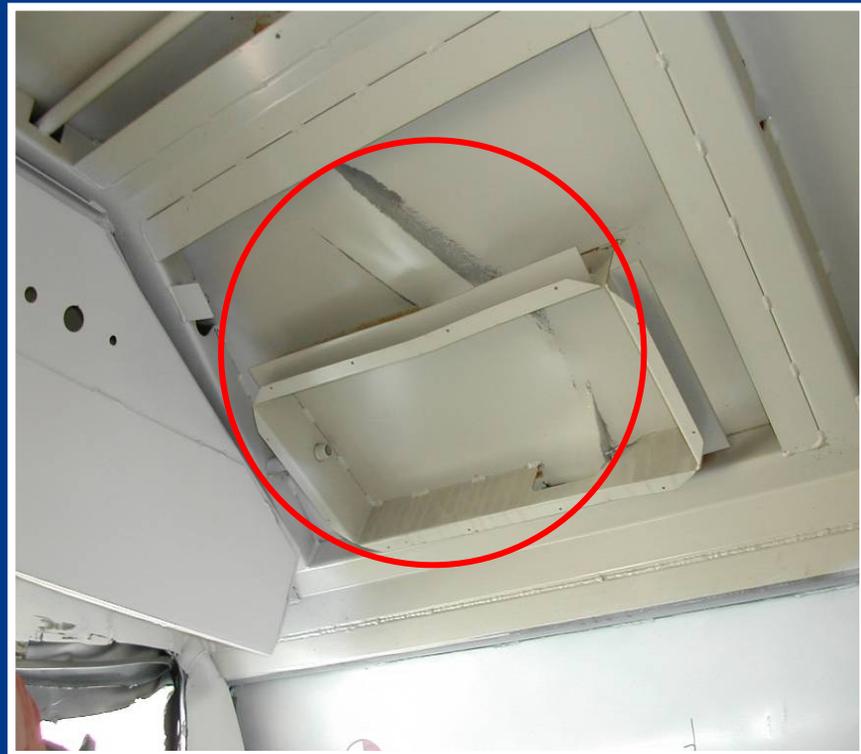
Substantial debris and glass directed into cab interior
