**Federal Railroad
Administration**

1997 Railroad Employee Fatalities: A Comprehensive Study

Date: June 18, 2001

Subject: **1997 Railroad Employee Fatalities: A Comprehensive Study**

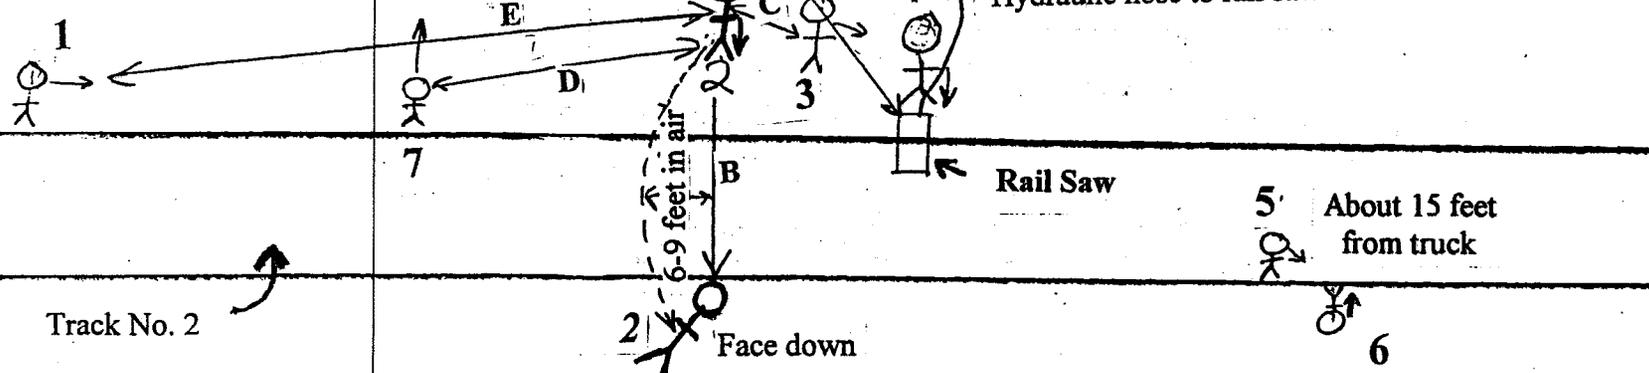
REPORT: FE-01-97
RAILROAD: Soo Line Railroad (SOO)
LOCATION: Milwaukee, Wisconsin
DATE, TIME: Jan. 8, 1997, 11:25 a.m., CST
PROBABLE CAUSE: Vapors from an oxygen/acetylene gas tank set in an enclosed area were ignited by flying sparks from a rail saw which caused an explosion within the compartment. This resulted in debris striking the nearby employee.

The Gang A Assistant Foreman was going to saw off about three inches of rail to eliminate a broken rail end. The Gang B Foreman told the Assistant Foreman he would saw this rail end, as the Assistant Foreman had sawed the previous ones. The saw, hydraulic-powered from the F-800 truck, was operated from the same side of the truck as the gas compartment. The hydraulic hose reel was in a rear compartment on the left side of the truck. The rail was being cut ten feet away from the gas compartment.

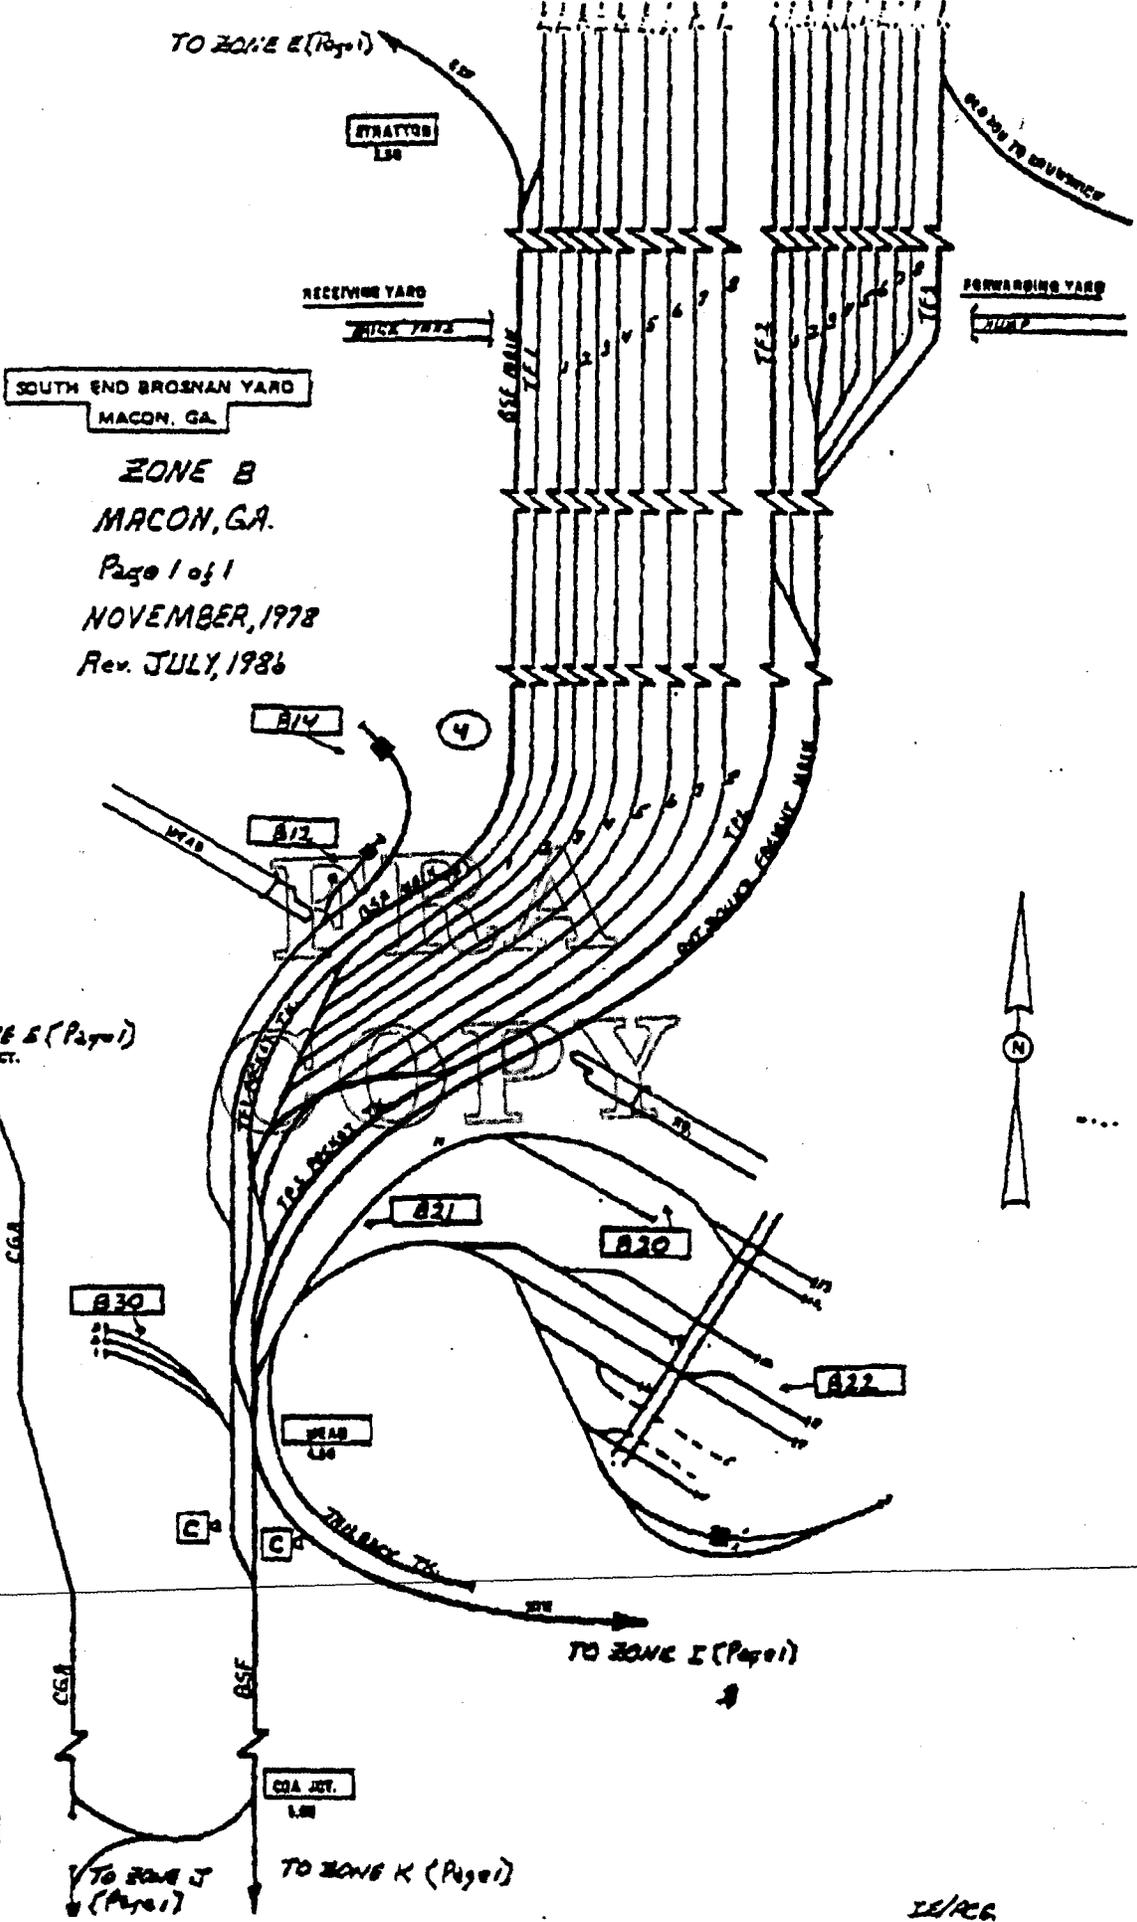
SOUTH END BROSNAN YARD
MACON, GA.

The company truck assigned to the Carman for this tour of duty was found parked near the switches leading to the forwarding yard. The Carman had left his hard hat, safety glasses, and hand-held, battery-powered light on the seat of the truck. He was apparently attempting to perform his assigned duties while utilizing illumination supplied by the pole-mounted light in the yard near his location.

The Carman was wearing layered clothing with a stocking-type cap and a hooded sweatshirt at the time of the accident. His outer clothing was dark in color. It is unknown if the stocking cap and hooded sweatshirt he was wearing at the time had reduced his ability to hear. He also had gloves and a radio with him. His gloves and radio were found in the gage of the track north of the point of impact. His transected body was found approximately 191 feet north of the switch to Tracks Nos. 2 and 3. His upper torso was found in the gage of Track No. 1, while his lower portion was found outside the gage of the east rail.

Evidence observed on Locomotive NW 6143 of Train No. M-98 indicated that it had passed over the Carman's body. The Engineer was operating from the control stand from the west side of the south unit (NW 8067). The locomotive consist was moving northward onto Track No. 1 to couple to its train. The Conductor was controlling the northward movement of the locomotives from the cab of Locomotive NW 6143; he was seated on the west side. The Conductor's view of the track in the direction of movement was hampered by the long hood end of Locomotive NW 6143.

Additionally, the Carman was standing in darkness and did not have a hand-held light with him. Nor was he wearing any reflective equipment that would have enabled the Crew of Train M-98 to be aware of his presence. The sound from the locomotives of Train No. G-25 in close proximity to the Carman may have masked the sound of the approaching locomotives of Train M-98, leaving him unaware of their approach to his location.

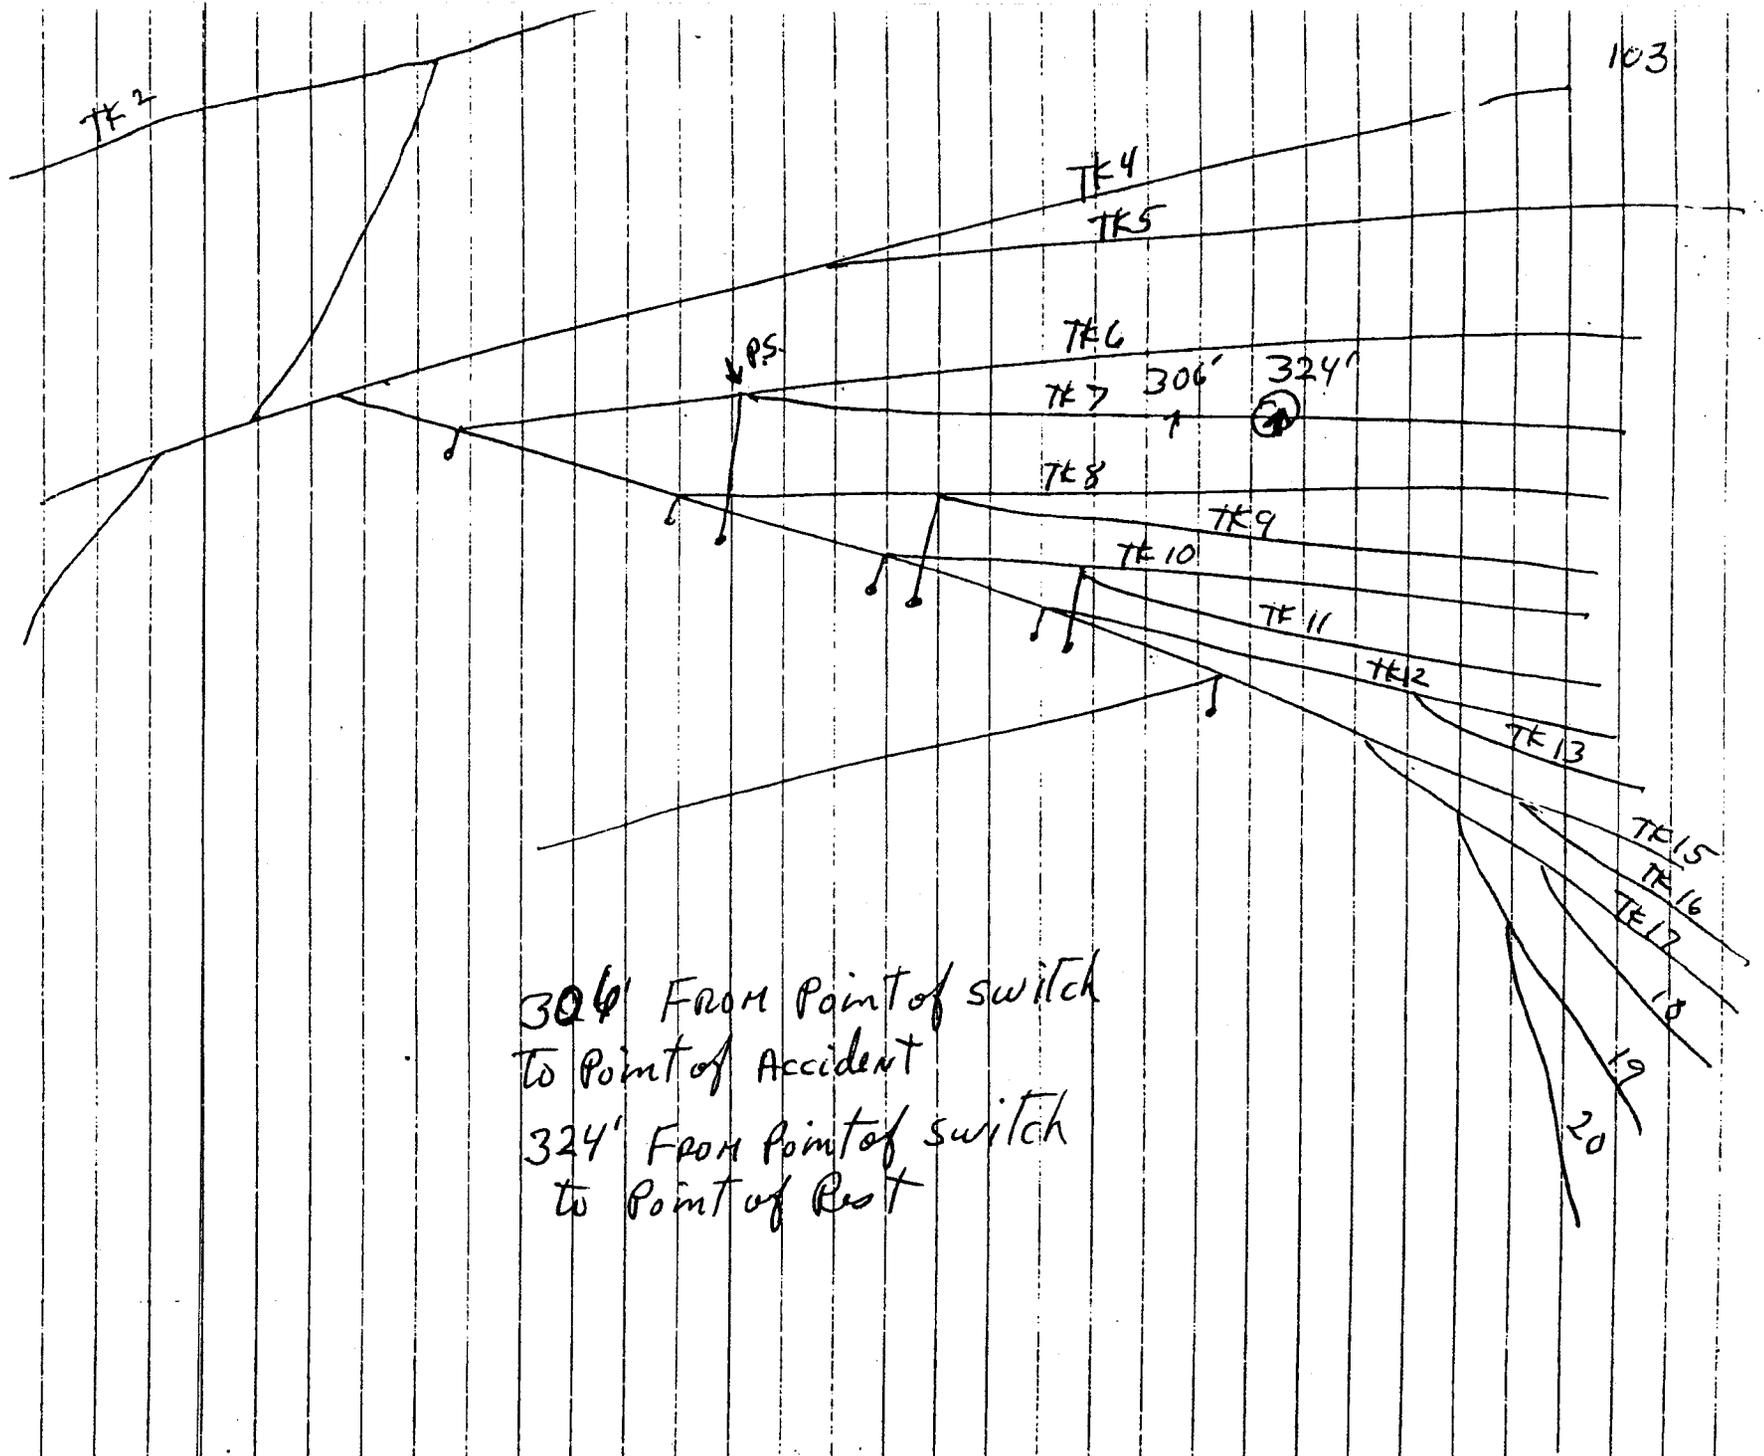
- G = GLOVE — 141" FROM REST - Laying AGAINST NR.
 ⊙ = GLASSES — 151" FROM REST - 14" FROM BASE OF NR EDGE OF TIE
 R = RADIO — 159" FROM REST - 29" FROM BASE OF NR
 E = EYE LENSE — 217" FROM REST - 5" FROM BASE OF NR
 L = LANTERN — 276" FROM REST - 34" FROM BASE OF NR
 S = SWITCH LIST - 345" FROM REST - 71" FROM BASE OF NR

306' From Point of switch
to Point of Accident

324' From Point of switch
to Point of Rest

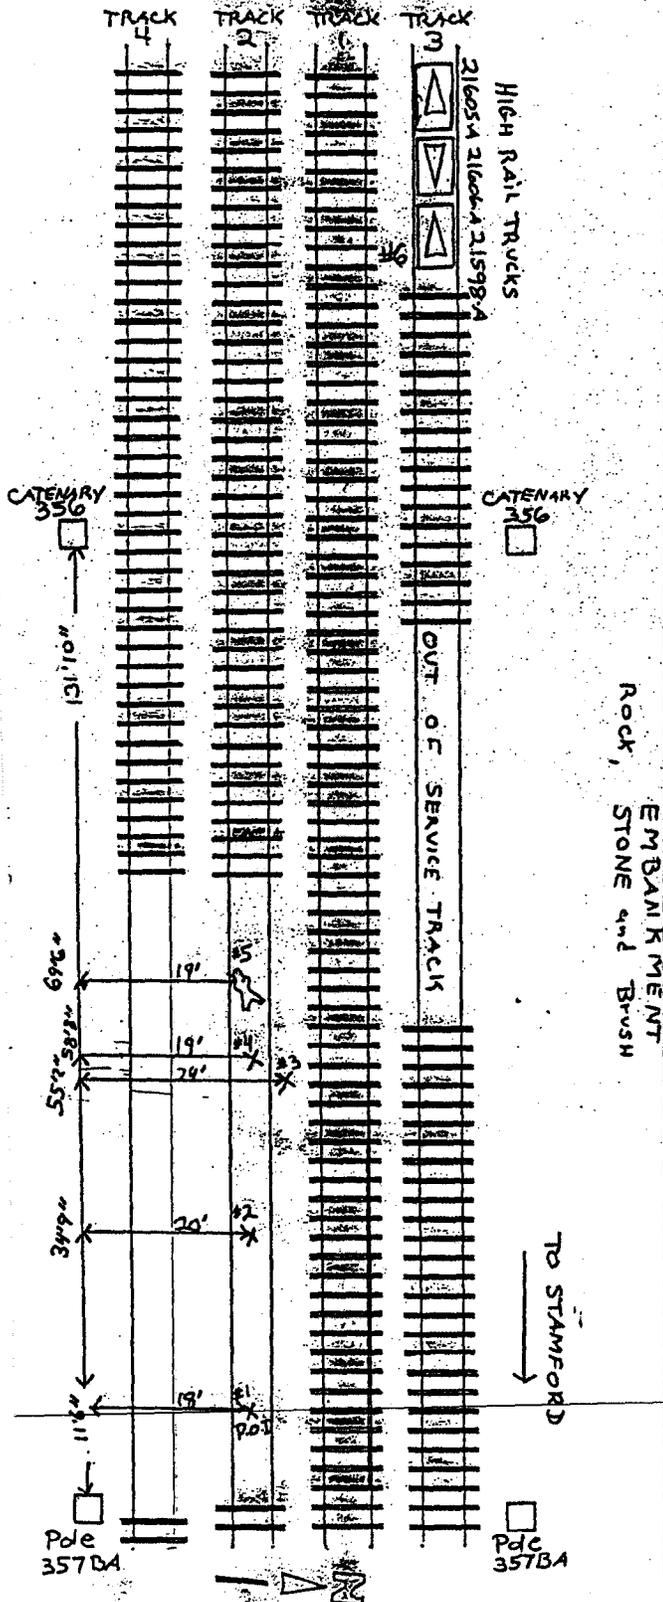
DIAGRAM KEY

- #1- Point of Impact. Approx. 11'6" WEST of Pole 357BA and approx. approx. 18 feet North of the track #4 SOUTH TIE end. Within the gauge of track #2.
- #2- Radio battery pack within the gauge of track #2 and approx. 34'9" WEST of Pole 357BA and approx 20' NORTH of the track #4 SOUTH TIE end.
- #3- Victims RIGHT arm between the track #1 and #2, approx. 55'2" WEST of Pole 357BA, and approx. 24' NORTH of the track #4 SOUTH TIE end.
- #4- Upper portion of a RRPCO radio approx. 58'8" WEST of Pole 357BA and approx 19 feet North of the Track #4 SOUTH TIE end, and within the gauge of track #2
- #5- Body of the victim within the Gauge of track #2, and approx. 69'6" from Pole 357BA and approx. 19' NORTH of the TRACK #4 SOUTH TIE end.
- #6- A RED baseball style cap located between track #1 and 3 approx 200 feet WEST of the point of impact.

A cross-over is present between tracks #2 and #1 in this area and has been deleted from this diagram.

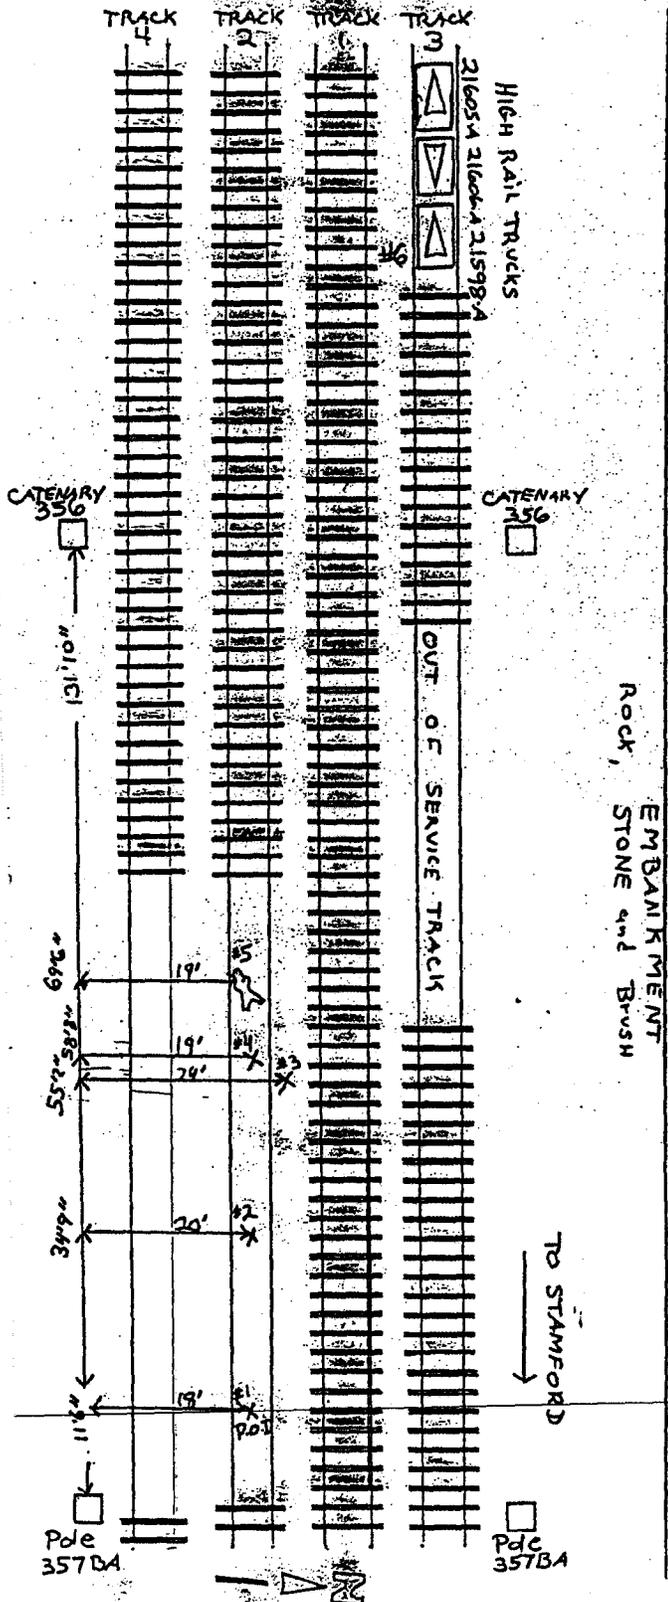
DIAGRAM KEY

- #1- Point of Impact. Approx. 11'6" WEST of Pole 357BA and approx. approx. 18 feet North of the track #4 SOUTH TIE end. Within the gauge of track #2.
- #2- Radio battery pack within the gauge of track #2 and approx. 34'9" WEST of Pole 357BA and approx 20' NORTH of the track #4 SOUTH TIE end.
- #3- Victims RIGHT arm between the track #1 and #2, approx. 55'2" WEST of Pole 357BA, and approx. 24' NORTH of the track #4 SOUTH TIE end.
- #4- Upper portion of a RRPCO radio approx. 58'8" WEST of Pole 357BA and approx 19 feet North of the Track #4 SOUTH TIE end, and within the gauge of track #2
- #5- Body of the victim within the Gauge of track #2, and approx. 69'6" from Pole 357BA and approx. 19' NORTH of the TRACK #4 SOUTH TIE end.
- #6- A RED baseball style cap located between track #1 and 3 approx 200 feet WEST of the point of impact.

A cross-over is present between tracks #2 and #1 in this area and has been deleted from this diagram.

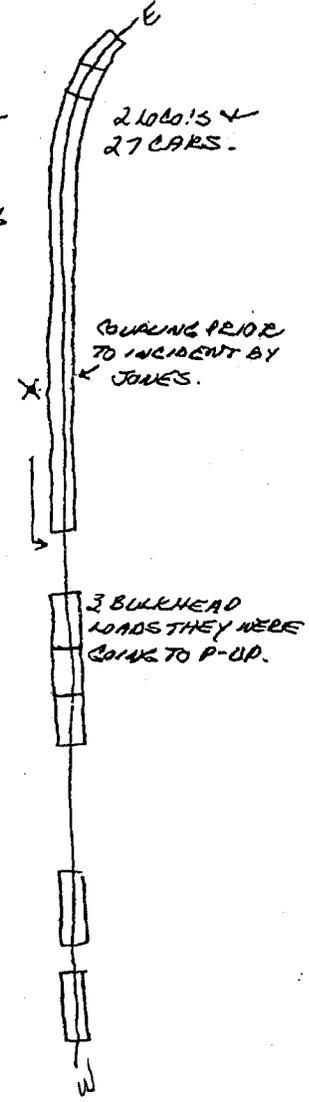
POSSIBLE CAUSE AT THIS TIME IS THAT AFTER MAKING
FIRST COUPLING, JONES WALKED BACK TO REAR OF CUT &
STEPPED INSIDE RAIL TO ADJUST COUPLERS. THE
ASSUMPTION IS THAT WHEN MAKING THE FIRST COUPLING
THE 3 BULKHEAD FLATS WERE KNOCKED WEST ABOUT 3
CARS ON A SLIGHT GRADE & WHEN JONES STEPPED
BETWEEN RAIL THE BULKHEAD CARS ROLLED BACK
EAST COUPLING JONES UP.

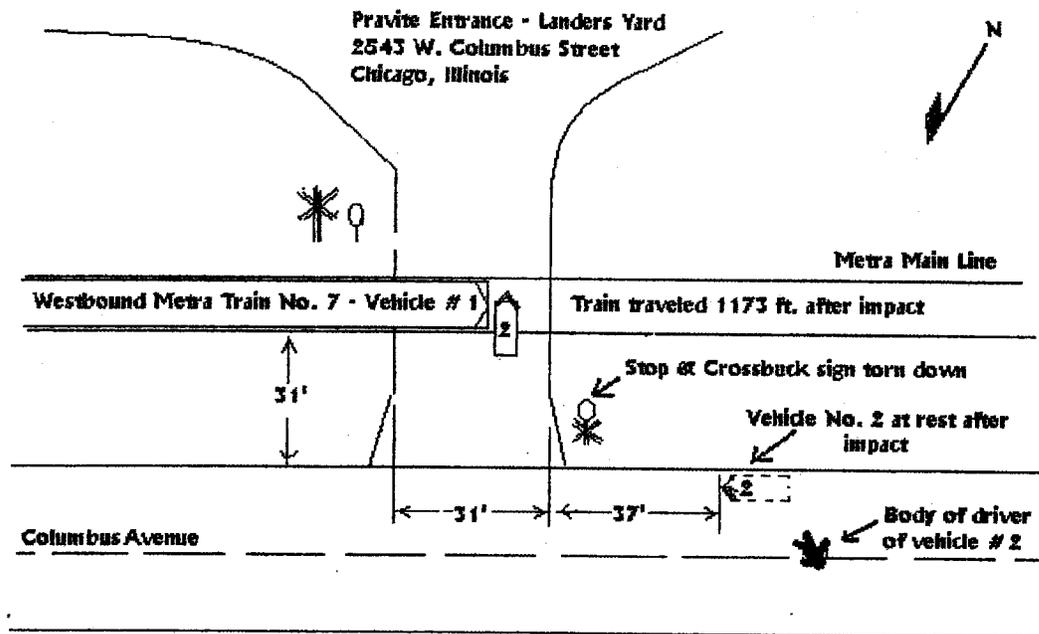
Grade Crossing Accident
Chicago, Illinois
October 7, 1997
FE-30-97

The automobile was damaged beyond repair. A review of the maintenance records on the automobile indicated the vehicle had been maintained in accordance with departmental standards. A complete (front and rear) brake job had been performed on July 10, 1997.

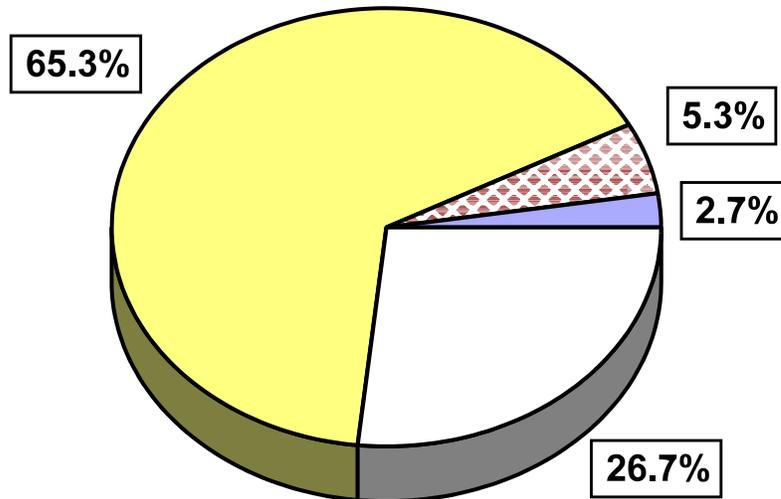
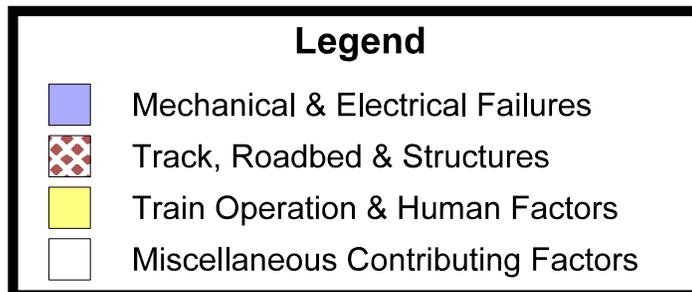
Major Possible Contributing Factor Categories Involved in 1997 Railroad Employee Fatalities

- The majority (over 65 percent) of all PCFs in the 28 fatalities were Train Operation & Human Factors, followed by nearly 27 percent which were Miscellaneous Contributing Factors. The latter category included highway collisions, inexperience, environmental conditions, highway-rail crossing accidents, inadequate training, object(s) on tracks, excessive noise, and driving under the influence (highway).

Slightly over 5 percent of all PCFs concerned Track, Roadbed & Structures, specifically irregular cross level of track, insufficient ballast section, and problems with engineering design or construction. Nearly 3 percent involved Mechanical & Electrical Failures, specifically defective steps on the outside of a rail car, and a defective coupler drawhead. (*See Appendix H, pie chart entitled "Major Possible Contributing Factor Categories Involved in 1997 Railroad Employee Fatalities."*)

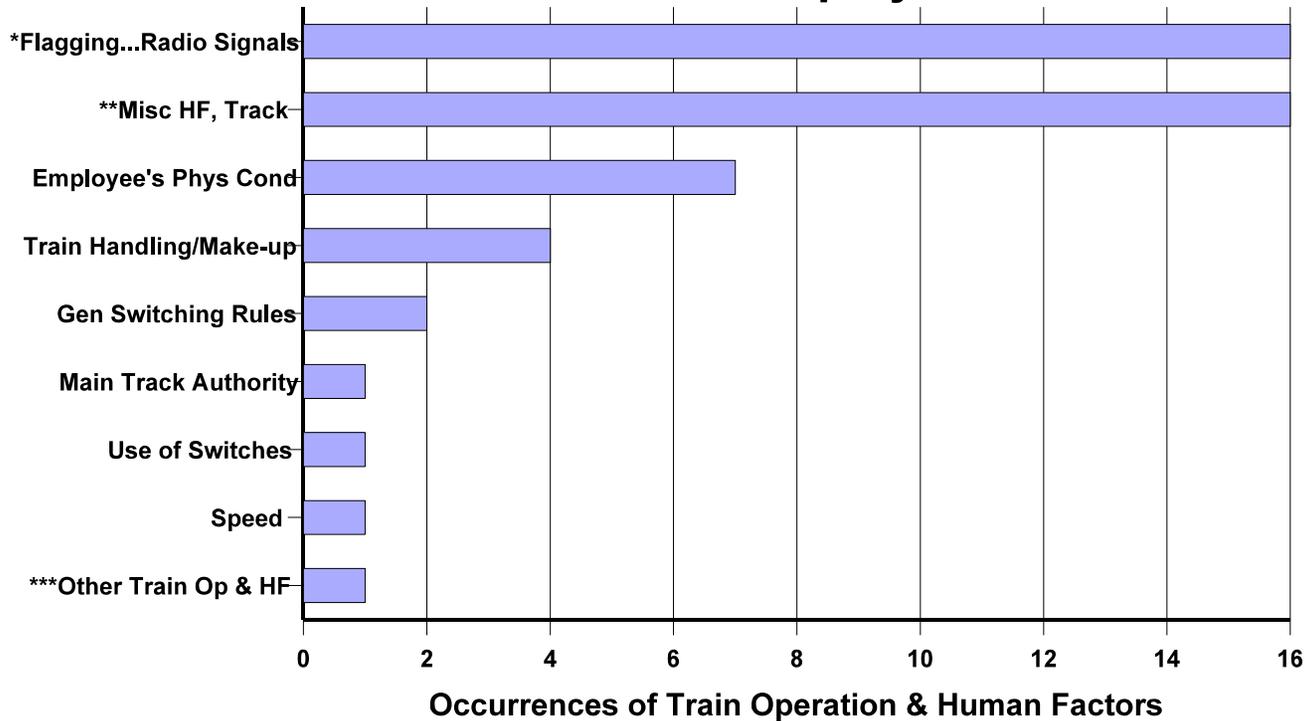
Train Operation & Human Factor Categories Involved in 1997 Railroad Employee Fatalities

The "Flagging, Fixed, Hand & Radio Signals" category included the absence of a fixed signal (blue signal), improper hand signal, improper radio communication, failure to give or receive radio communication, inappropriately using or failing to use the train's headlights, and inappropriately using or failing to use the train's horn.

The “Miscellaneous Human Factors, Track” category included inadequate fall protection, fouling the track, intercommunication problems affecting safety for workers on the tracks, non-compliance with on-track-safety rules, non-compliance with Roadway Protection Standards, track repair error, and errors by a Crane Operator and Flagman. *(See Appendix I, bar chart entitled “Train Operation & Human Factor Categories Involved in 1997 Railroad Employee Fatalities.”)*
