REPORT: FE-01-97
RAILROAD: Soo Line Railroad (SOO)
LOCATION: Milwaukee, Wisconsin
DATE, TIME: Jan. 8, 1997, 11:25 a.m., CST
PROBABLE CAUSE: Vapors from an oxygen/acetylene gas tank set in an enclosed area were ignited by flying sparks from a rail saw which caused an explosion within the compartment. This resulted in debris striking the nearby employee.

GLENDALE YARD (B-YARD)
MILWAUKEE, WISCONSIN
FE-01-97

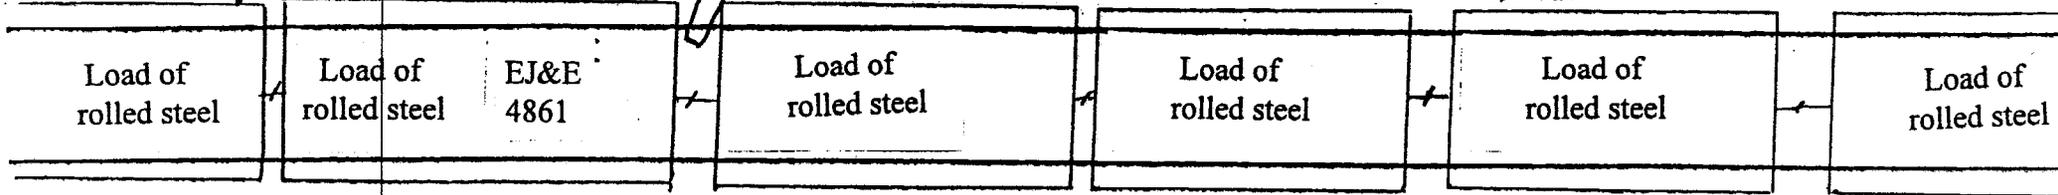
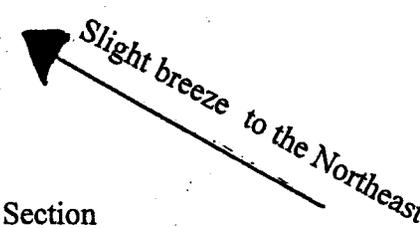
Please see the attached diagram of the Glendale Yard to better visualize the accident scene and chain of events leading up to the fatality.

An examination of the gas compartment showed little carbon on the walls of the cabinet. The acetylene tank was turned off, but the oxygen tank shut-off valve was a half turn open. Oxygen may have accumulated in the bottom of the gas compartment and mixed with a small amount of acetylene. The saw produced sparks that were thrown toward the truck. The gas compartment doors were closed, but a 2-inch drain hole in the bottom of the gas compartment may not have had a plastic plug in place. The location of the small fire in the bottom of the gas compartment was near the drain hole. A spark from the saw could have caused a mixture of oxygen and acetylene vapors in the gas compartment, exiting through the drain hole, to explode.
