REPORT: FE-04-97
RAILROAD: Union Pacific Railroad Company (UP)
LOCATION: Mason City, Iowa
DATE/TIME: Jan. 29, 1997 - 12:55 a.m., CST

PROBABLE CAUSE:

Failure of employees (Conductor and Engineer) to properly communicate/acknowledge, via company radio, directions involving a backing movement.

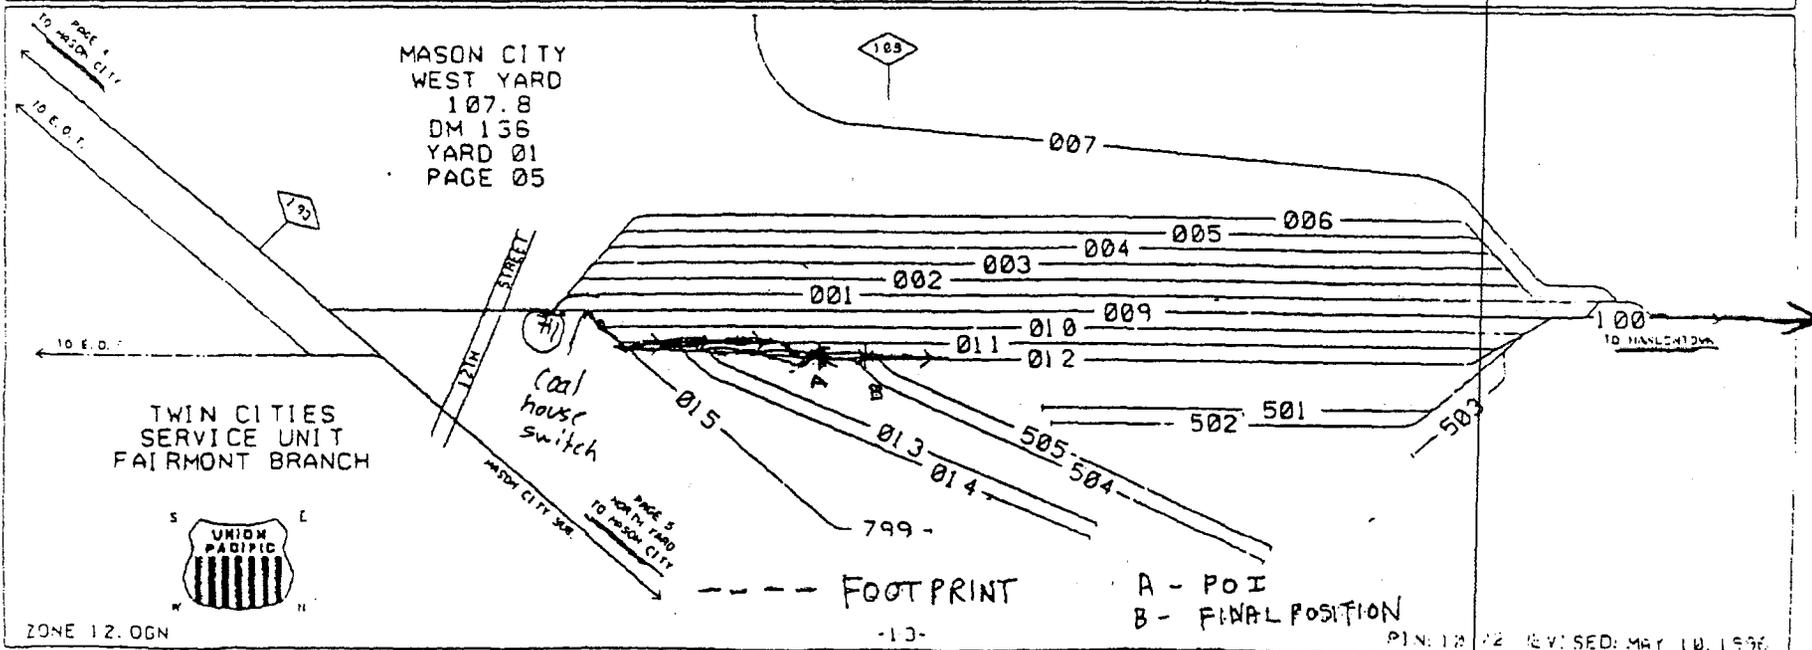
Please see the attached diagram of the Mason City West Yard to better visualize the accident scene and the chain of events leading up to the fatality.

An Officer from the Mason City Police Department started his investigation immediately following the accident. The Police Investigator indicated he was able to trace the Conductor's footprints in the snow leading from Switch 504 northward along the east side of the Come-Out Track for approximately 130 feet. The footprints then crossed over the Come-Out Track and continued northward in between the Come-Out Track and Yard Track No. 12 for approximately 40 feet, at which point they crossed onto the middle of Yard Track No. 12.

The footprints continued for a distance of approximately 12 feet to the point where the Conductor was struck from behind by the locomotive consist. The Conductor's body came to rest at a point approximately 150 feet north of the point of impact.
