REPORT: FE-10-97
RAILROAD: Consolidated Rail Corporation (CR)
LOCATION: Newark, New Jersey
DATE, TIME: March 21, 1997, 7:15 p.m., EST

PROBABLE CAUSE:

The Carman failed to maintain proper vigilance for moving railroad equipment while fouling unprotected track.

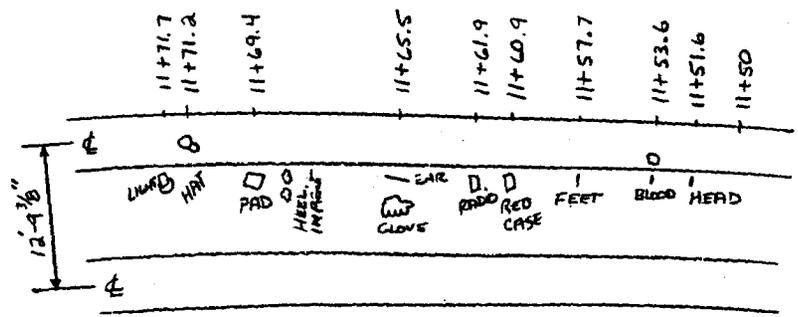
ACCIDENT SITE DETAIL

At approximately 8:00 p.m., the Carman was found fatally injured lying between Tracks Nos. 7 and 8. Evidence indicates that the Carman was struck in the back and left shoulder by the moving equipment traveling east on Track No. 8. His right arm was severed above the elbow by the wheels of the passing equipment. While awaiting the arrival of the emergency responders

Please see the attached diagram of the Oak Island Yard to better visualize the accident scene and the chain of events that led up to the fatality.
