REPORT: FE -15-97
RAILROAD: Long Island Railroad (LIRR)
LOCATION: Nassau, New York
DATE, TIME: June 5, 1997, 10:40 a.m., EST

REPORT: FE-16-97
RAILROAD: Central Michigan Railway Company (CMGN)
LOCATION: Bay City, Michigan
DATE, TIME: June 6, 1997, 9:35 p.m., EST

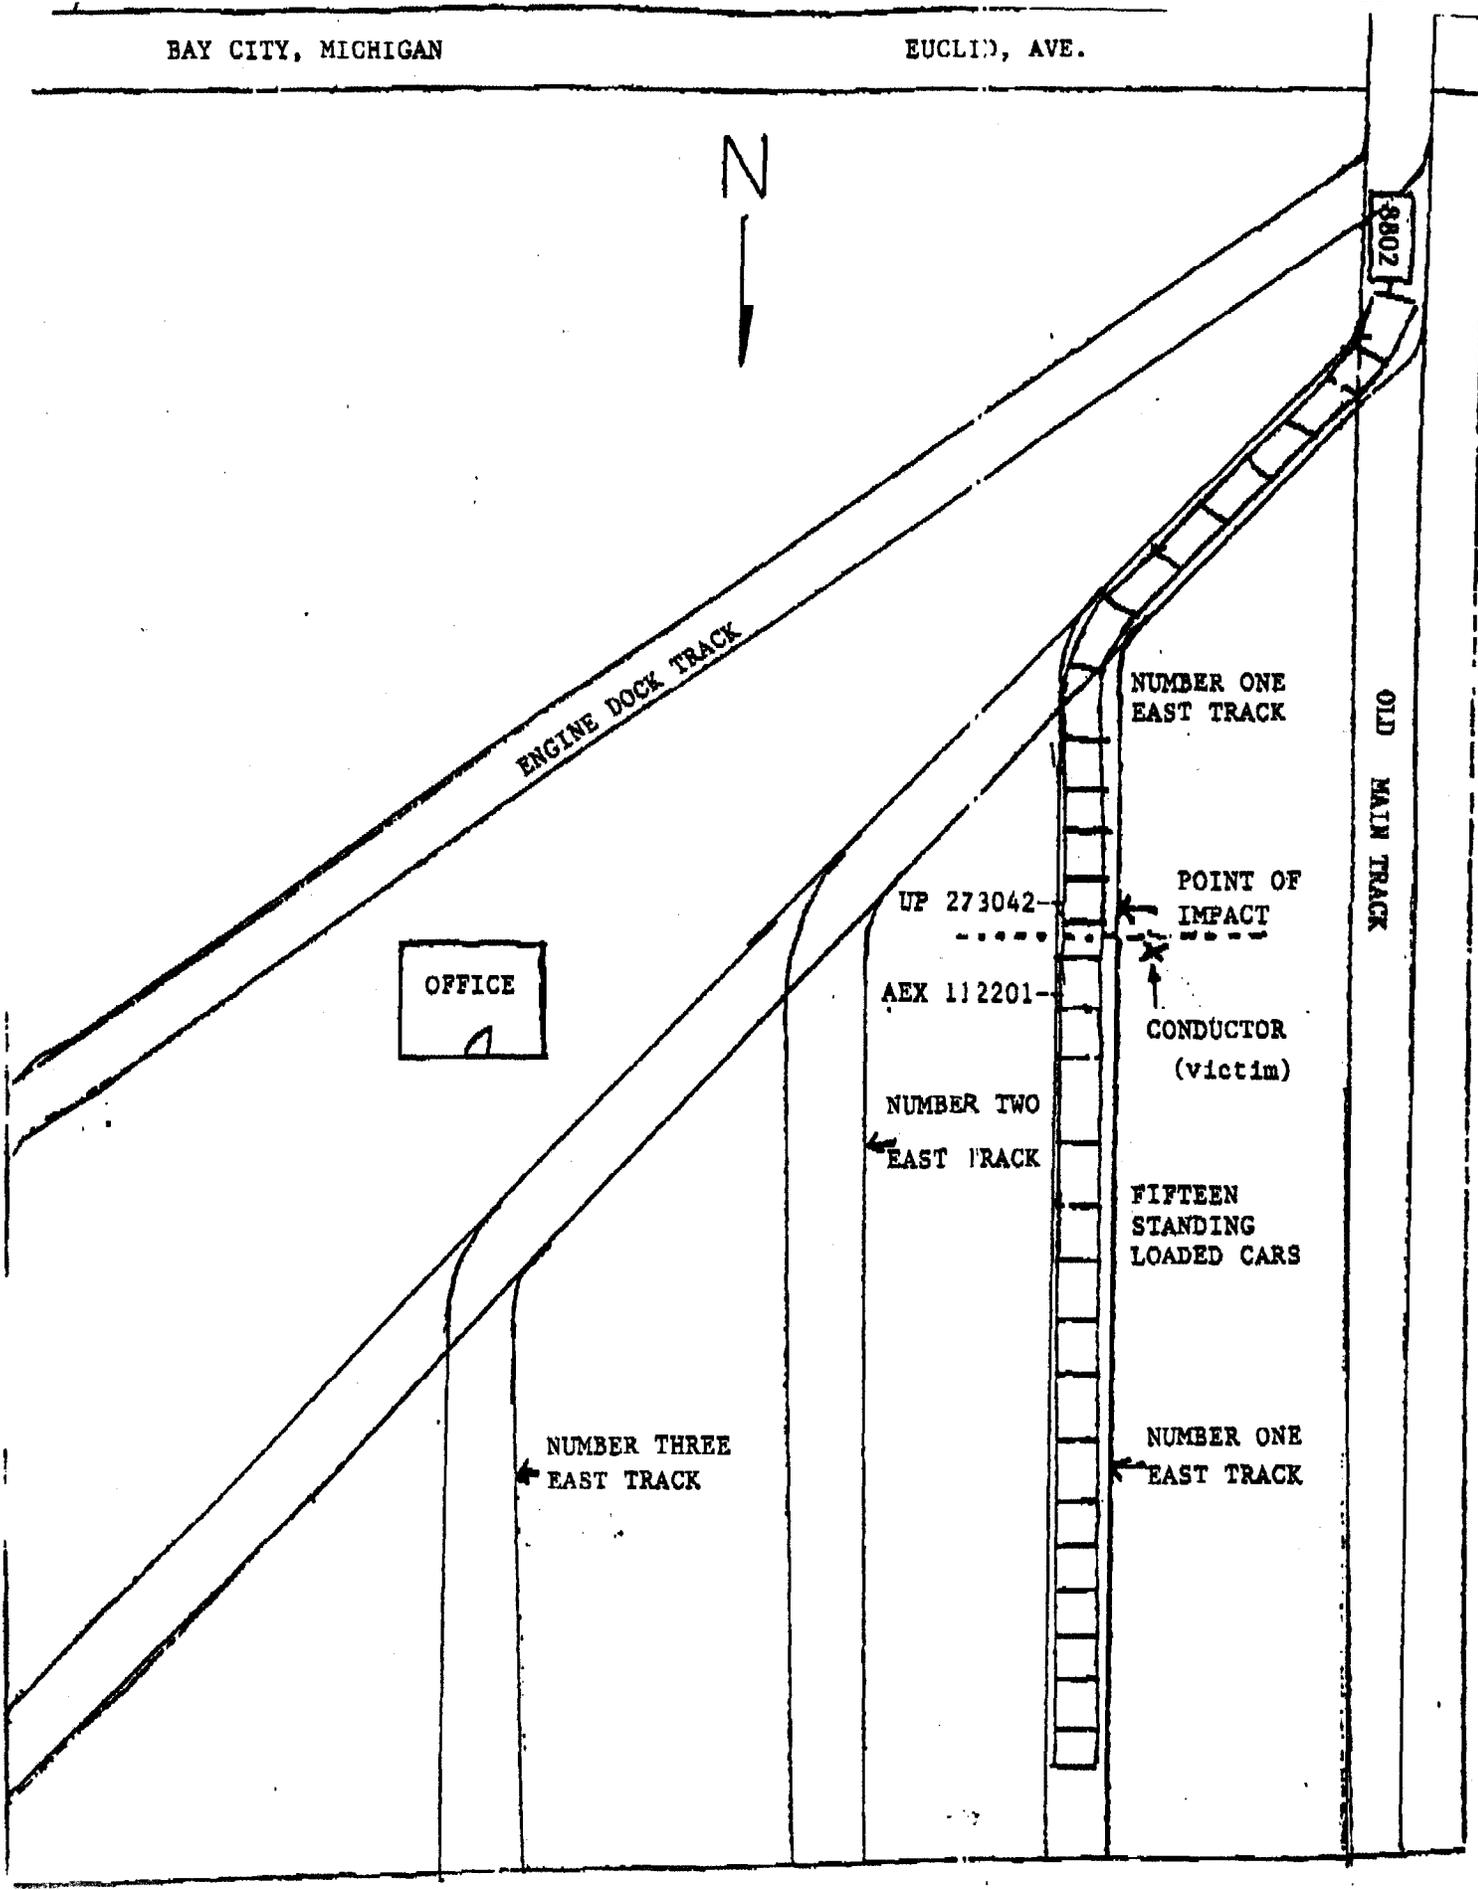
Please see the attached diagram of Winona Yard and the Euclid Avenue Grade Crossing to better visualize the accident scene and chain of events that led up to the fatality.

The investigation revealed a severe impact between AEX 112201 (covered hopper), the southernmost car of 15 standing cars, and UP 273042 (bulk head flatcar), the northernmost car of the 14 cars being shoved onto Track No. 1. Evidence indicates the Conductor was riding on the west side of the bulk head flatcar in a position to be crushed by the resulting impact. The force of the collision caused considerable damage to both cars. It was also noted that the angle cock on the bulk head flatcar was open after the accident, suggesting an explanation for the emergency brake application. Measurements taken at the scene revealed the impact had occurred approximately 16 car lengths from the point where the northbound movement had begun.

POINT OF IMPACT
