REPORT: FE-31-97

RAILROAD: National Railroad Passenger Corporation (ATK)

LOCATION: Concord, Massachusetts

DATE, TIME: Oct. 10, 1997; 12:01 p.m., EST

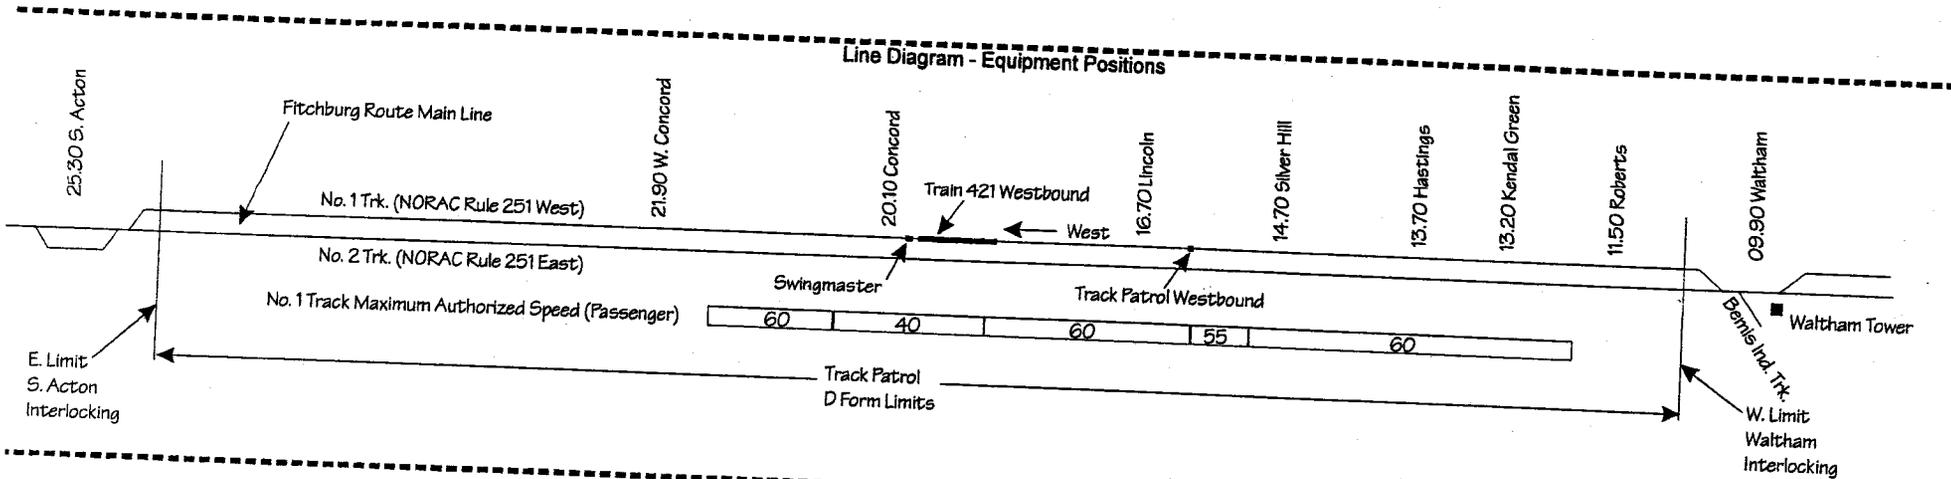
Line Diagram - Equipment Positions

At the crossing, the Track Foreman, Track Laborer, and the Roadmaster heard and saw Train 421 approaching. The personnel on the ground shouted to the Swingmaster Operator to jump off of the machine. All personnel on the ground cleared the track prior to impact. At 12:01 p.m., Train 421 struck the Swingmaster, which was shoved down the track approximately 172 feet and thrown across Track No. 2. Train 421 stopped 335 feet west of the point of impact, which was approximately 400 feet east of the point where the locomotive otherwise would have been positioned for a regular stop at Concord station.

At the time of the accident, the Swingmaster was facing west while straddling the rails of Track No. 1. The train struck the machine in the rear, and it was shoved down the track, then thrown across Track No. 2. When it came to a rest, the machine was on its side approximately 180 degrees from its original position and was fouling Track No. 2.

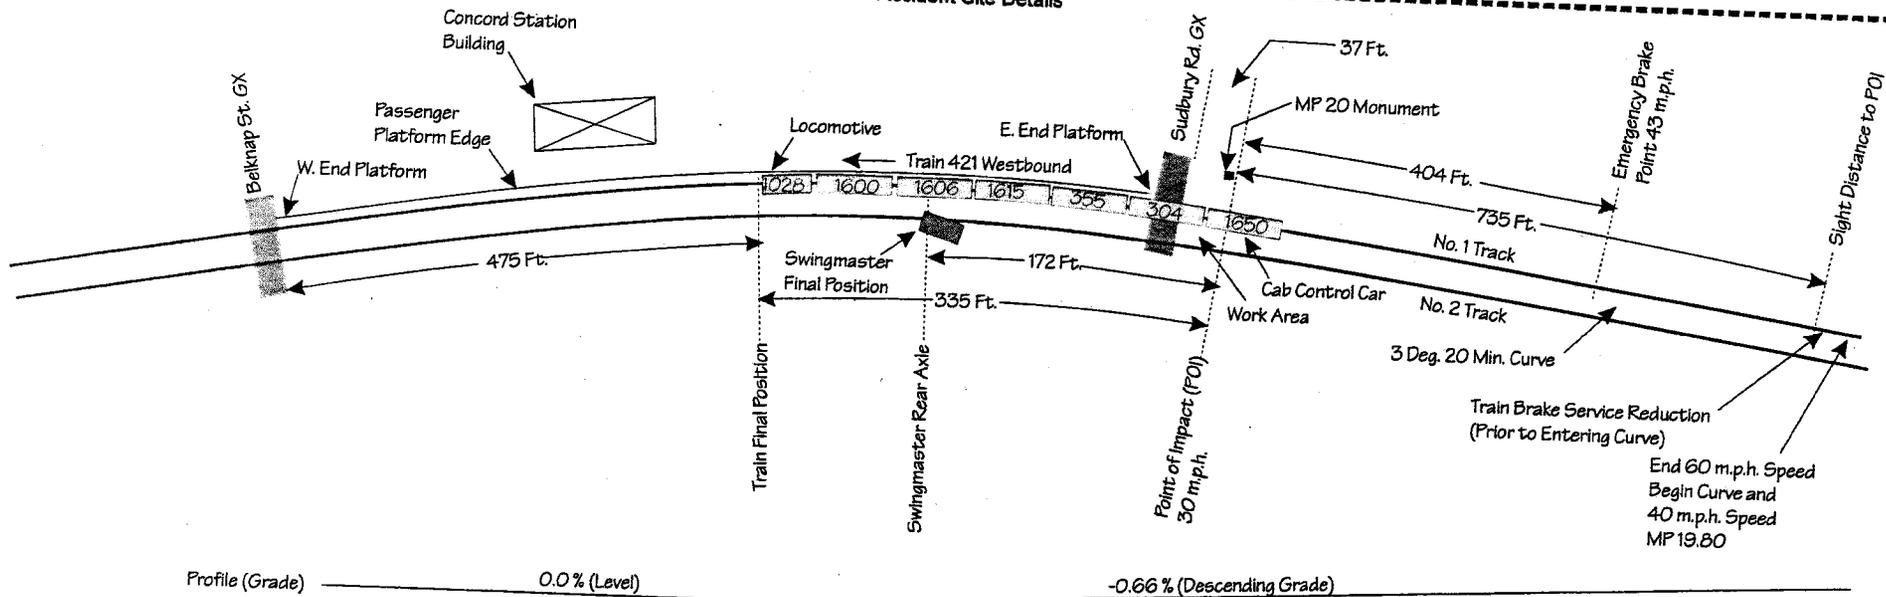
Accident Site Details

Track No. 1 in the vicinity of the accident comprised 115 RE jointed rail. The geometry in the vicinity of the accident included a 3-degree, 20-minute curve to the left as viewed from the operating compartment of a westbound train. The sight distance was determined to be 725 feet in advance of the point of impact. There was a 0.66 percent sustained descending grade for 1.2 miles that westbound trains negotiated while approaching milepost 20.

Profile (Grade) 0.0% (Level)

-0.66% (Descending Grade)
