The Accident

Post-Accident Investigation

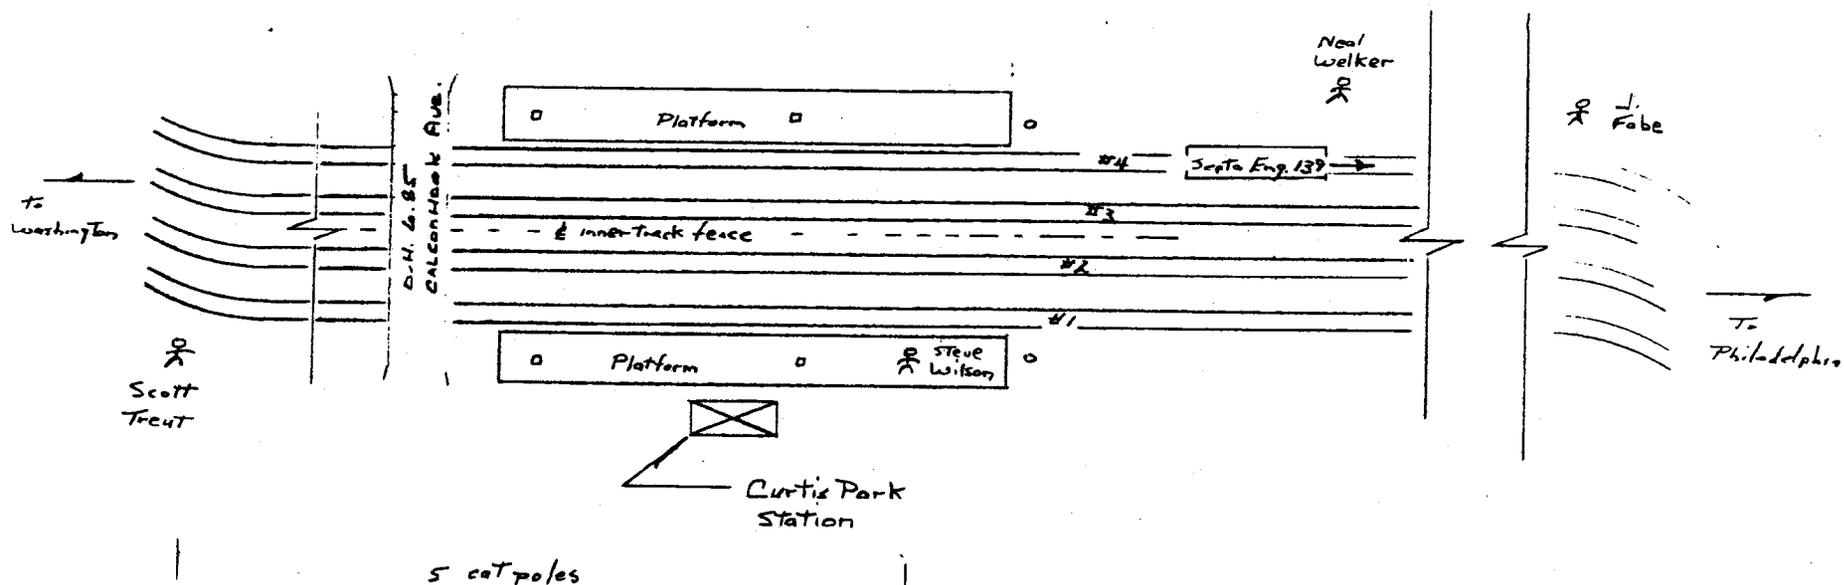
Curtis Park, VA.

- Dimensions Approximate
- Locations of watchmen as stated themselves.

3 catpoles

4 catpoles??
