REPORT: FE-36-97

RAILROAD: Burlington Northern Santa Fe Railway Company (BNSF)

LOCATION: Emporia, Kansas

PROBABLE CAUSE: The Conductor was standing foul of Track No. 6802 and did not move in the clear as an oncoming train approached.

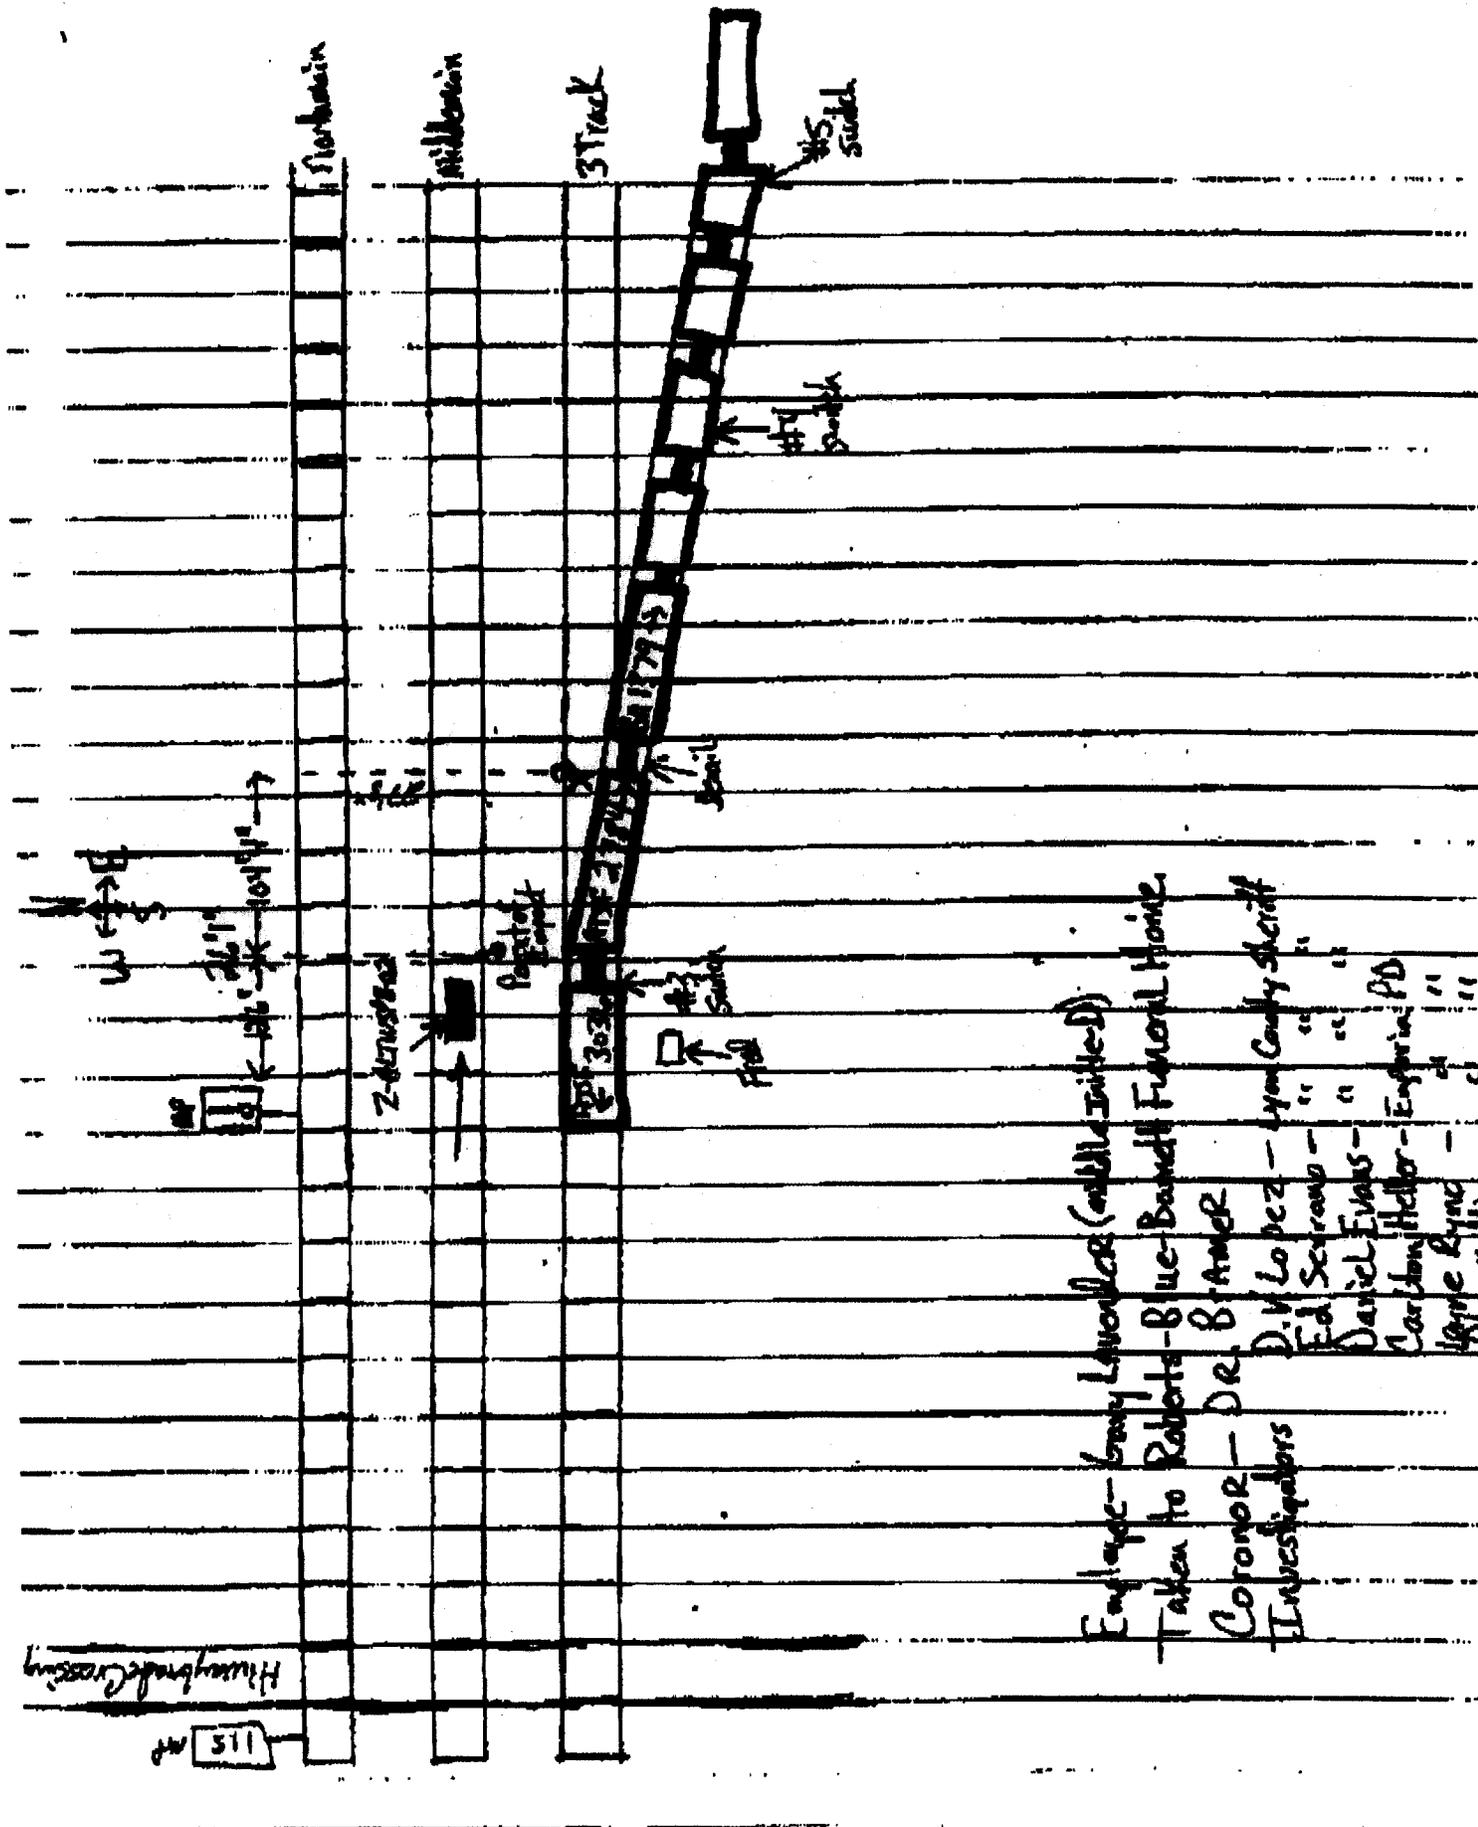
(Please see the attached diagrams of the Emporia Subdivision and accident scene to better visualize the chain of events that led up to the fatality.)

steps of the second locomotive in his consist when he was struck by the passing train. The Conductor was standing on the end of the crossties between Track No. 6803 and the Middle Main Track with his back toward the oncoming through-freight train. Investigators could not determine why the Conductor was fouling the adjacent track or why he did not respond to the whistle being sounded by the oncoming freight train.
