***Federal Railroad Administration
Office of Railroad Safety
Accident and Analysis Branch***

***Accident Investigation Report
HQ-2014-1014***

***Montana Rail Link (MRL)
Bonner, MT
November 13, 2014***

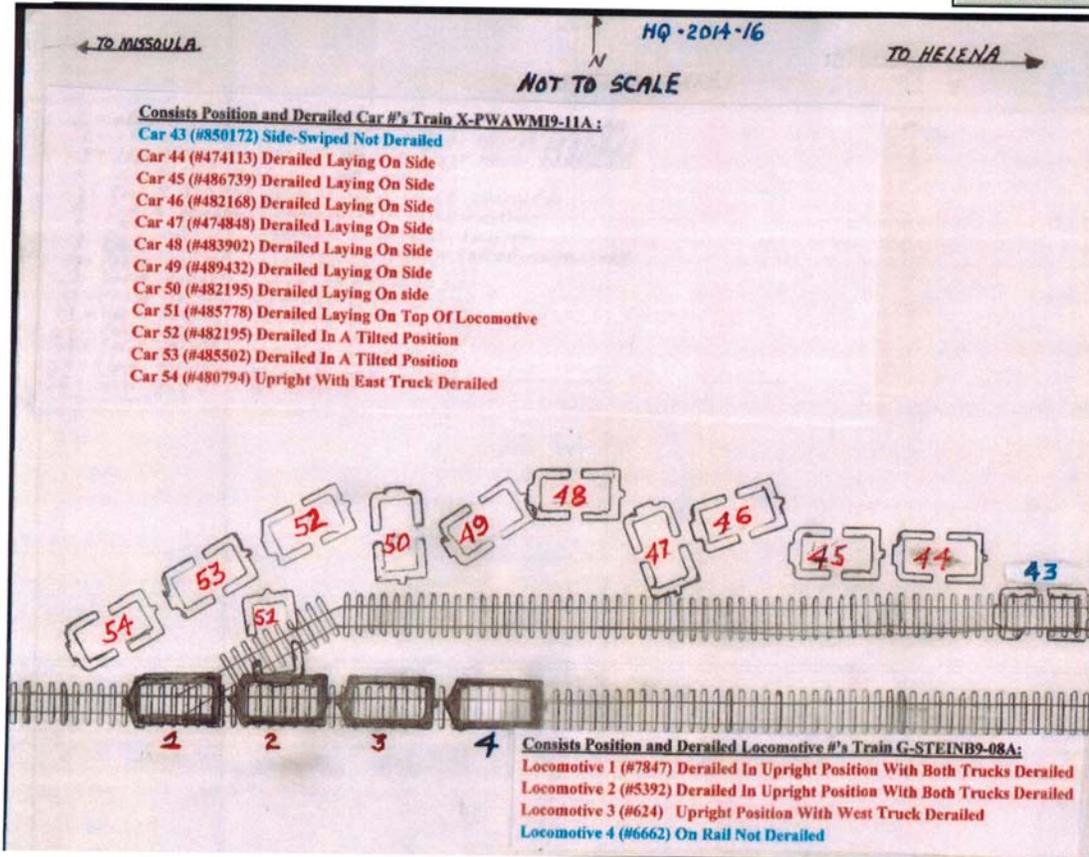
HQ-2014-16 Sketch

On November 13, 2014, at approximately 10:20 PM (MST), westbound Montana Rail Link (MRL) Train G-STEINB9-08A failed to stop at a stop signal indication at the West Bonner, Montana Control Point (CP) resulting in an impact of their train with the side of eastbound MRL Train X-PWAWMI9-11A which was traveling eastward into the siding at Bonner. The westbound derailed 3 (three) of its 4 (four) head end locomotives causing significant damage to the leading unit and also damaging the second unit. The resulting collision caused a derailment of 11 (eleven) empty grain cars (consist positions 44 through 54) of the eastbound train.

Eastbound X-PWAWMI9-11A was traversing through the turnout and into the siding track, at the West Bonner CP, at a recorded speed of 20 mph when westbound G-STEINB9-08A impacted (side swiped) the 43rd car in its consist. After the collision the eastbound train crew contacted the MRL's Dispatching Center and informed the dispatcher of the collision and the ensuing derailment.
