***Federal Railroad Administration  
Office of Railroad Safety  
Accident and Analysis Branch***

***Accident Investigation Report  
HQ-2015-1041***

***Southwestern Railroad Company, Incorporated (SW)  
Chisum, NM  
April 28, 2015***

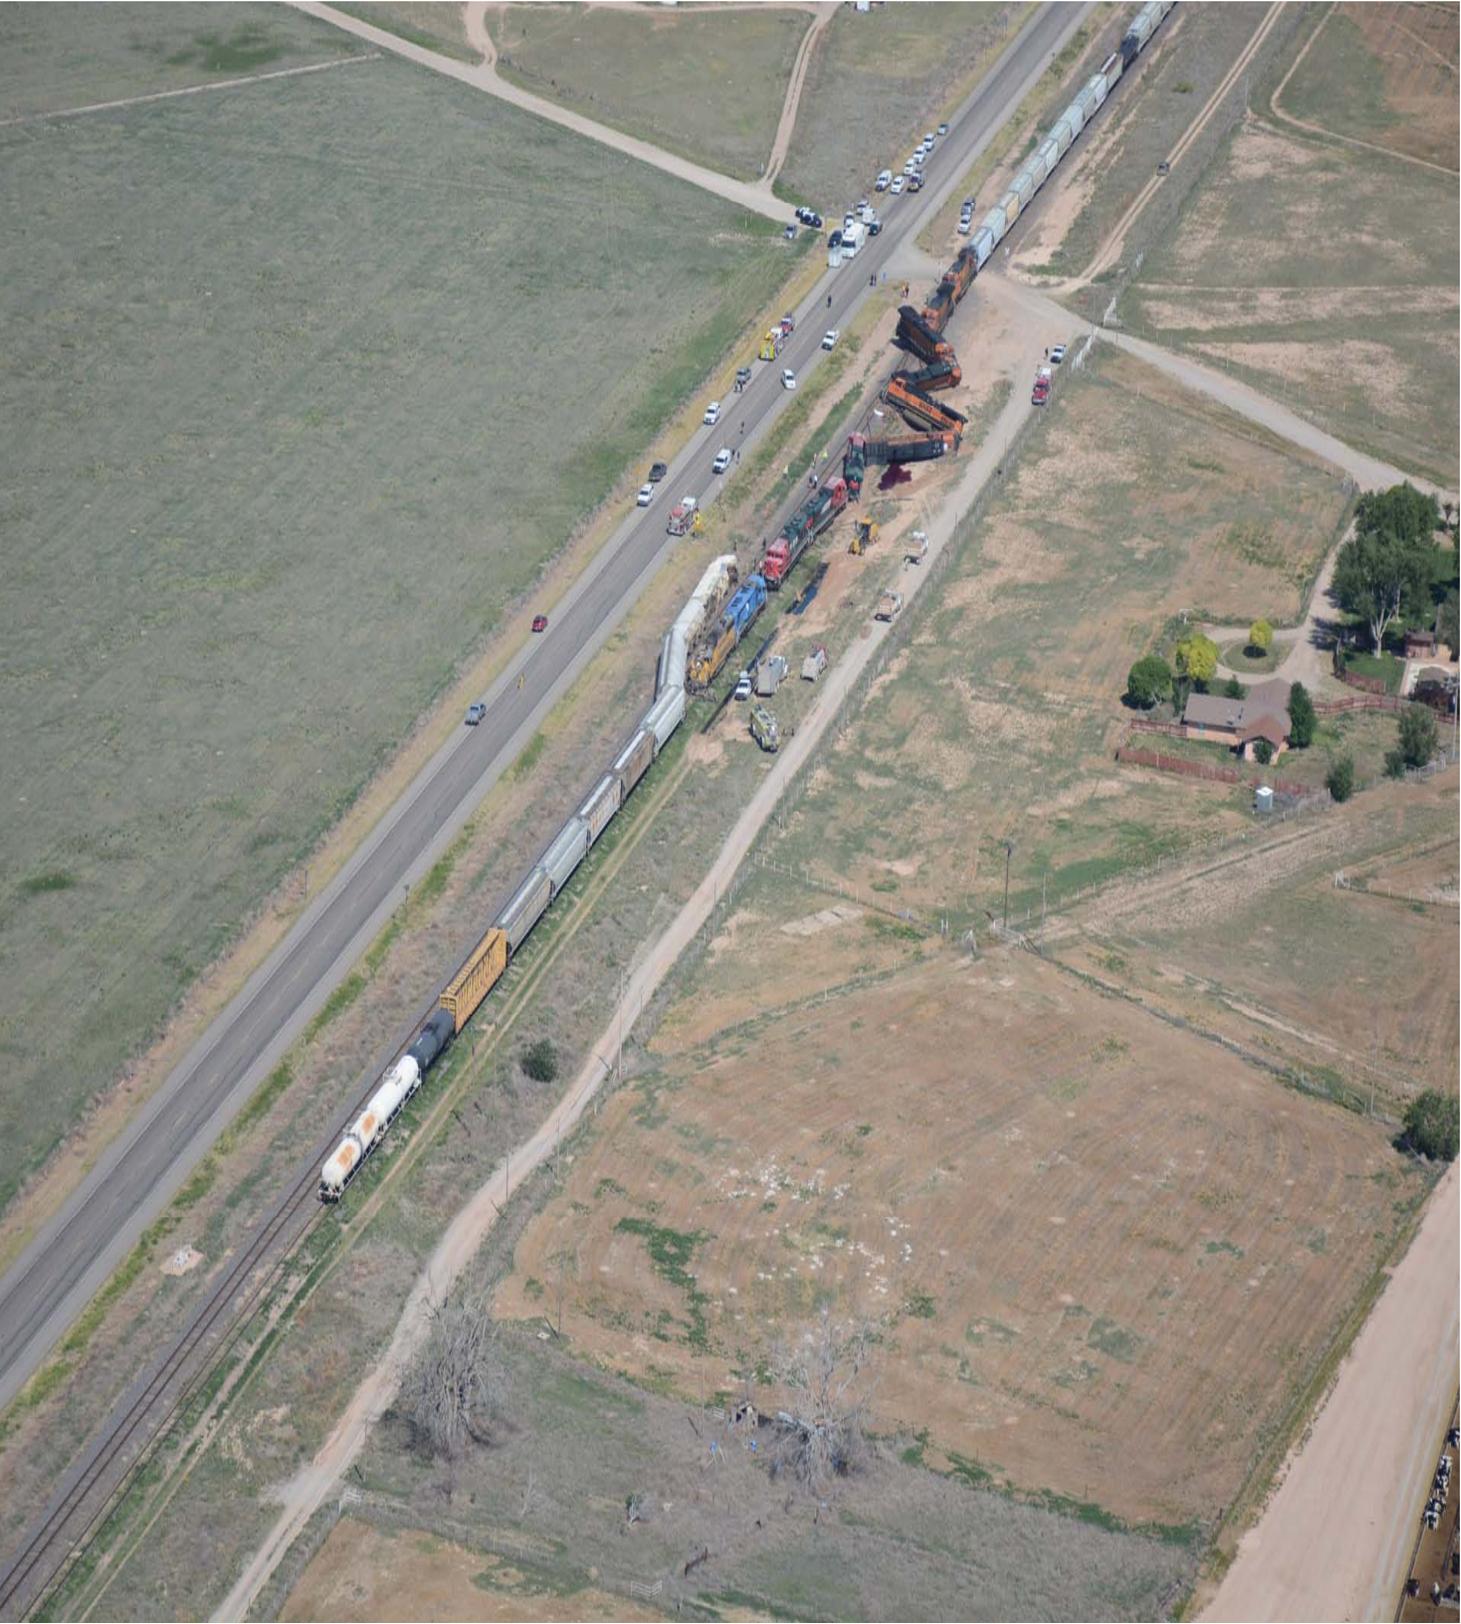
Site Photo

On April 28, 2015, at 6:24 a.m., MST, a southbound Southwestern Railroad (SW) freight train, MCLOCRL127A, struck a standing freight train (LSWC0021271) head-on in the Chisum Siding, at Milepost 118.3, on the Carlsbad Subdivision near Chisum, New Mexico. The standing train was an unattended local train secured in the Chisum Siding. Eight of the nine locomotives derailed on the striking train and two locomotives and three empty hopper cars derailed on the struck train.

The cause of this accident was a failure to insure the Chisum siding switch was lined for movement on the main track. FRA concluded the accident occurred because the local train Conductor failed to line the Chisum siding switch back to normal (cause code H702).
