**Federal Railroad
Administration**

Research Results

RR08-15
October 2008

Performance of Two Concrete Bridges at the Facility for Accelerated Service Testing for 500 MGT

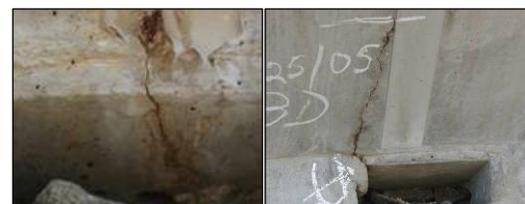
Cracks initiated from several of the deck drain openings and propagated in ballast curbs (Figure 6). The ballast curbs were cast separately at the plant after the box girders were removed from the prestressing bed. The curbs are cast with asphalt separation panels along their length to minimize the amount of live load they carry. The asphalt panels are centered at the drain opening locations. Since the ballast curbs are not a structural part of the main girder, the cracks do not seem to pose any problems at this point. Figure 7 shows the largest of these cracks.

Figure 6. Typical Cracking near Deck Drain Opening (left). Figure 7. Largest Crack near Deck Drain Opening (right).

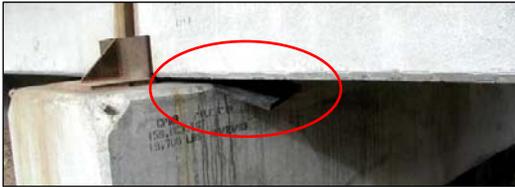
Figure 8 shows a bearing pad on one span at the center pier of the conventional bridge that worked its way out from under the girder. To restrict movement, this pad was glued to the top of the pile cap. Shortly thereafter, a crack was observed at the girder corner nearest that pad, as Figure 9 shows.

Figure 8. Bearing Pad Working out from Concrete Span.

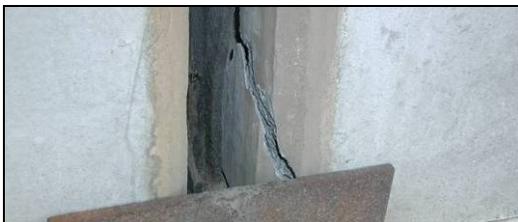
Figure 9. Cracked Girder Corner after Bearing Pad was Glued in Place.

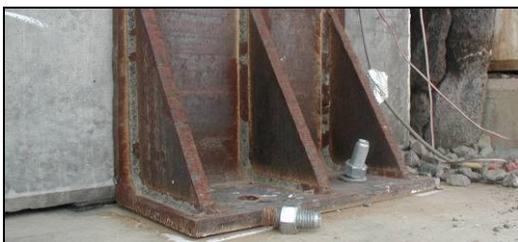
Figure 10 shows bent and broken anchor bolts on the 42-foot span of the SOA bridge. The span has moved outward slightly on the 5-degree curve.

Figure 10. Bent and Broken Anchor Bolts on SOA Bridge.

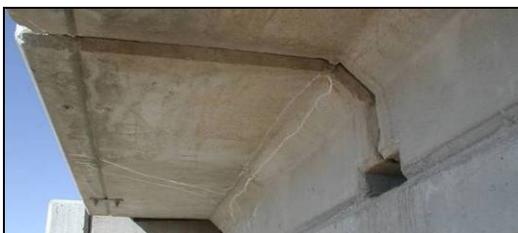
During a normal track surfacing operation, a regulator struck the ballast curb at the southwest corner of the conventional concrete bridge. This appears to have caused a crack in the curb. Figure 11 shows the ballast curb crack.

Figure 11. Ballast Curb Crack.

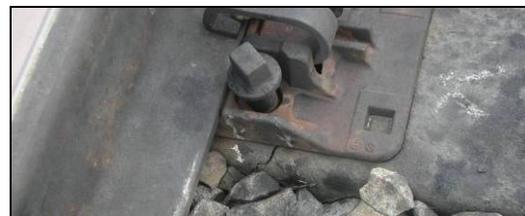
A total of 10 plastic ties cracked on the SOA bridge. On the outside (high) rail, there were nine cracked or broken ties. On the inside (low) rail, there were three broken or cracked ties. Two ties were cracked under both rails. There were two broken tie plates on the outside rail and two broken tie plates on the inside rail. Also, three ties on the outside rail had screw spikes that loosened significantly. All of the cracks pass through the holes for the screw spikes. Figures 12 and 13 show plastic composite tie cracks and a broken tie plate on the SOA bridge.

Figure 12. Cracked Composite Tie with a Loose Screw Spike.

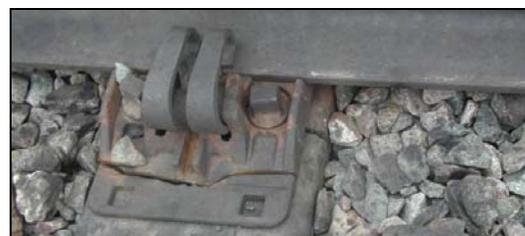
Figure 13. Broken Tie Plate on Cracked Plastic Composite Tie.

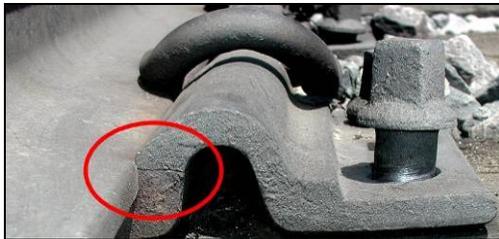
Thirty-six timber ties (oak) on the conventional bridge accumulated 335 MGT of 315,000-pound GRL traffic. Some ties became slightly skewed so that the rail is wearing into the inside of the curved part of the Pandrol plate causing a crack. Figure 14 shows a cracked Pandrol plate with a loose screw spike on the high rail of the conventional bridge. This wearing caused the cracking of 12 tie plates, all on the high rail. Four of the plates were side by side. All 12 plates were replaced. Two of the plates had the screw spikes broken off. Others had loose screw spikes. A cut spike was used to hold each plate temporarily. Similar problems have been noted in the tie and fastener experiment at FAST [Ref. 4].

Figure 14. Cracked Pandrol Plate with a Loose Screw Spike.

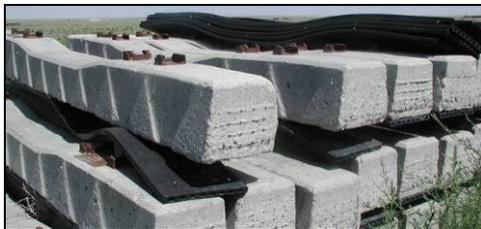
Two generations of UP prestressed concrete ties with rubber pads attached to the bottoms installed on the SOA bridge accumulated over 100 MGT each. The first generation ties featured rubber pads glued to the bottoms. After 130 MGT, the rubber showed no signs of wear, but the pads became partially unglued on some ties (Figure 15). The second generation ties featured rubber pads cast into the bottoms. After 155 MGT, some deterioration of the interface was evident near the edges (Figure 16).

Figure 15. Concrete Ties with Glued and Unglued Rubber Pads.
