***Federal Railroad Administration
Office of Safety
Headquarters Assigned
Accident Investigation Report
HQ-2010-06***

***CSX Transportation (CSX)
Meyersdale, PA
February 6, 2010***

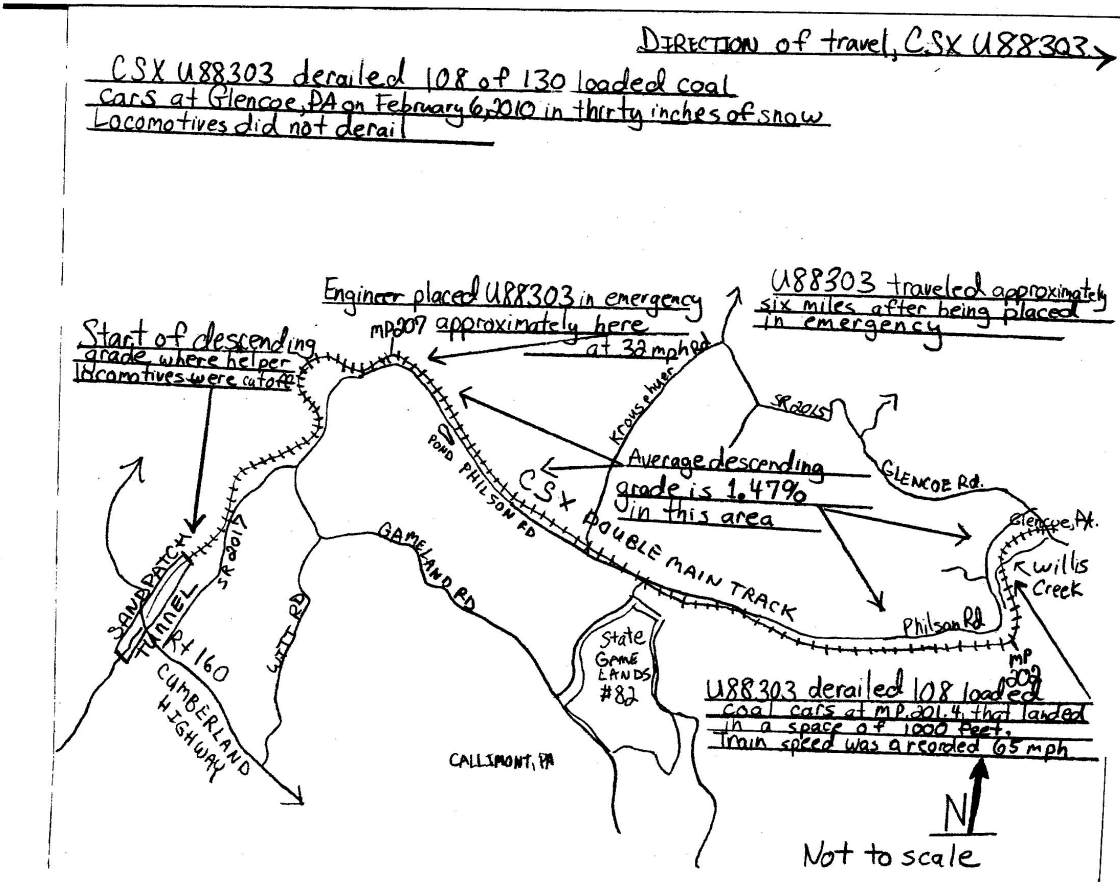
U.S. Department of Transportation Federal Railroad Administration	FRA FACTUAL RAILROAD ACCIDENT REPORT	FRA File # HQ-2010-06
			Report
106. DRAW A SKETCH OF ACCIDENT AREA INCLUDING ALL TRACKS, SIGNALS, SWITCHES, STRUCTURES, OBJECTS, ETC., INVOLVED.			
		TIC ID# 22353

On February 6, 2010 at 2:15 a.m. EST CSX loaded coal train U883-03, operating from Connellsville, PA to Baltimore, MD, derailed 108 coal hopper cars at milepost BF 201.4 at Glencoe, PA. The train was traveling in an eastward direction according to the CSX Baltimore division timetable, which is also the geographical direction. At the time of the accident it was dark and snowing heavily. There were 24-30 inches of snow on the ground and near white out conditions. The train consisted of two GE locomotives, CSX 565 and CSX 50, and 130 loaded coal hopper cars. The train was 6581 feet long and had a trailing tonnage of 17,300 tons. The derailment occurred while descending the 1.47% Sandpatch grade operating on the Main Track number two. There were no reported injuries or hazardous materials released. Estimated damages including equipment, track, and signal, is a reported \$2,200,500.
