***Federal Railroad Administration
Office of Safety
Headquarters Assigned
Accident Investigation Report
HQ-2007-29***

***Union Pacific (UP)
Nisqually, Washington
May 16, 2007***

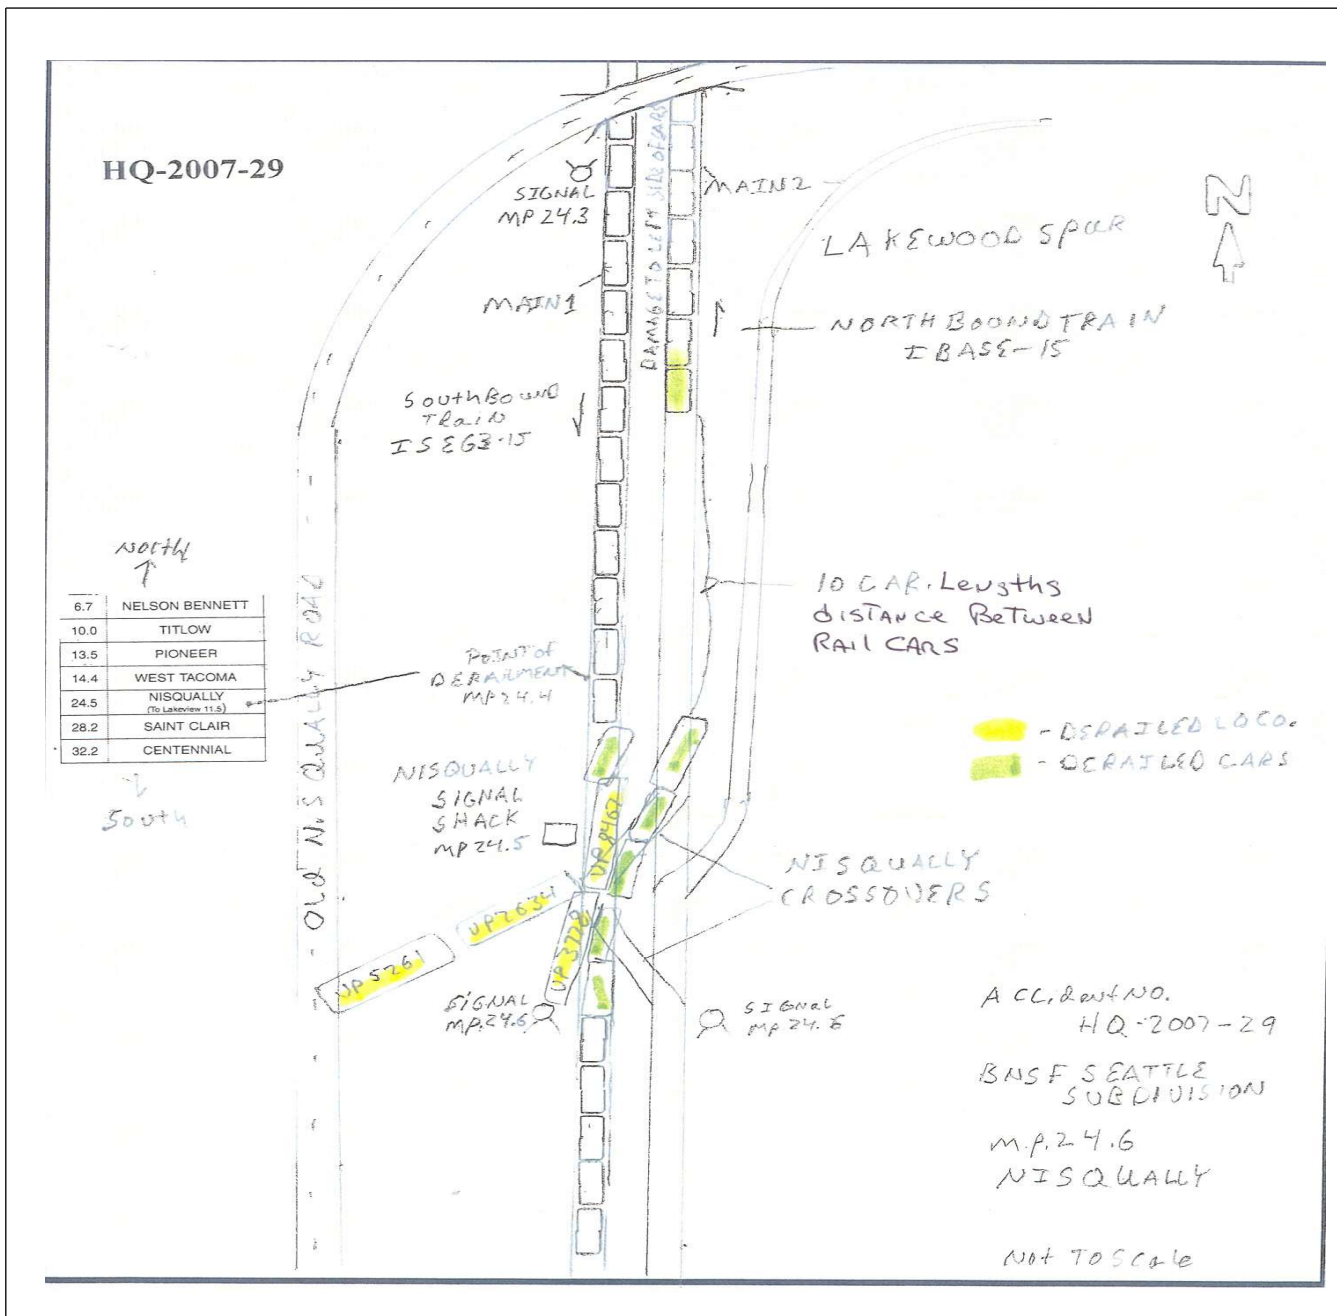
136. DRAW A SKETCH OF ACCIDENT AREA INCLUDING ALL TRACKS, SIGNALS, SWITCHES, STRUCTURES, OBJECTS, ETC., INVOLVED.

As a result of the collision, four locomotives and two multi-unit intermodal cars of the southbound train derailed. The two leading locomotives went over an embankment and stopped at the edge of a nearby county road in upright positions. The two trailing locomotives derailed but remained on the railroad right-of-way in upright positions. Two multi-unit intermodal cars of the northbound train and two multi-unit intermodal cars of the southbound train derailed.

The accident occurred on the BNSF Northwest Division, Seattle Subdivision, Nisqually station, milepost 24.5. Nisqually is located about four miles southwest of Du Pont, Washington, and about 50 miles south of Seattle.
