***Federal Railroad Administration
Office of Safety
Headquarters Assigned
Accident Investigation Report
HQ-2007-62***

***DeQueen & Eastern Railroad Company (DQE)
Wright City, Oklahoma
October 18, 2007***

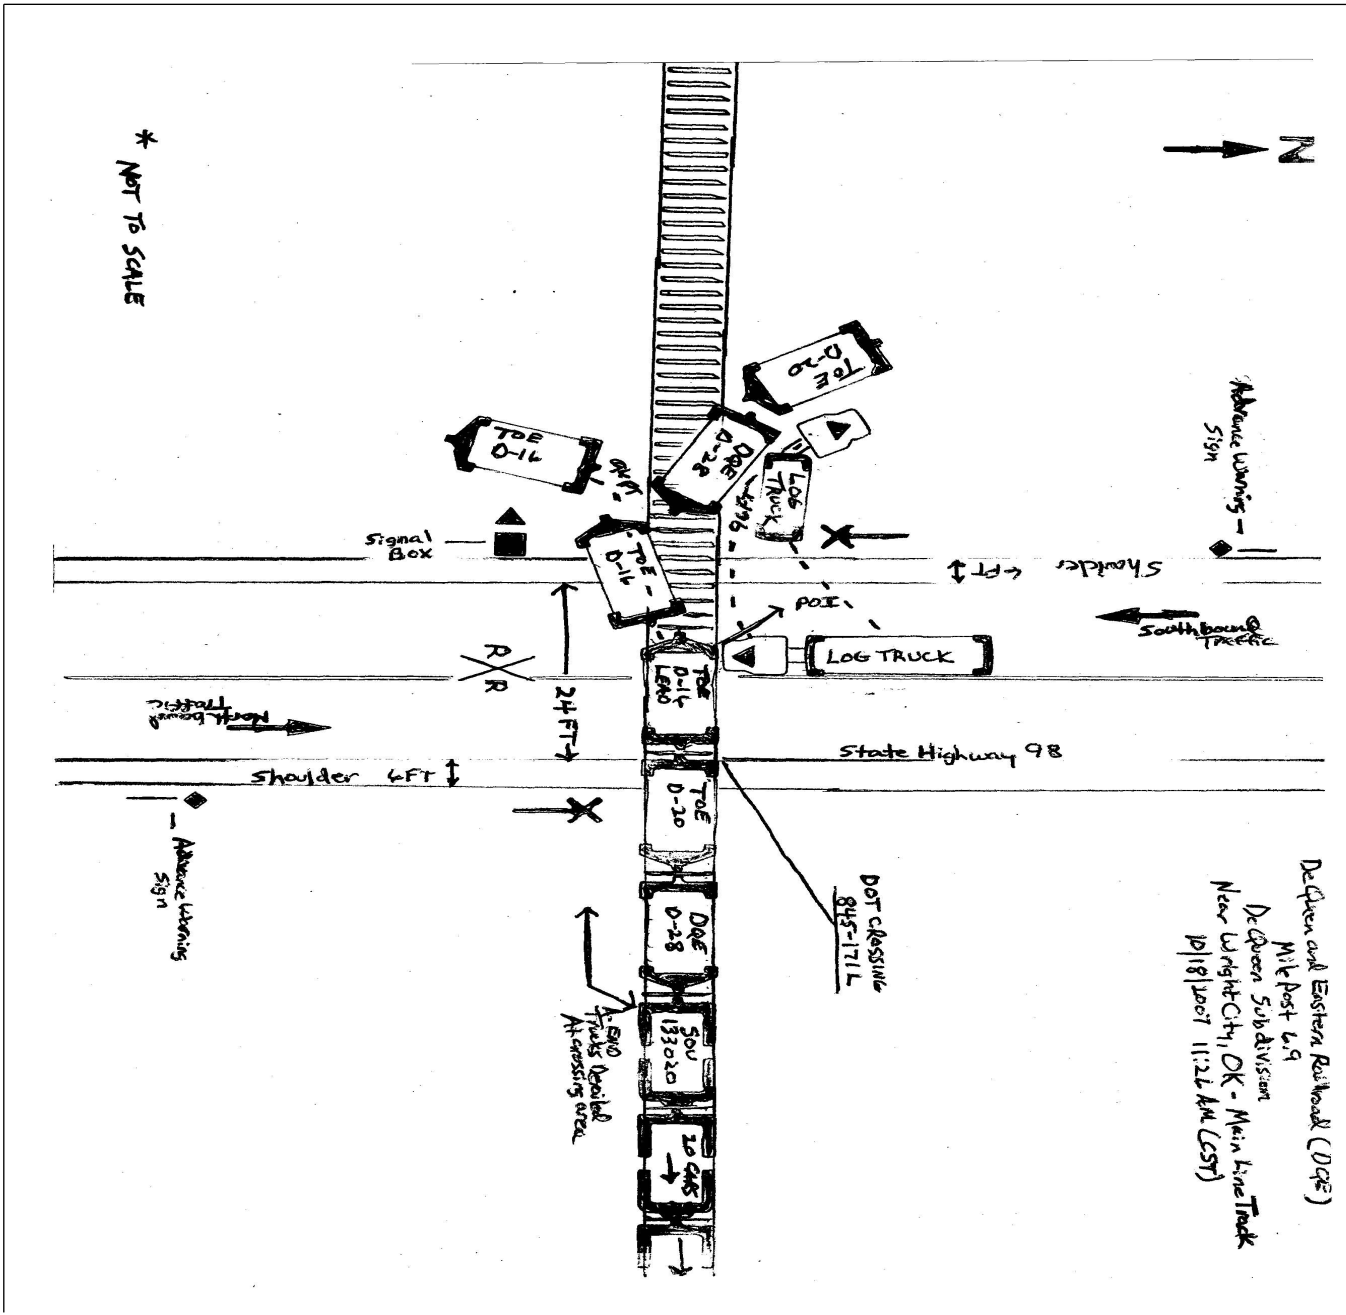
136. DRAW A SKETCH OF ACCIDENT AREA INCLUDING ALL TRACKS, SIGNALS, SWITCHES, STRUCTURES, OBJECTS, ETC., INVOLVED.

An accident report, filed by the Oklahoma Highway Patrol officer, stated the motor vehicle attempted to cross the tracks, struck the lead locomotive and that the point of impact was approximately at center of the roadway. Following the impact the motor vehicle rotated clockwise and rested 96 feet west of point of impact. The lead locomotive was derailed and came to rest 96 feet west and 54 feet south of point of impact.
