***Federal Railroad Administration  
Office of Safety  
Headquarters Assigned  
Accident Investigation Report  
HQ-2006-46***

***Union Pacific  
Morrison, Missouri  
June 10, 2006***

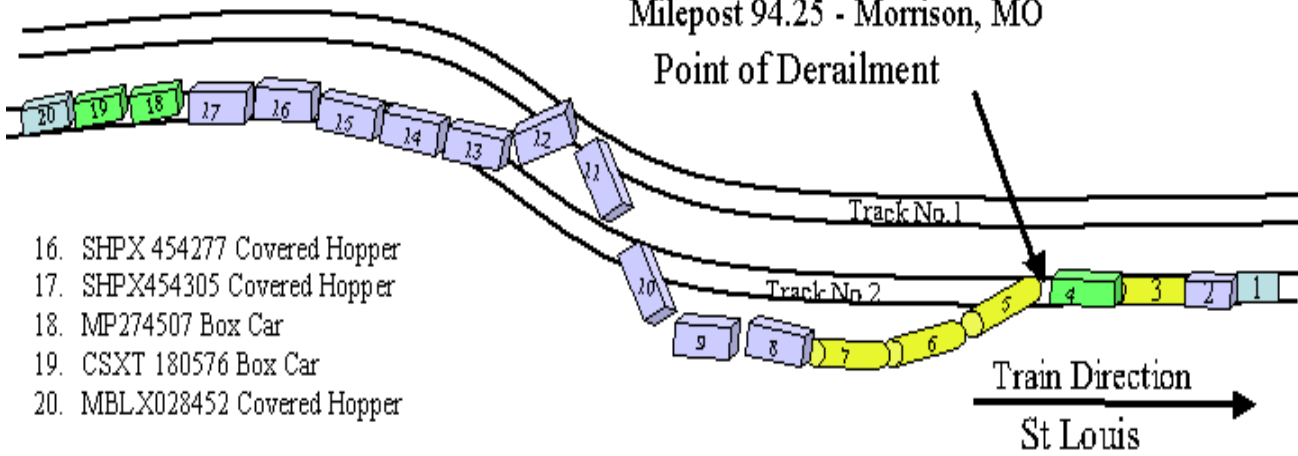
Union Pacific Railroad  
St Louis Service Unit  
Jefferson City Subdivision  
Milepost 94.25 - Morrison, MO  
Point of Derailment

1. TTGX964735 Auto Rack
2. MBLX53960 Covered Hopper
3. NATX77369 Tank Car
4. EEC1406 Box Car
5. NATX37865 Tank Car - Flammable Liquid
6. NATX300037 Tank Car - Flammable Liquid
7. GATX70811 Tank Car
8. ACFX51025 Covered Hopper
9. CCLX51063 Covered Hopper
10. SHPX 454242 Covered Hopper
11. SHPX 454227 Covered Hopper
12. ACFX 59505 Covered Hopper
13. ACFX 58854 Covered Hopper
14. SHPX 454137 Covered Hopper
15. GACX50929 Covered Hopper

16. SHPX 454277 Covered Hopper
17. SHPX454305 Covered Hopper
18. MP274507 Box Car
19. CSXT 180576 Box Car
20. MBLX028452 Covered Hopper

The eastbound train stopped to wait for a westbound train to clear single main track at Morrison Junction. Locomotive event recorder data indicates the use of dynamic braking was improper due to rapid adjustment, causing the slack to run in. The run-in caused the leading end of the 32nd head car, Car No. EEC1406, to derail. There was no inspection of the train conducted after the stop by the crew. The train was pulled about 1,200 feet east, resulting in the derailment of the 29th through 48th head cars. All derailed rail cars remained in the upright position.
