***Federal Railroad Administration
Office of Safety
Headquarters Assigned
Accident Investigation Report
HQ-2006-73***

***CSX Transportation
Rome, NY
August 16, 2006***

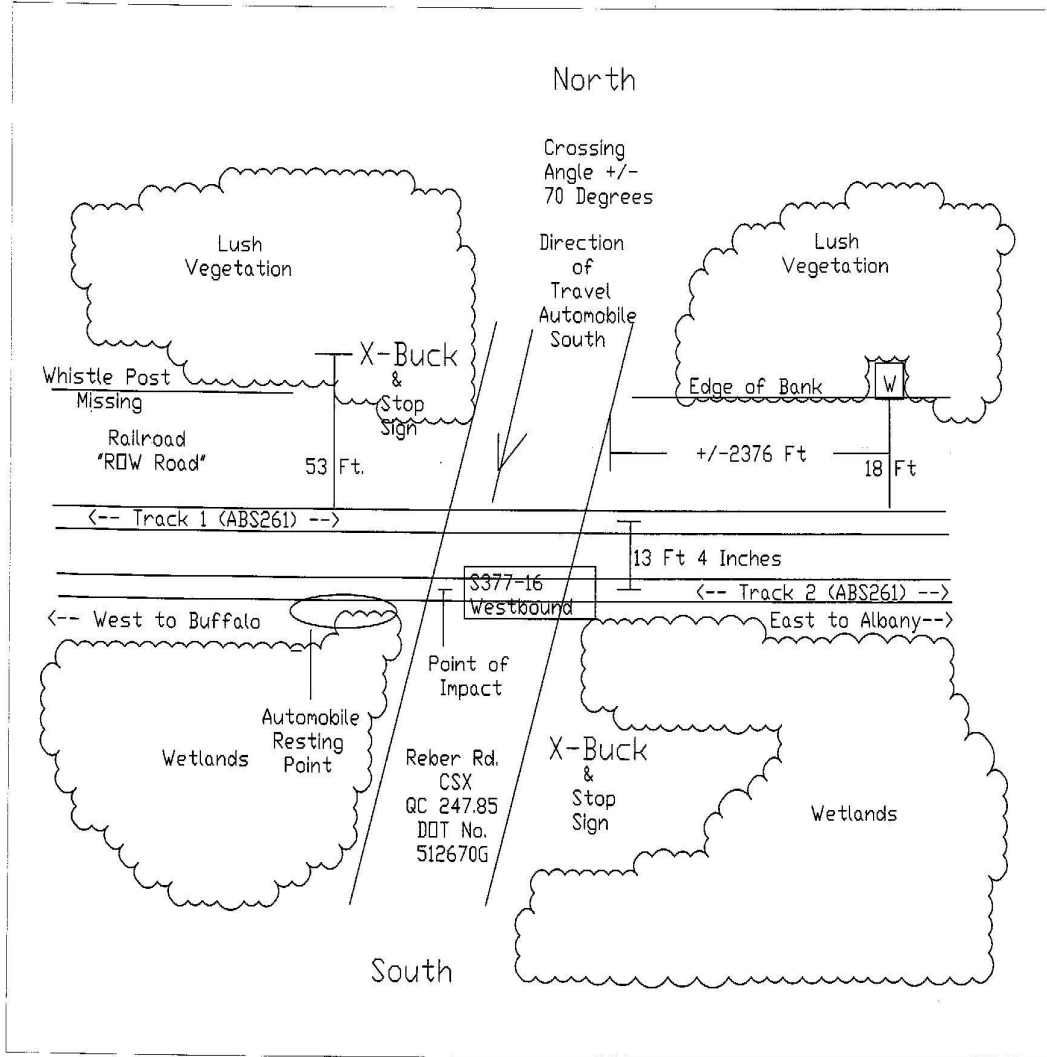
Final_Sket
ch.JPG

108. DRAW A SKETCH OF ACCIDENT AREA INCLUDING ALL TRACKS, SIGNALS, SWITCHES, STRUCTURES, OBJECTS, ETC., INVOLVED.

A westbound CSX freight train collided with an automobile at Reber Road highway-rail grade crossing (DOT #512670G), on August 16, 2006, at 6:29 p.m. The accident occurred near Rome, NY, at CSX Milepost 247.85, on Main Track No. 2, on the CSX Mohawk Subdivision, Albany Division.

The vehicle was struck in the rear quarter on the driver's side and was completely destroyed. There were no skid marks found at the scene; it appears the driver made no attempt to stop. The vehicle came to rest in the track ballast approximately 35 to 40 feet west of the paved portion of the crossing.
