***Federal Railroad Administration
Office of Safety
Headquarters Assigned
Accident Investigation Report
HQ-2005-03***

***Burlington Northern Santa Fe (BNSF)
Bieber, California
January 8, 2005***

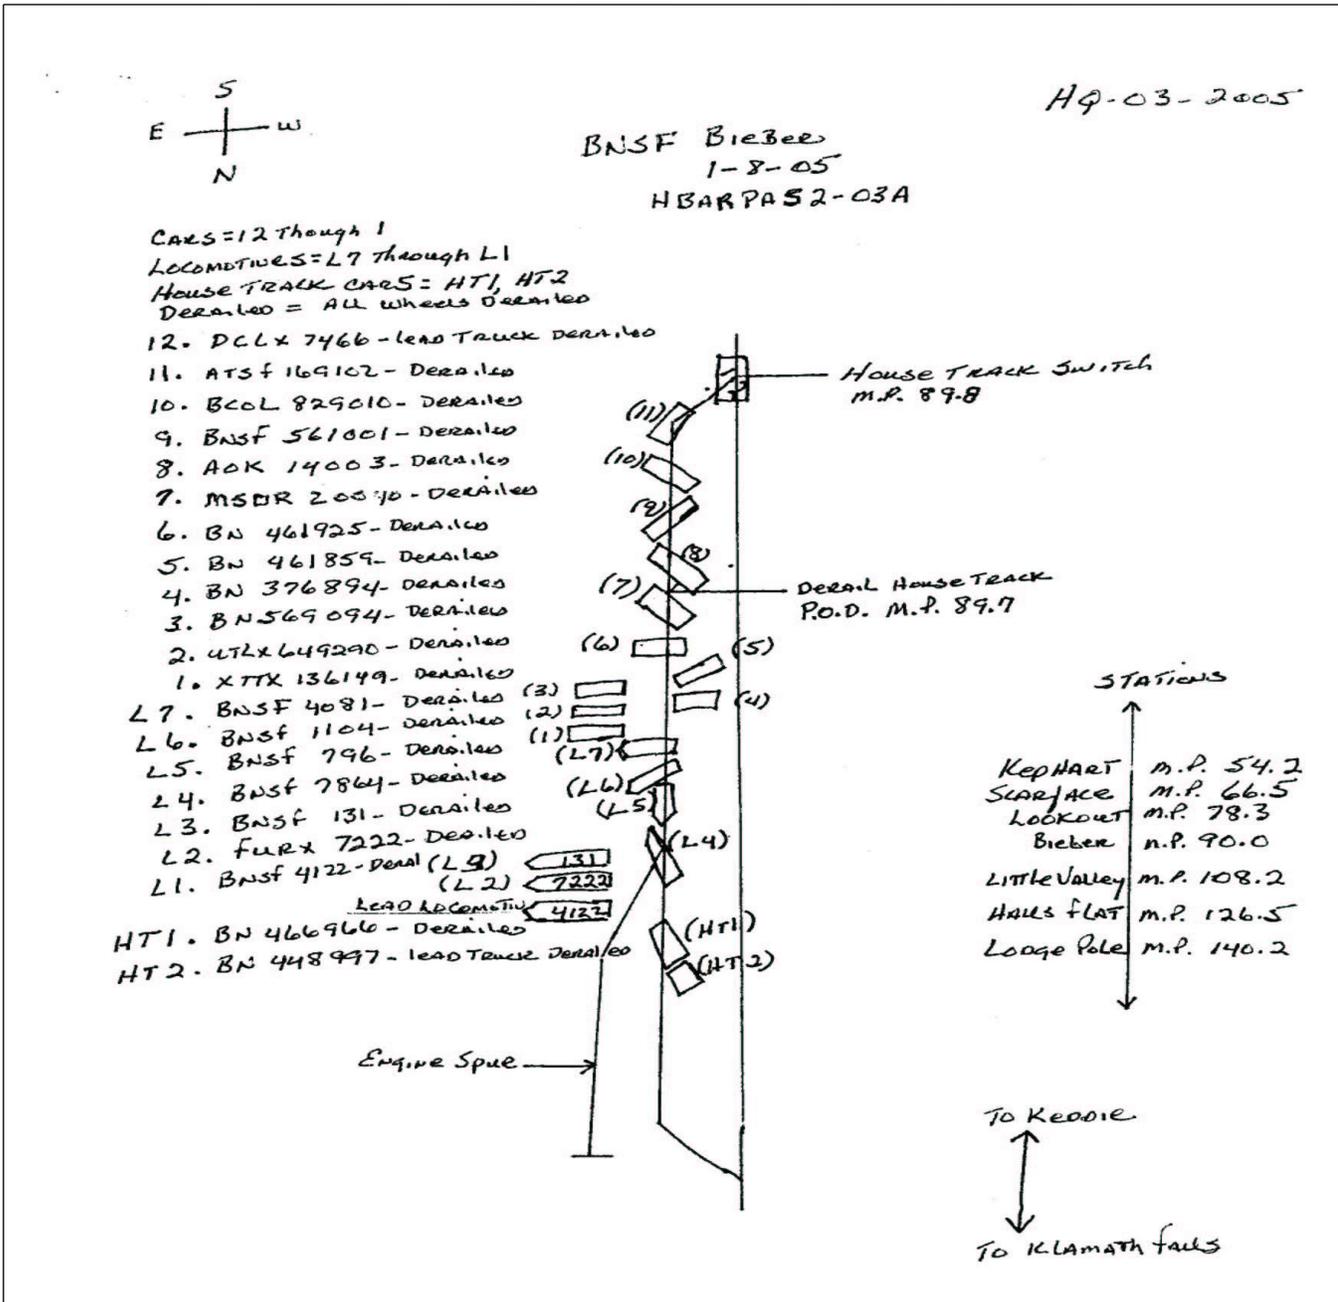
108. DRAW A SKETCH OF ACCIDENT AREA INCLUDING ALL TRACKS, SIGNALS, SWITCHES, STRUCTURES, OBJECTS, ETC., INVOLVED.

The accident was caused by failure of the brakeman on the southbound local freight train to return the main track switch to its normal position for main track operations.

At about 4:55 a.m., the lead locomotive hit the bi-directional derail placed at the clearance point about 120 feet north of the entrance switch to the house track on the south end of the house track. The derail was placed on the east rail (engineer's side approaching north) of the house track, and is designed to derail equipment moving over it from either direction.

After hitting the derail, the lead locomotive was immediately directed in an easterly direction and away from a direct hit on the eight standing cars, approximately 30 feet north of the derail. After derailing, the lead locomotive struck the south car standing in the house track in a glancing blow. Due to the impact of the lead locomotive with the standing cars in the house track, the lead locomotive overturned to the east (to the right, or engineer's side). Train No. 2 derailed all seven locomotives and 12 leading cars in its consist, and two grain hopper cars of Train No. 1 standing on the house track. The severity of the derailment was due to the speed at the time of the derailment, the sudden buffing force caused by the derailment and subsequent impact with the standing loaded grain cars. An overview of the derailment looked like what is commonly known as a "general pile up."
