***Federal Railroad Administration
Office of Safety
Headquarters Assigned
Accident Investigation Report
HQ-2005-68***

***Union Pacific (UP)
Heber, California
August 20, 2005***

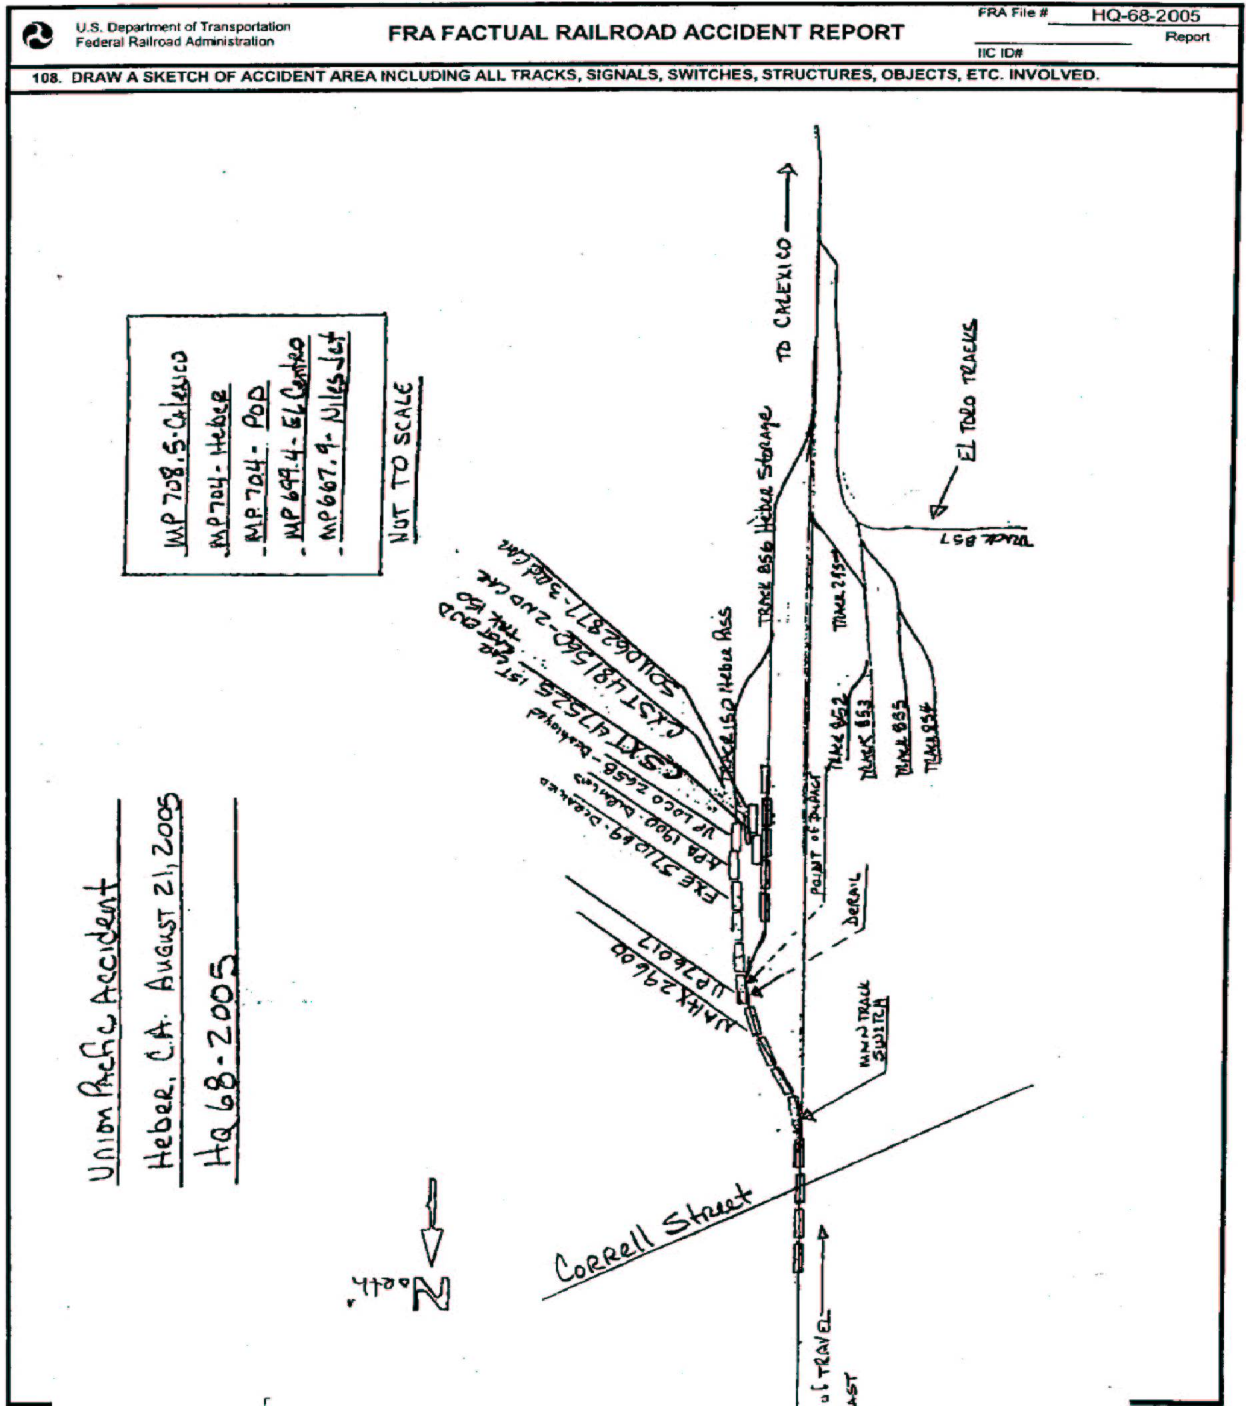
108. DRAW A SKETCH OF ACCIDENT AREA INCLUDING ALL TRACKS, SIGNALS, SWITCHES, STRUCTURES, OBJECTS, ETC., INVOLVED.

On August 21, 2005, at 10:30 p.m. PDT, an eastbound Union Pacific (UP) freight train LKE35-21 (Train # 2) operating on main line track and consisting of a single locomotive with 39 cars impacted an unattended standing cut of cars on the Heber passing track (MP704.0) at a recorded speed of 23 mph. The collision derailed three cars of Train # 2 and five of 22 cars set out by UP freight train LKE34-19 (Train #1) to derail. The three crew members of Train # 2 were transported by ambulance to a hospital where they were treated for multiple lacerations of their heads, arms and chests. There was no release of hazardous materials and no evacuation ordered.

The accident was caused by the failure of Train #1's crew to re-line a switch back to the main track after completing switching operations on the Heber passing track and failure to comply with Timetable Special Instructions, Conductor's Report Form, TT/SSi Rule 1.47, Duties of Crew Members.
