# Federal Railroad Administration Hazmat Seminar Reno, NV

June 25-27, 2013

# Tank Car Forensics

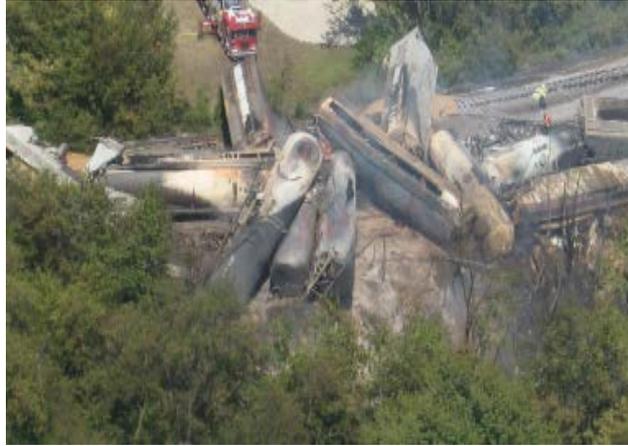
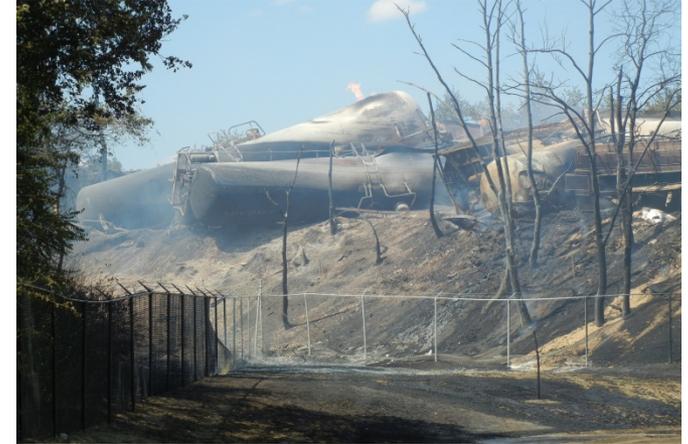
NATX364118 B-end  
Heat Induced Tear

NATX364083 B-end  
(Puncture in B-end)

NATX364017 A-end  
Heat Induced Tear

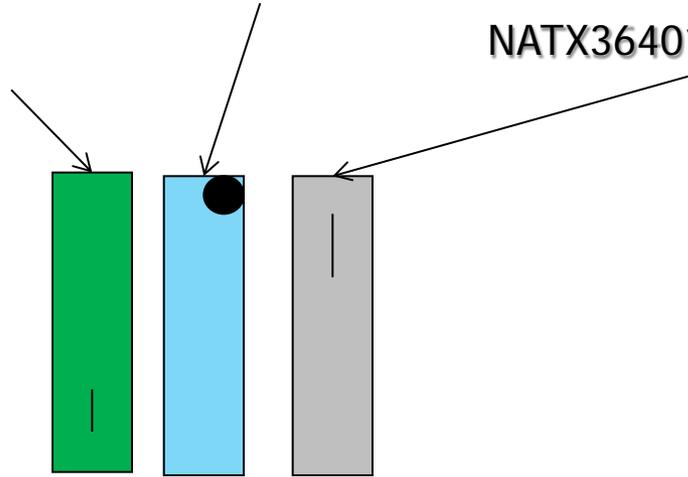
NATX364083 B-end

NATX364017 A-end

NATX364118 A-end

- Inspection preformed at staging area
- No indication of post-derailment orientation
- Difficult to determine puncture scenario

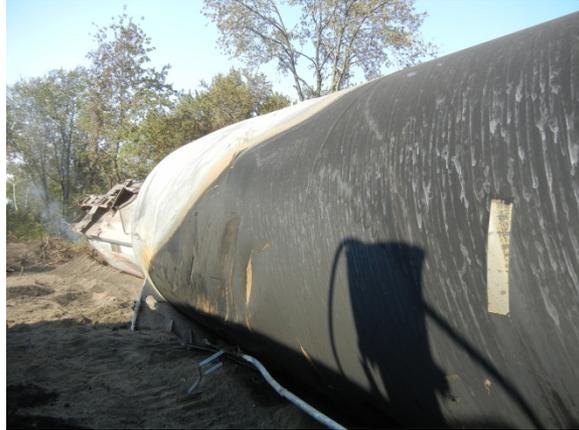
# Columbus, OH NATX364118

- Vapor space during pool fire
- Race between pressure increase and decreasing steel strength.
- PRV below liquid line

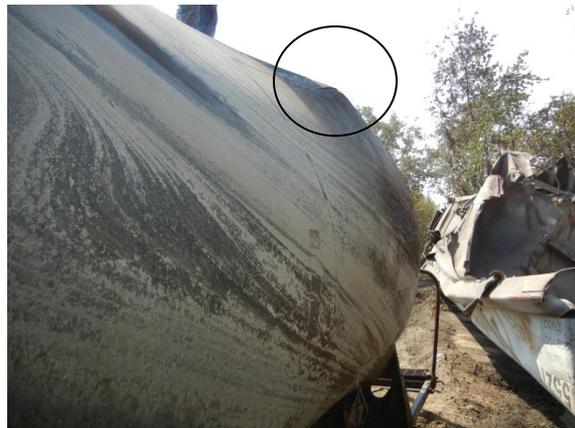
- 3' tear, B-end 11 o'clock
- In longitudinal weld

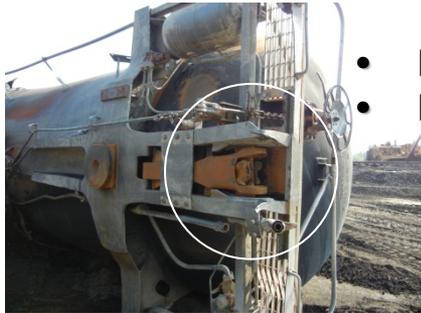
- B-end draft gear
- Broken coupler

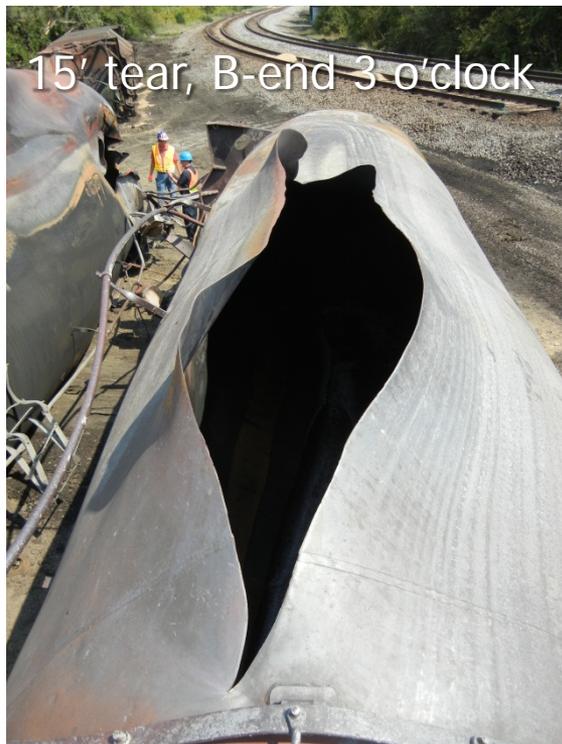
15' tear, B-end 3 o'clock

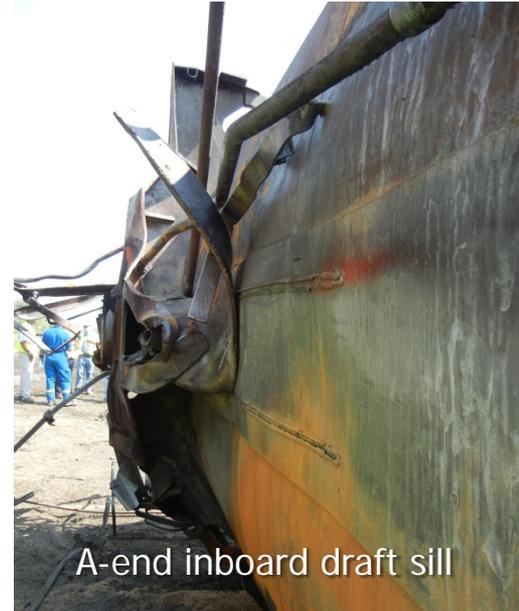
A-end inboard draft sill

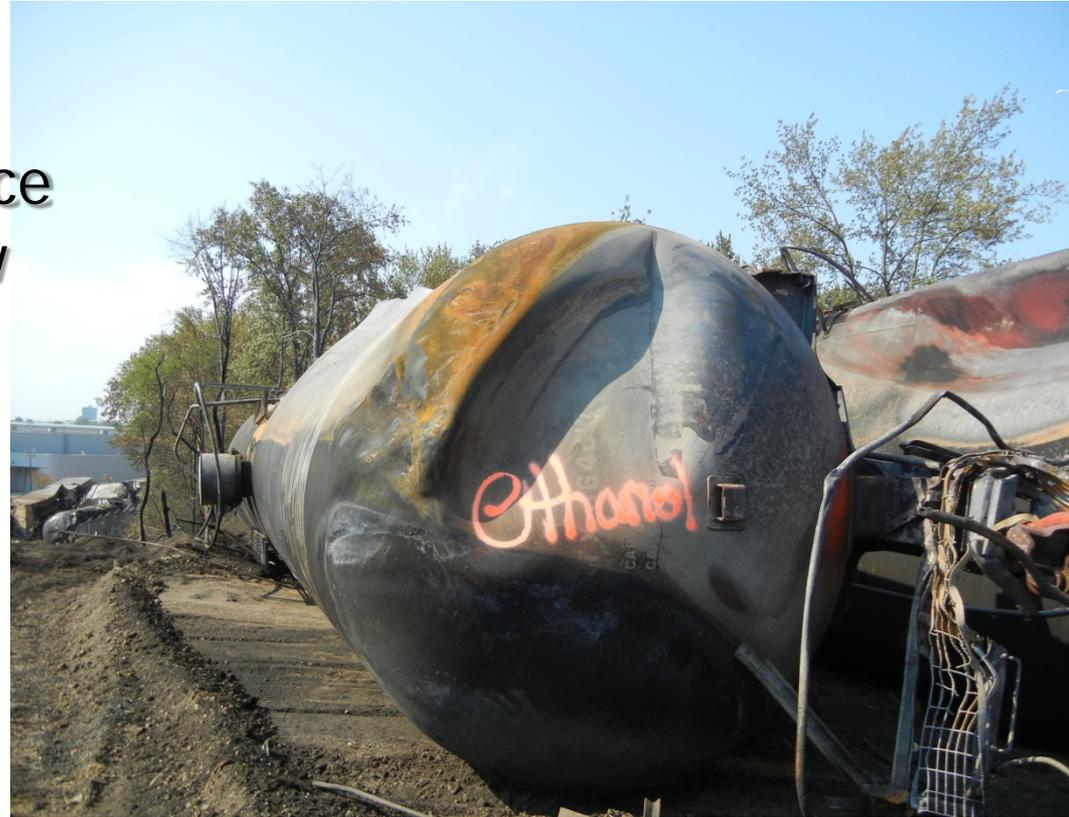
# Columbus, OH NATX364017

- Vapor space
- PRV below liquid line

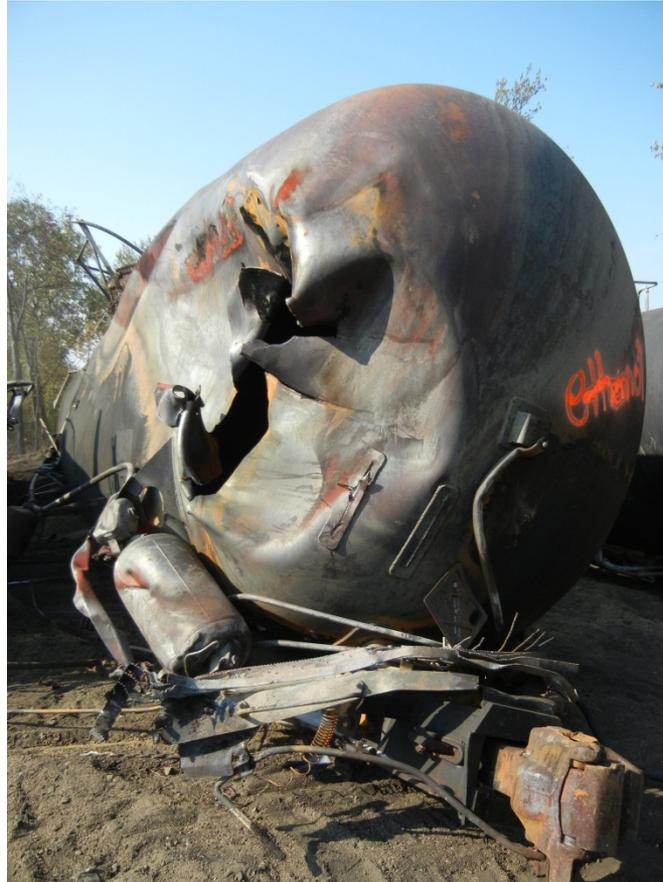
# Columbus, OH NATX364083

- Puncture B-end head and ring 1
- Gouge above hand brake pads

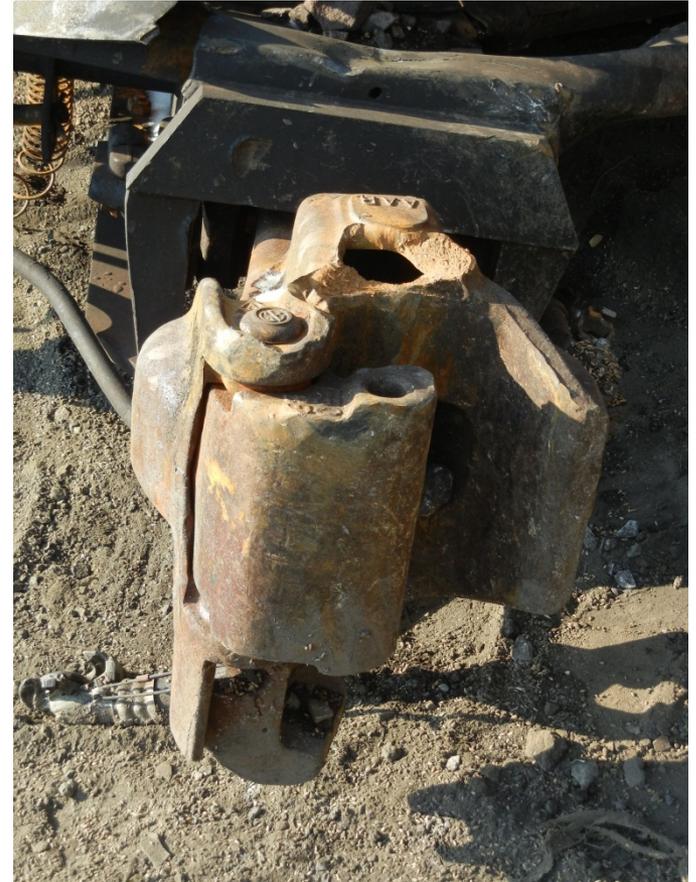
- Broken B-end shelf coupler
- Suggests significant upper motion of connected coupler
- Initially thought B-end coupler of 017 punctured 083

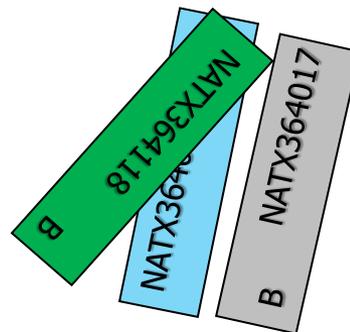
At time of derailment – arrows indicate initial forces

Trailing cars  
continuing to  
push along  
tangent of  
track

Head of 083 slides into  
the inboard termination  
of the draft sill

017 rotates 90°  
clockwise exposing  
the draft sill to 083

Broken coupler

Less than 1 minute  
after derailment a fire  
was started. A steady  
pool fire after two  
minutes

Approximately 36  
minutes after derailment  
there was an explosion

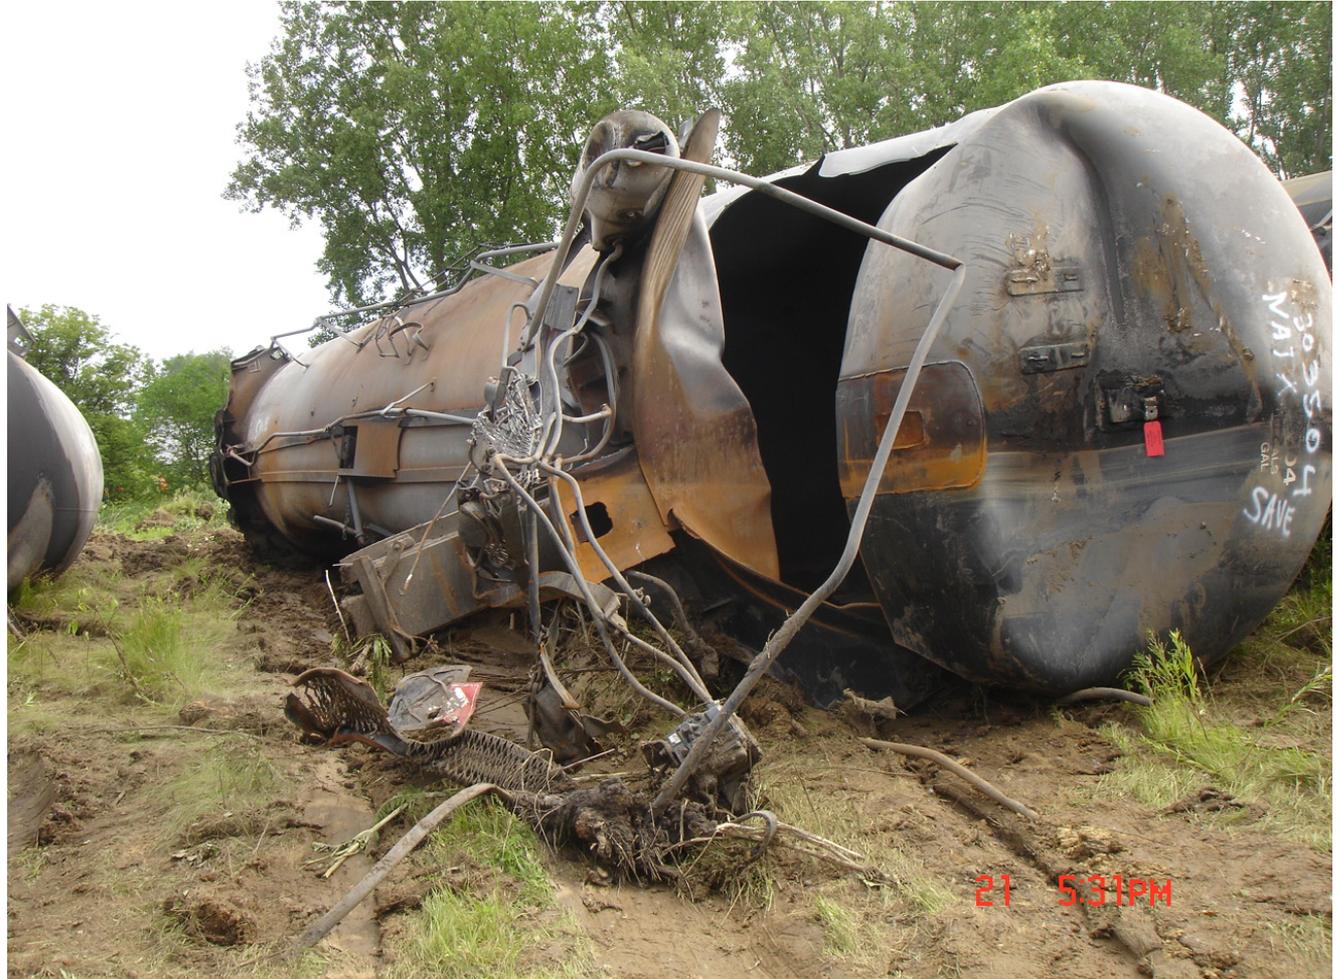
# Cherry Valley

- Similar failures identified in three derailments
  - Cherry Valley, IL
  - Arcadia, OH
  - Tiskilwa, IL
- Sill Designed to meet all AAR standards
- Subject of NTSB Recommendation
  - Proximity of transverse welds
- Ongoing FRA Investigation

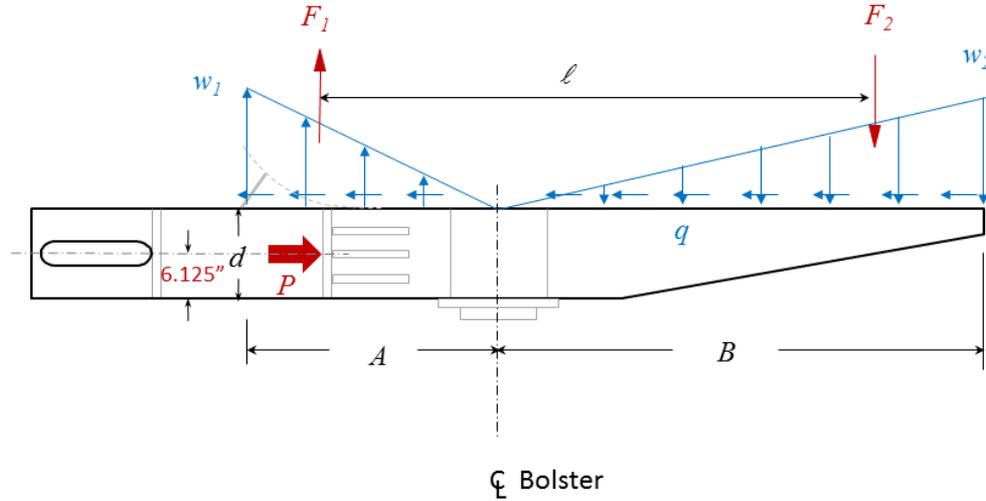
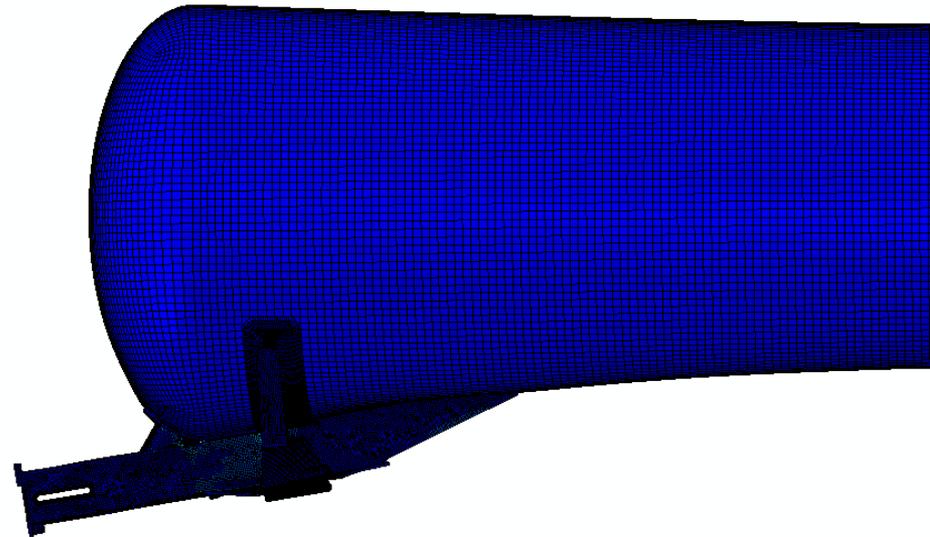
# Analysis of Sill Behavior

- AAR M-1001 and M-1002
- 85% throat rule
- Sills designed in accordance with standards
- Local vs global
- Qualify Assurance
  - Design vs As-Built Weld Sizes
  - Weld procedures

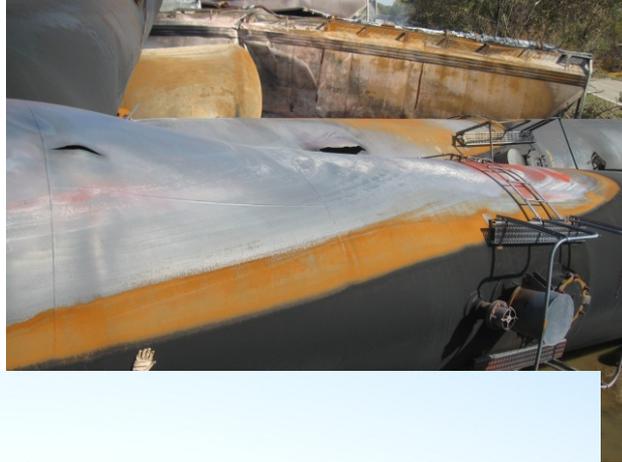
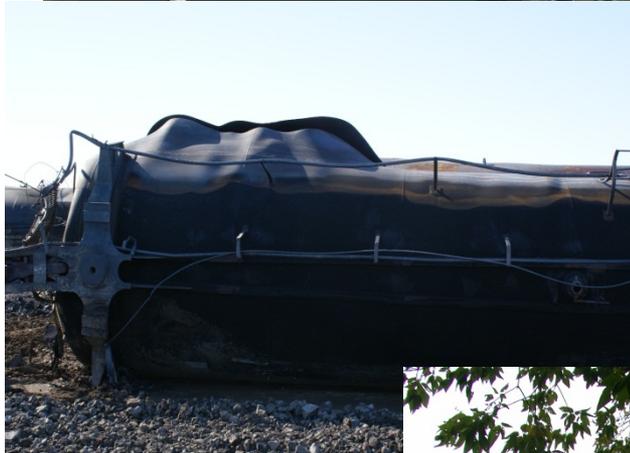
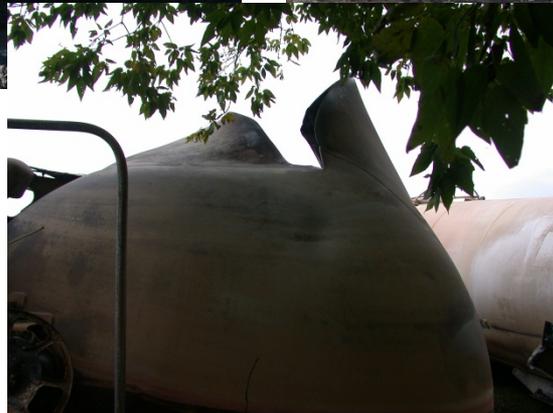
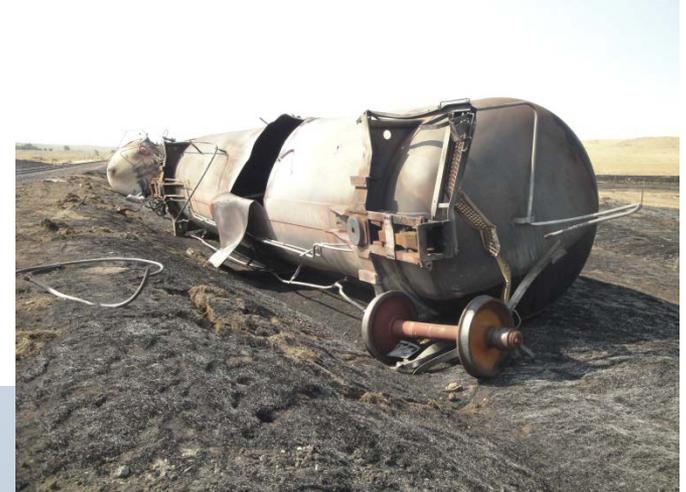
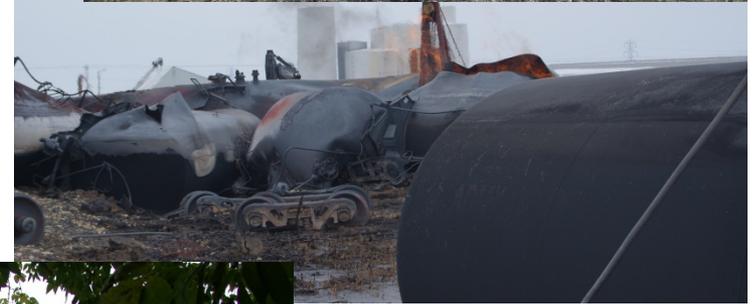
# Thermal Tear

- Large explosions resulting in classic tank destruction (BLEVEs) occurred in two derailments
  - Arcadia (3)
  - Plevna (2)
- Large explosion with limited tank damage (thermal tears) occurred in five derailments
  - Arcadia (2)
  - Tiskilwa (3)
  - Columbus (2)
  - Plevna (6)
  - New Brighton (1)
- Birk (1995) found that in cases where a fissure (tear) are similar in length to the tank diameter the resulting release and fireball was virtually identical to a BLEVE.
