ENSCO PUB. NO. DOT-FR-05-07

Investigation of Cracks in
Acela Coach Car Brake Discs: Test and Analysis
Volume I - Final Report

November 2005

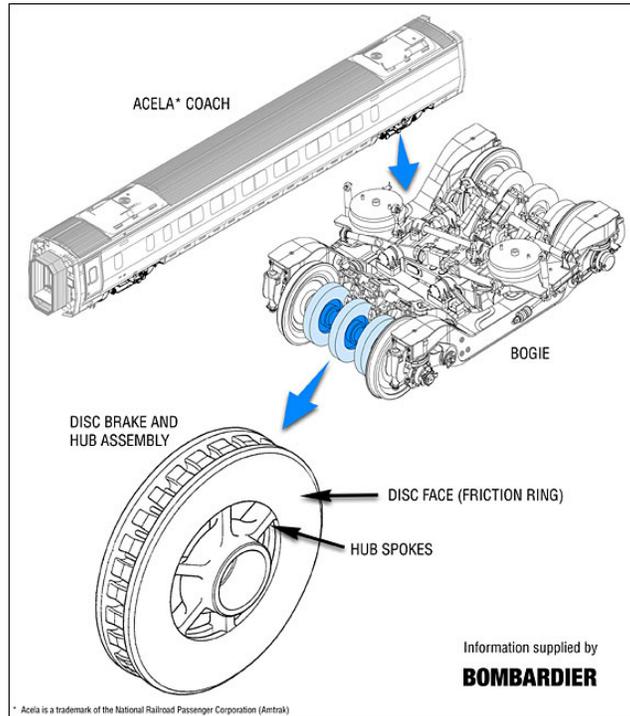
Figure 1.1. Typical Acela Coach, Bogie and Brake Disc

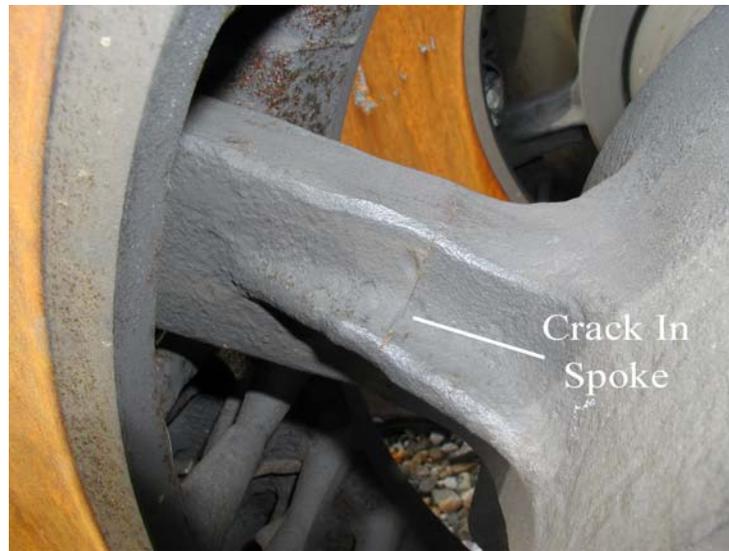
Figure 1.3. Example of a Crack in Spoke of WABTEC/SAB-WABCO Supplied Brake Disc Used on Acela Coach Car

The brake discs are considered a “monoblock” design, one in which the disc is made from a one-piece casting as opposed to designs that have the friction ring bolted to the hub. Figure 1.3 illustrates an example of a crack identified during the inspections. Many cracks observed on the brake discs were in a location corresponding to discontinuities found on the surface of some spokes arising from a mold parting line. As can be seen by considering the crack shown in Figure 1.3, crack propagation through each of the spokes joining the friction ring to the hub of the disc would lead to a situation in which there is no rigid connection between the braking surface of the disc and the hub, and therefore the axle itself. Not only would this result in an elimination of contribution to braking effort from this disc, it could also result in significant damage caused to the truck, therefore presenting a potential derailment scenario, should a portion of the disc separate from the axle. This situation would be exacerbated by the high speeds associated with the operation of the Acela fleet. It is important to note that although inspections revealed individual spokes in which cracks had propagated completely through the material and exhibited signs of corrosion, indicating that cracks have propagated for a significant period of time, *no* disc within the fleet had the braking surface separate from the hub.

- 1) A detailed metallurgical analysis of a section of a cracked brake disc conducted at the onset of the investigation revealed that cracks developed due to a progression of bending fatigue that originated along a decarburized surface layer. The report states:

Although the decarburized surface provided a site for fatigue initiation, the root cause of the cracking is the level of bending stresses at the crack sites.

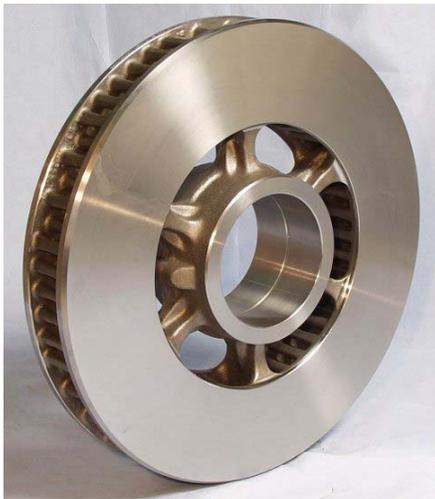
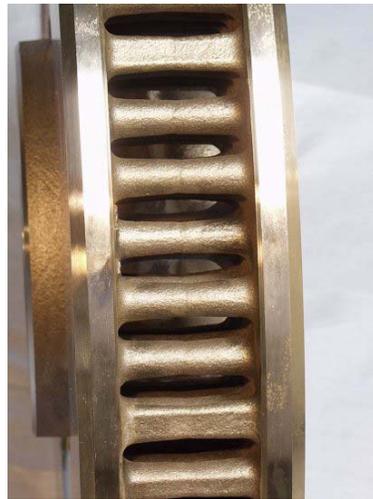
In Phase 3, a replacement disc was identified and provided by Knorr and an axle equipped with brake discs of this alternate design was included in the test program. An illustration of the Knorr disc is provided in Figure 1.4; a photograph of the spokes of the Knorr disc is included as Figure 1.5. The goal of this portion of the evaluation was to determine if the Knorr disc design demonstrated substantial improvements over the original disc design and was likely to be successful in service. The axle with the set of alternative discs was placed on an adjacent car within the test train and the instrumentation suite was expanded to accommodate measurements on the axle equipped with the Knorr disc and on the axle equipped with the WABTEC/SAB-WABCO supplied disc. A final test series was run, during which direct comparisons were made between the Knorr disc and the WABTEC/SAB-WABCO supplied disc in over-the-road tests. Data was collected in a manner that would allow decisions to be made about the potential for success of the Knorr design in revenue service.

Figure 1.4. Knorr Brake Disc

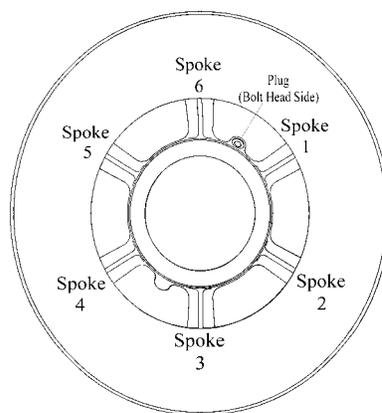
Figure 2.2 illustrates the designation of the spokes on the WABTEC/SAB-WABCO supplied brake disc. An illustration of the location of all strain gages employed during Phase 1 of the study is provided in Figure 2.3. The installation of a weldable strain gage on one of the spokes of a WABTEC/SAB-WABCO supplied disc is pictured in Figure 2.4.

Figure 2.2. Spoke Designations for the WABTEC/SAB-WABCO Supplied Brake Disc

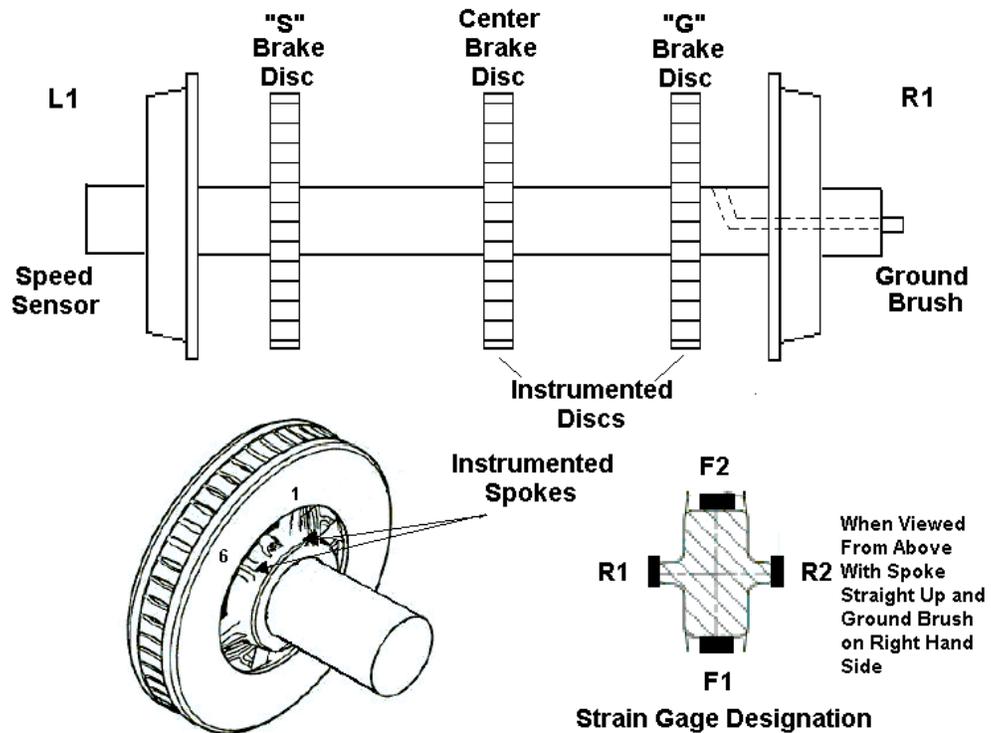
**Location of Instrumentation on WABTEC/SAB-WABCO Axle
on Car 3413 During Phase 1 of Acela Brake Disc Study**

**Figure 2.3. Location of Strain Gages on WABTEC/SAB-WABCO Supplied Discs
During Phase 1 of Study**

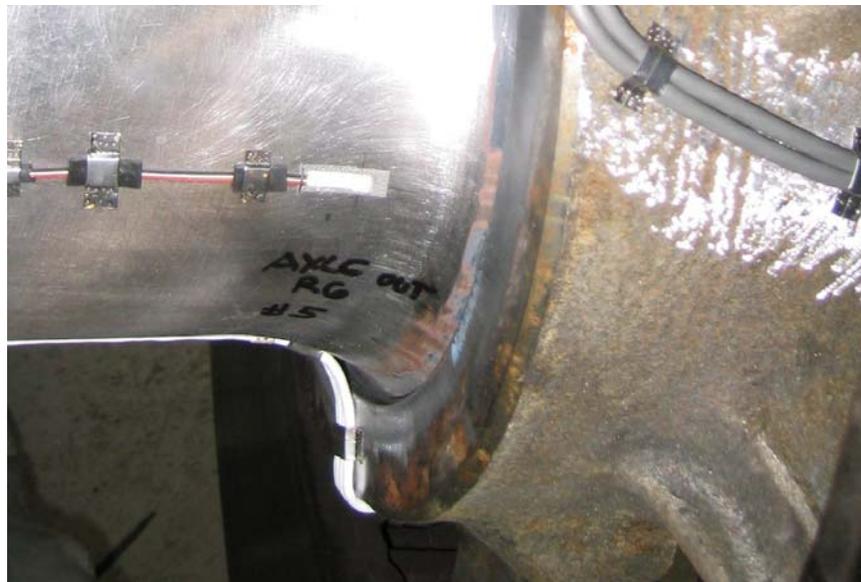
In addition to the new strain gages on spokes of the center disc, four (4) strain gages were mounted to the axle, two (2) gages 180° apart as close to the center disc as possible and two (2) gages 180° apart at a location approximately $\frac{1}{4}$ of the distance between the two wheels. According to Knorr, the purpose of these gages was to observe the behavior of the axle, including the frequency associated with the second mode of axle bending. The strain gages were installed in a manner such that their location corresponded to spokes 6 and 3 of the center disc; due to the geometry of the axle, the geometric centers of the gages were located 9 inches from each other and centered within the space between the two discs. A picture of an axle-mounted strain gage is provided in Figure 2.5. An illustration of the location of all strain gages employed during Phase 2 of the study is provided in Figure 2.6.

Figure 2.5. Strain Gage on Surface (Longitudinal Direction) of Axle with WABTEC/SAB-WABCO Supplied Discs

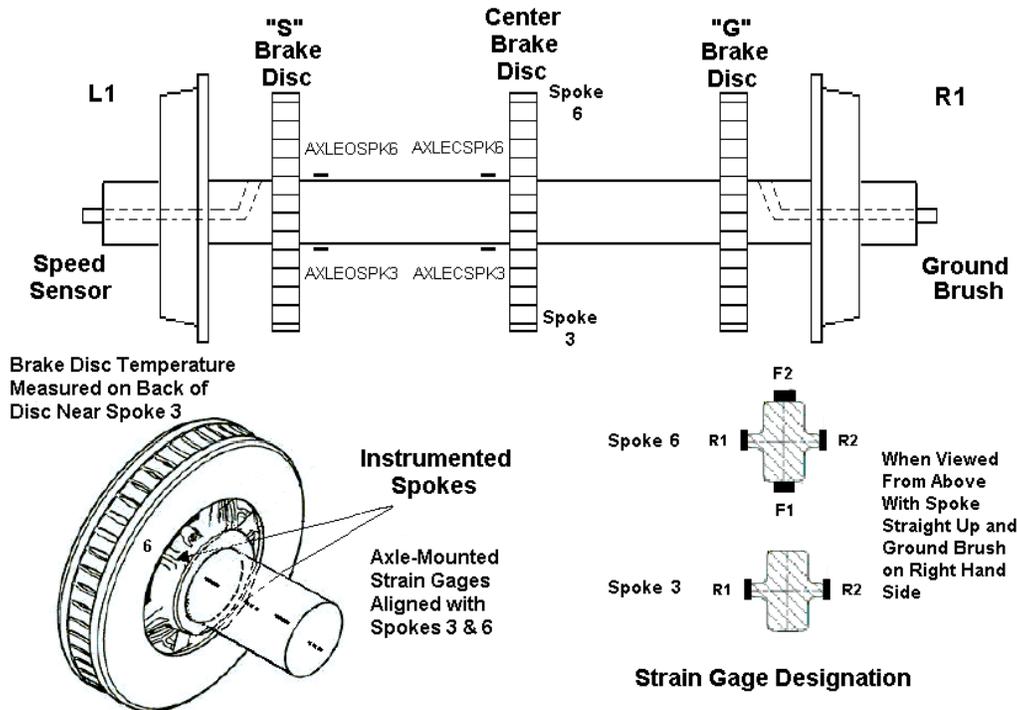
Location of Instrumentation on WABTEC/SAB-WABCO Axle on Car 3413 During Phase 2 of Acela Brake Disc Study

Figure 2.6. Location of Strain Gages on WABTEC/SAB-WABCO Test Axle During Phase 2 of Study

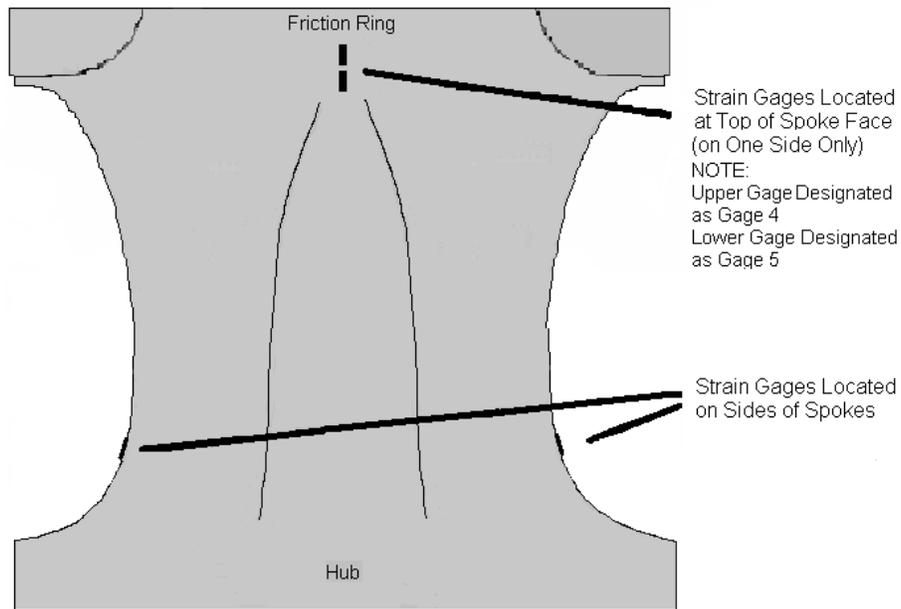
Strain gages were installed on the center-mounted disc at particular locations on spokes designated by Knorr; these locations are illustrated in Figure 2.7. The strain gages were located so as to coincide with the sites of highest strain in the spoke under typical operating conditions determined by FEA treatments conducted by Knorr.

Figure 2.7. Illustration of Strain Gage Locations on Knorr Disc Used During Phase 3 of Acela Brake Disc Study

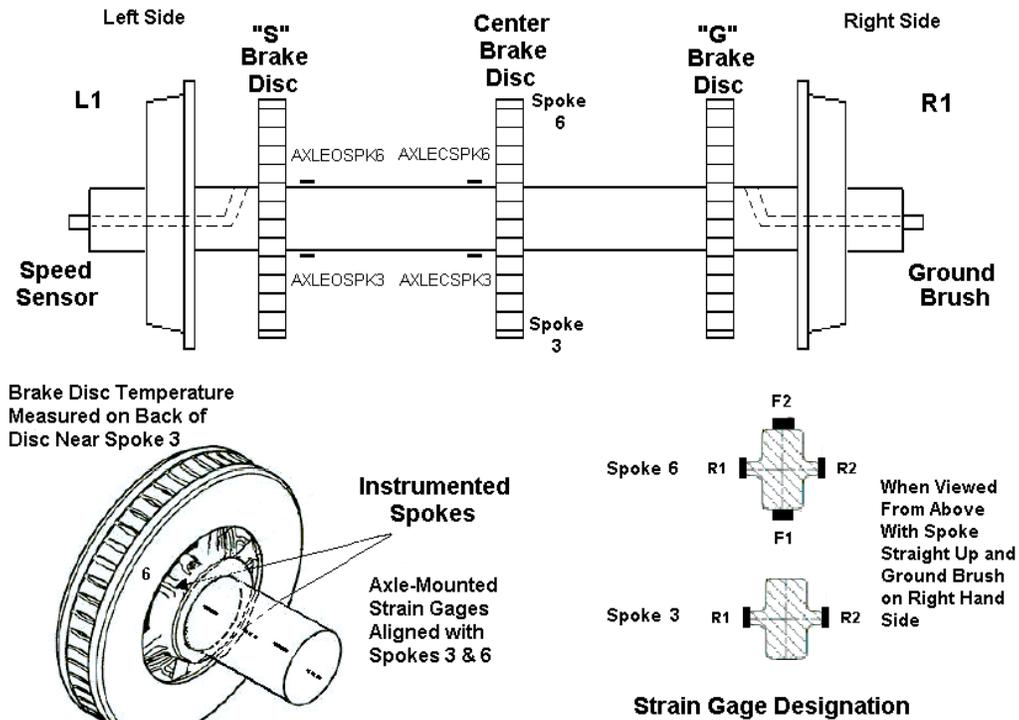
Location of Instrumentation on WABTEC/SAB-WABCO Axle on Car 3413 During Phase 3 of Acela Brake Disc Study

Figure 2.9a. Location of Strain Gages on WABTEC/SAB-WABCO Test Axle During Phase 3 of Acela Brake Disc Study

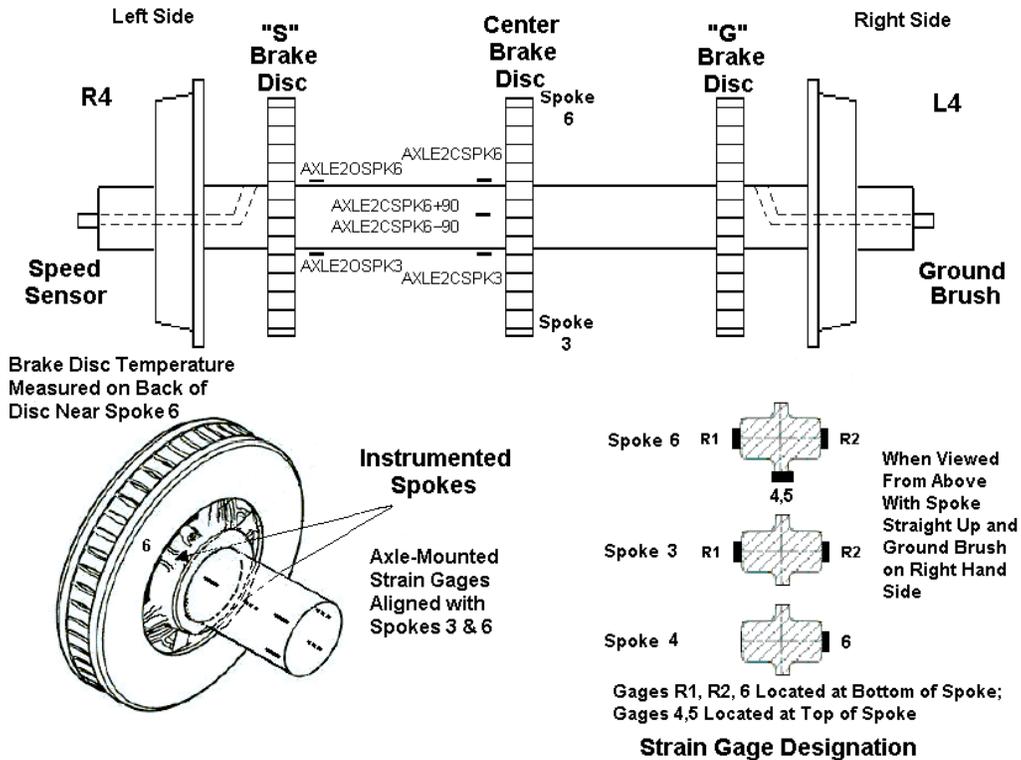
Location of Instrumentation on Knorr Axle on Car 3534 During Phase 3 of Acela Brake Disc Study

Figure 2.9b. Location of Strain Gages on Knorr Test Axle During Phase 3 of Acela Brake Disc Study

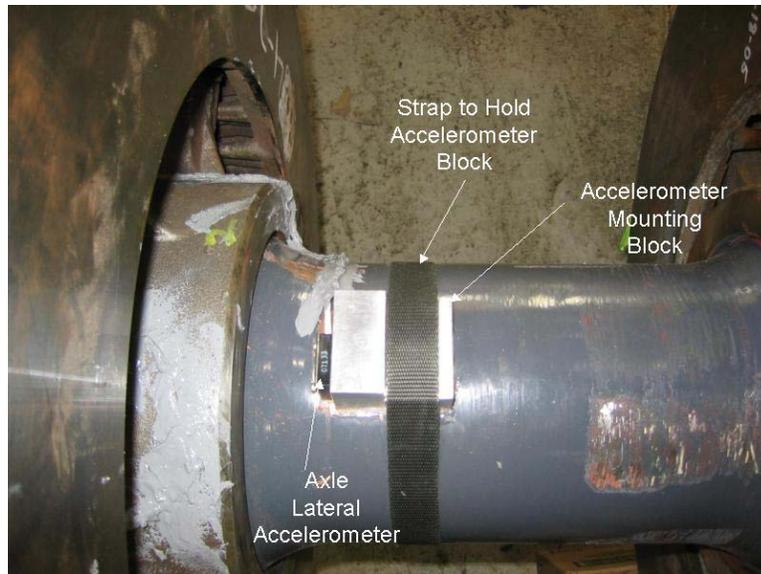
The lateral accelerations of the WABTEC/SAB-WABCO test axle in the vicinity of the center brake disc were recorded using a Silicon Designs Model No. 2410-200 +/- 200 g single-axis accelerometer (see Figure 2.12). The sensor was affixed to a mounting block that was held to the axle with a kevlar strap.

Figure 2.12. Lateral Accelerometer Mounted Near Center Disc on WABTEC/SAB-WABCO Test Axle During Phase 1 of Acela Brake Disc Study

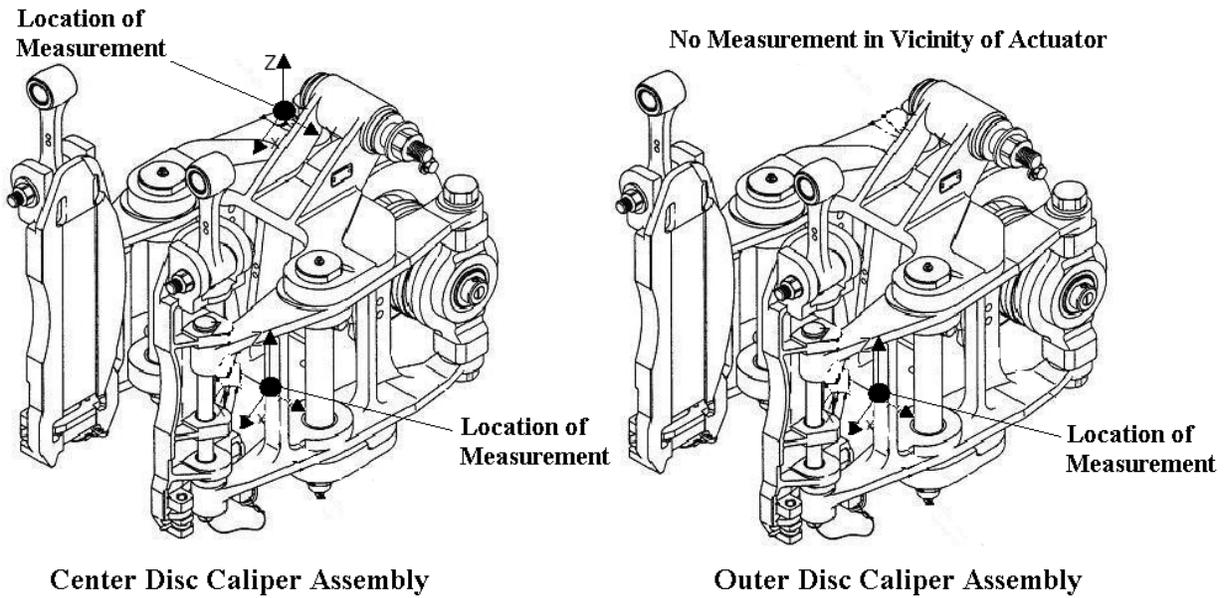
The lateral, vertical and longitudinal accelerations experienced by the brake caliper assemblies associated with the center and outer instrumented discs were measured using Silicon Designs Model No. 2440-100 +/- 100 g tri-axial accelerometers. On the center caliper assembly, accelerations were monitored near one of the brake pads and on the upper portion of the assembly near the actuator; on the outer caliper assembly, only accelerations near one of the brake pads were measured. The locations of these measurements are illustrated in Figure 2.13; mounting brackets and sensors affixed to the calipers are pictured in Figures 2.14 and 2.15.

Figure 2.13. Acceleration Measurement Locations on the Caliper Assemblies

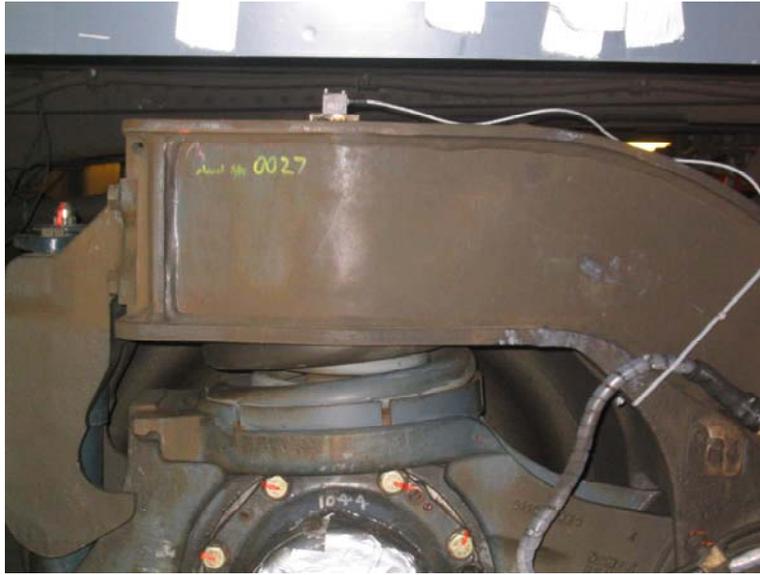
- A Silicon Designs Model No. 2440-025 +/- 25 g tri-axial accelerometer was mounted on the truck side frame, over each of the test axles to capture the movement of the truck frame. For the WABTEC/SAB-WABCO axle, the sensor was mounted over the L1 wheel; for the Knorr test axle, the accelerometer was mounted over the R4 wheel. The sensors were located directly over the primary suspension of each of the axles, approximately eight (8) inches from the end of the frame and approximately four (4) inches from the side of the frame. The accelerometer mounted over the Knorr test axle is pictured in Figure 2.17.

Figure 2.17. Tri-Axial Accelerometer on Truck Frame Over Primary Suspension of Knorr Test Axle During Phase 3 of Acela Brake Disc Study

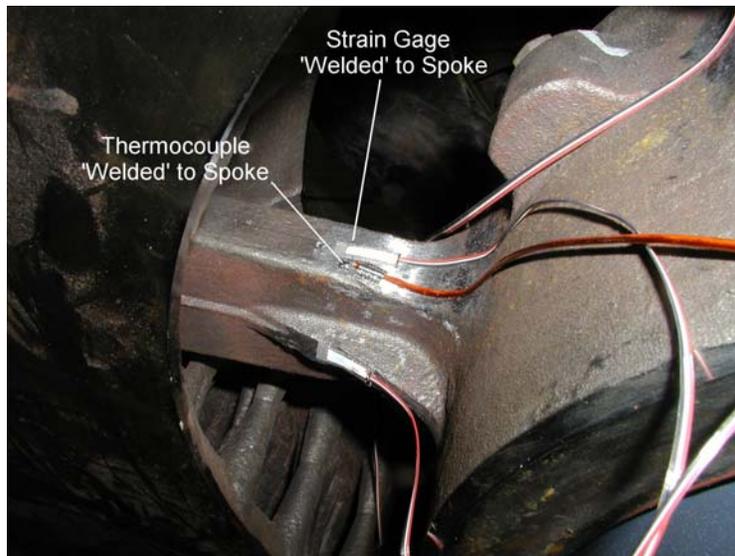
- Temperature measurements on the instrumented WABTEC/SAB-WABCO supplied disc mounted at the center of the test axle were initially made on the spokes instrumented with strain gages with the use of an Omega Engineering, Inc. Model No. 5SRTC-KK-K-24-36 K-type thermocouple. As observed in Figure 2.19, the thermocouple was welded in the vicinity of the strain gages installed on the same spoke.

Figure 2.19. Thermocouple Applied to Spoke on Instrumented WABTEC/SAB-WABCO Supplied Disc During Phase 1 of Acela Brake Disc Study

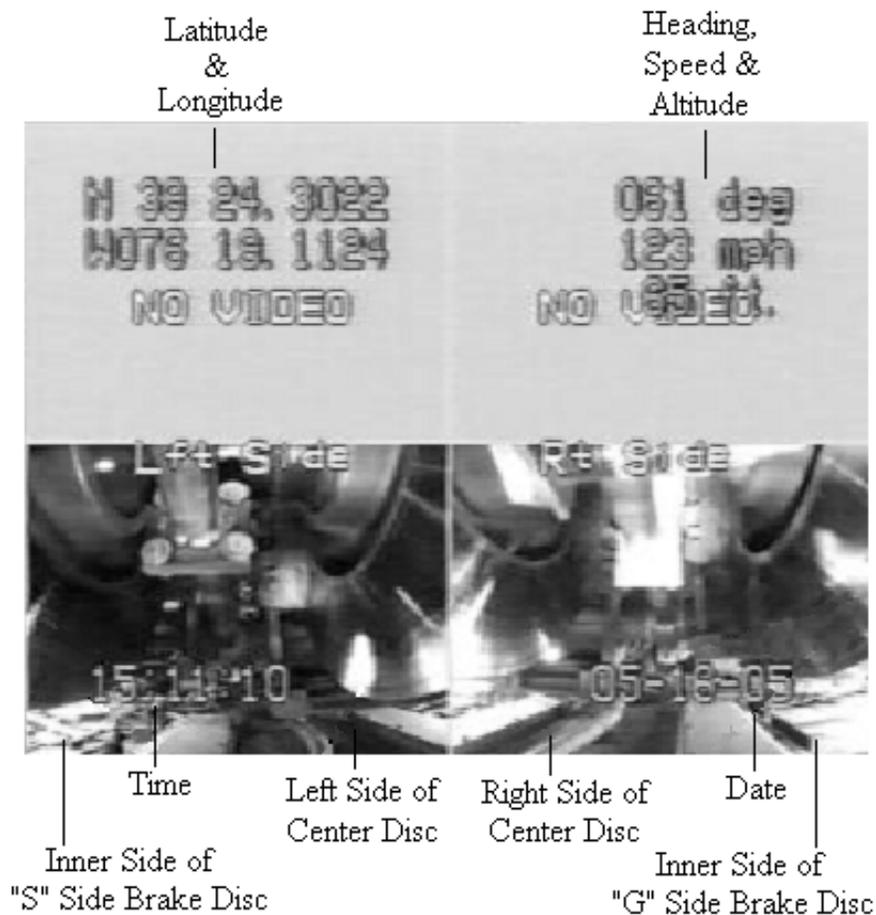
A sample frame from the video recorded over the WABTEC/SAB-WABCO test axle near MP 79 on the Philadelphia Division on May 16 is provided in Figure 2.26. Information provided on the video image and the views of the brake discs are labeled within the figure.

Figure 2.26. Example of Video Collected Over WABTEC/SAB-WABCO Test Axle

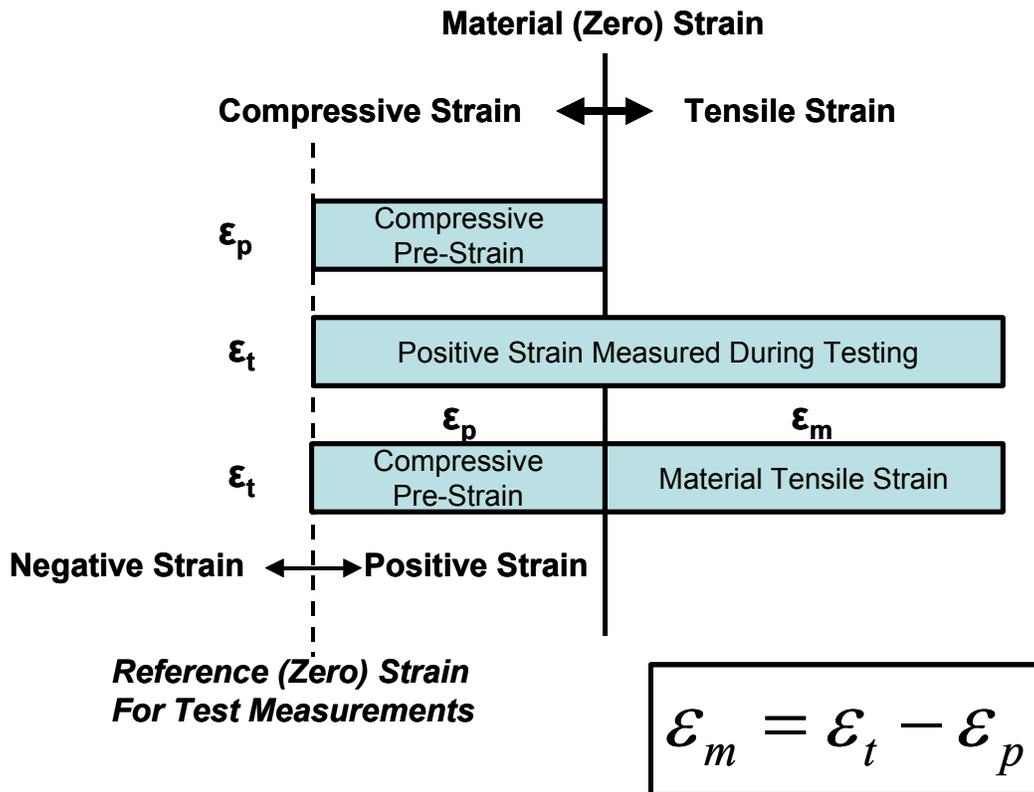
During the initial phase of the investigation, it was recognized that a measurement of mean strains in a spoke during service was not sufficient to yield a complete picture of the absolute strain, and consequently stress, in a spoke. Residual compressive stresses within the disc arising from several sources will subtract from those strains resulting from service loads; the sources of these compressive stresses are discussed in the document in Appendix M provided by Faiveley. A complete assessment of the stresses/strains associated with the discs required knowledge of the residual compressive stress or equivalent strain within the spoke. This concept is illustrated in Figure 2.27.

Figure 2.27. Illustration of Concept of Compressive Pre-Strain

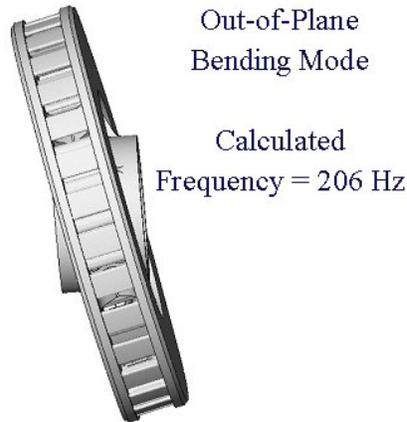
The second fundamental frequency associated with the case in which the hub of the disc was fixed was calculated to be 269 Hz; the motion associated with this frequency also resembled the opening and closing of an umbrella. Because this was determined using a model with a fixed hub, it is likely that the motion associated with this frequency is associated with excitation in the lateral direction.

Figure 3.1. Out-of-Plane Bending Mode Determined from Finite Element Analysis

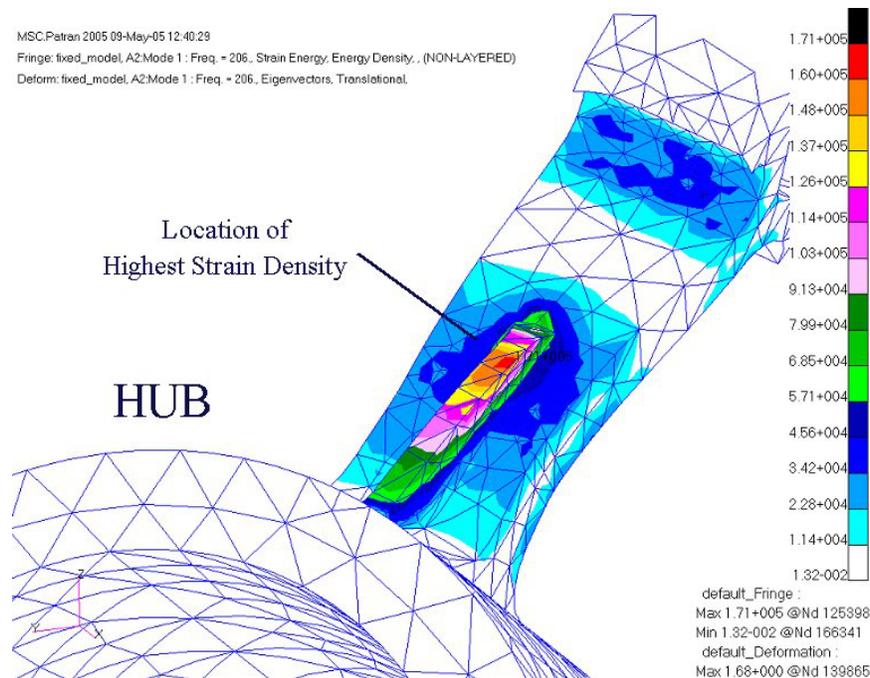
An important result of the analysis was the identification of the location on the spoke at which the highest strains could be expected. This location is highlighted in red in Figure 3.2. This finding was important for two reasons – this location was close to the location of many of the cracks observed on the brake discs identified to date and it corresponded to the location in which discontinuities arising from a mold parting line found on the surface of some spokes was observed.

Figure 3.2. Location of Highest Strain for Out-of-Plane Bending Mode Determined from Finite Element Analysis

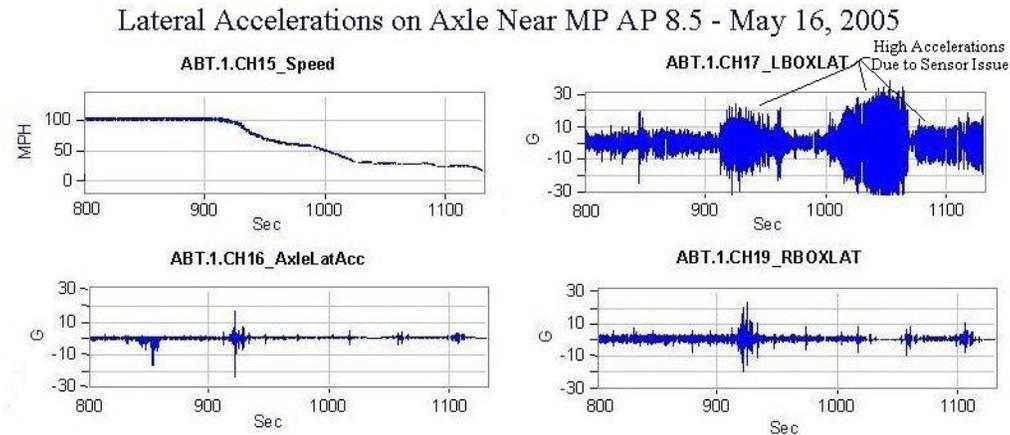
Lateral accelerations measured on the axle at the same geographic location are illustrated in Figure 3.4.

Figure 3.4. Lateral Accelerations Measured on Instrumented Axle 1 Near MP AP 8.5 (File 051605_08.ABT) – May 16, 2005

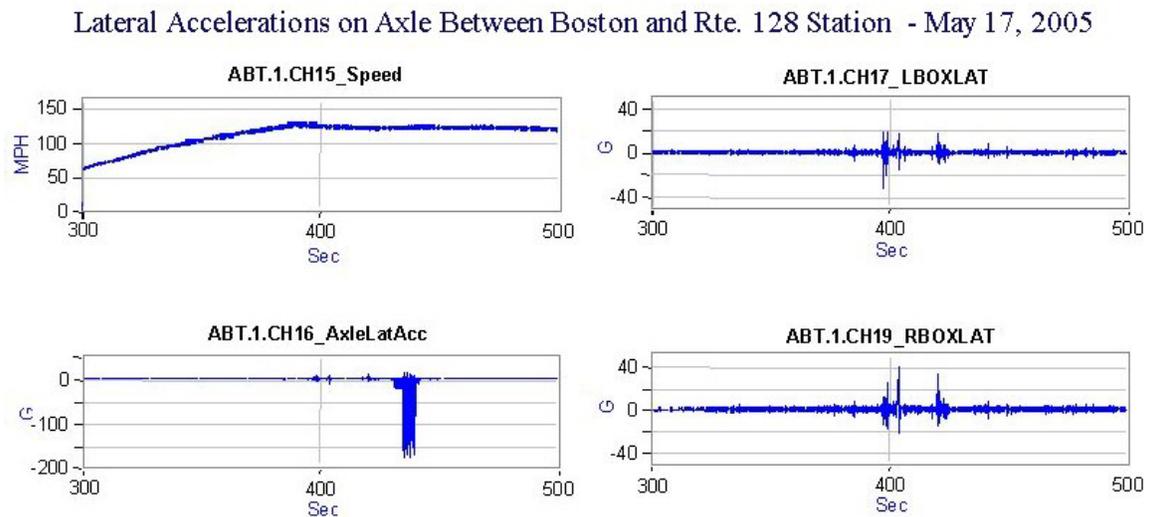
Figure 3.5. Lateral Accelerations Measured on Instrumented Axle 1 Between Boston and Rte 128 Station (File 051705_02.ABT) – May 17, 2005

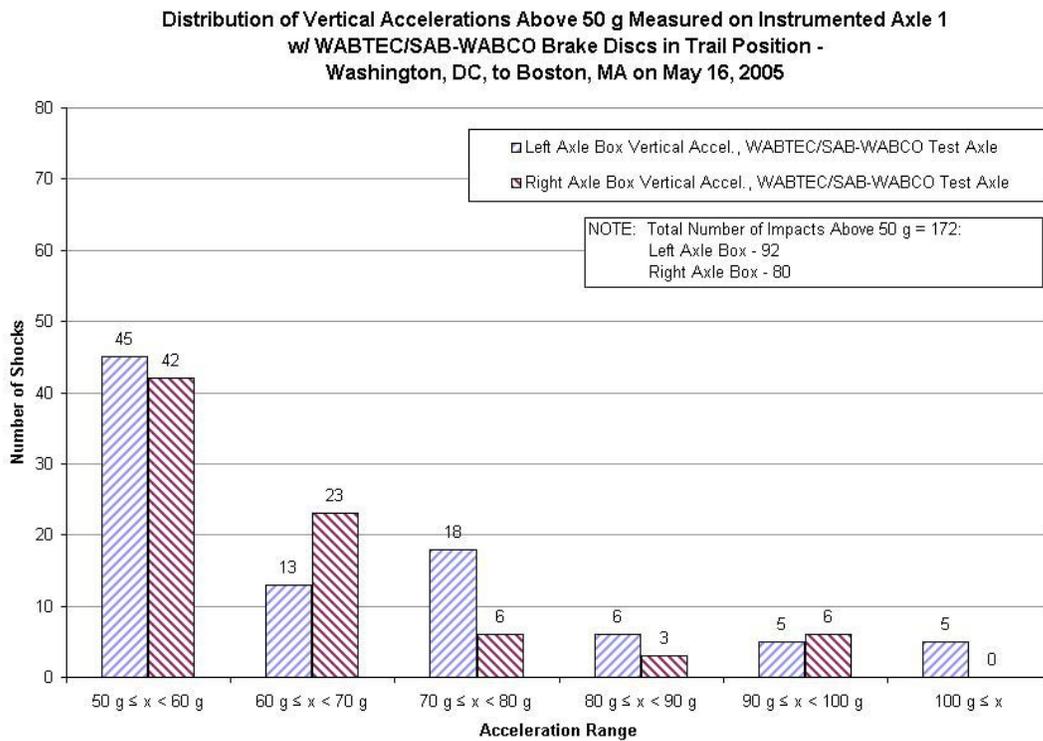
Figure 3.6a. Distribution of Vertical Accelerations Above 50 g Measured on Instrumented Axle 1 with WABTEC/SAB-WABCO Supplied Brake Discs in Trail Position – Washington, DC, to Boston, MA, on May 16, 2005

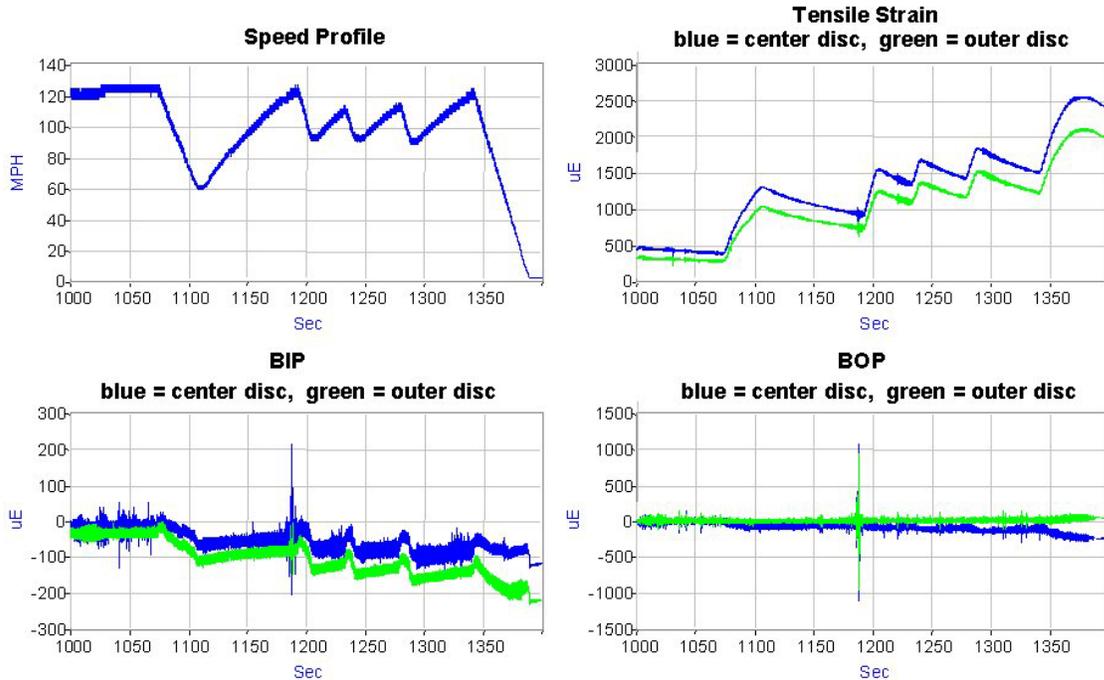
Figure 3.8. Strains on Spoke 6 of Center and Outer WABTEC/SAB-WABCO Supplied Brake Discs During Brake Applications (File 051605_09.ABT) – May 16, 2005

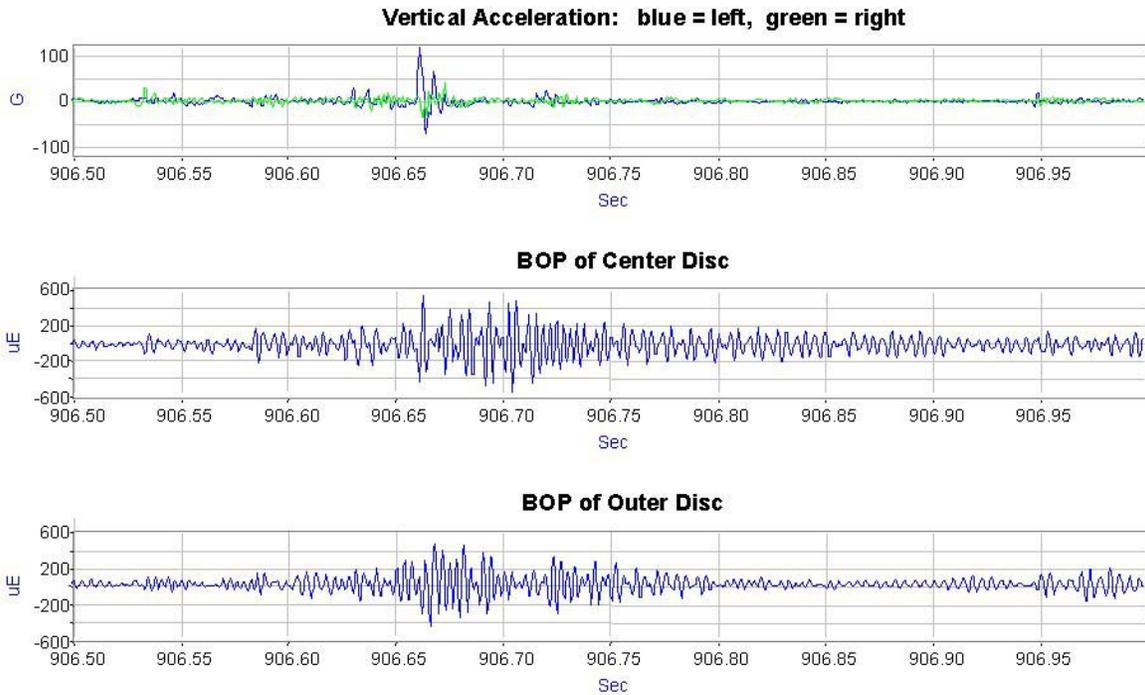
Figure 3.9. Vertical Accelerations and BOP Strains on Spoke 6 of Center and Outer WABTEC/SAB-WABCO Supplied Brake Discs During Vertical Shock (File 051705_19.ABT) – May 17, 2005

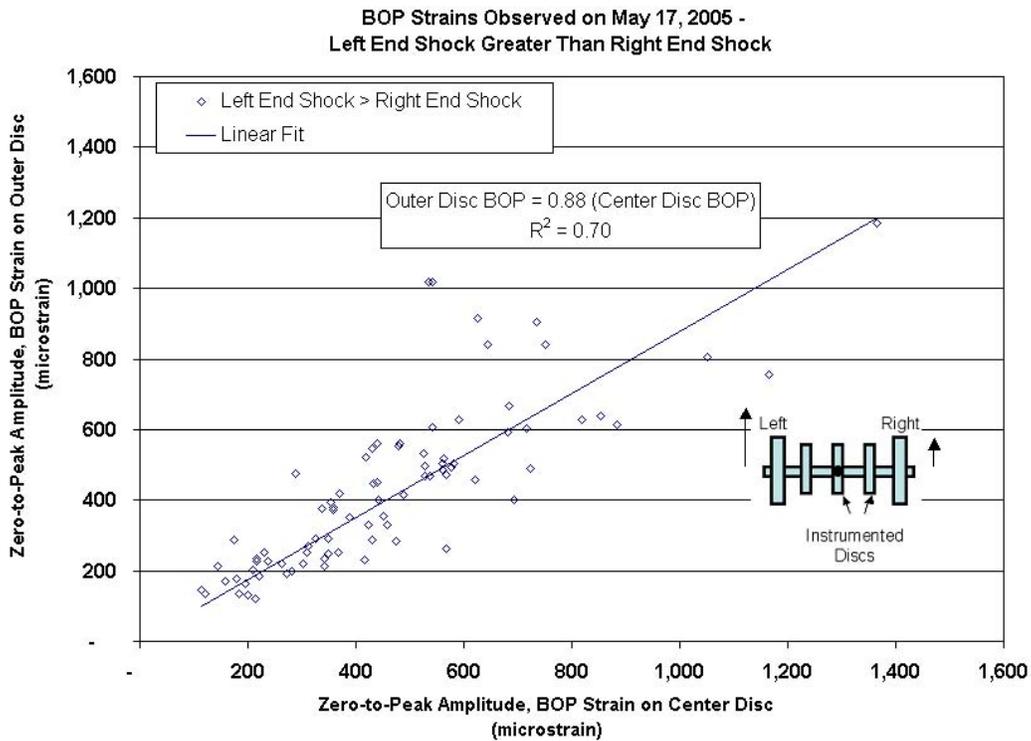
Figure 3.10a. Comparison of BOP Amplitudes of WABTEC/SAB-WABCO Supplied Center and Outer Discs Measured During Vertical Impacts, Left End Shock Greater Than Right End Shock – May 17, 2005

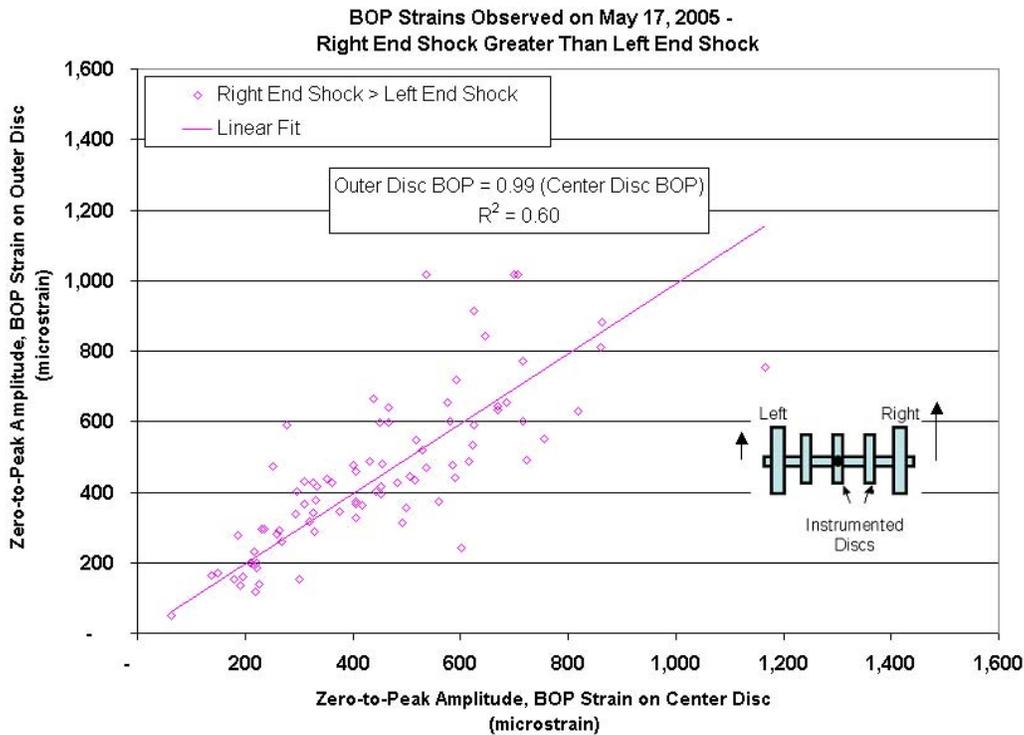
Figure 3.10b. Comparison of BOP Amplitudes of WABTEC/SAB-WABCO Supplied Center and Outer Discs Measured During Vertical Impacts, Right End Shock Greater Than Left End Shock – May 17, 2005

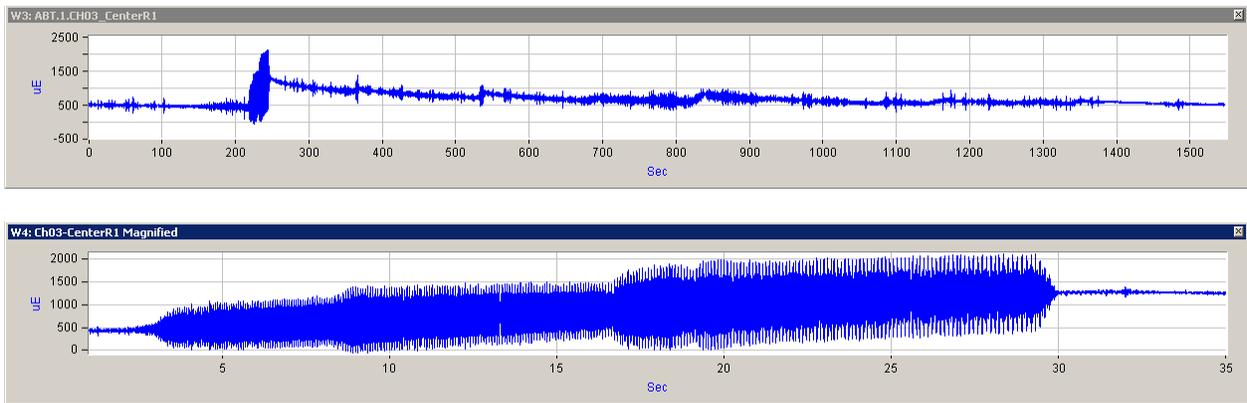
Figure 3.11. Strain Recorded on Gage R1 of Center WABTEC/SAB-WABCO Supplied Brake Disc During Braking Near MP E17 (File 051705_17.ABT) – May 17, 2005

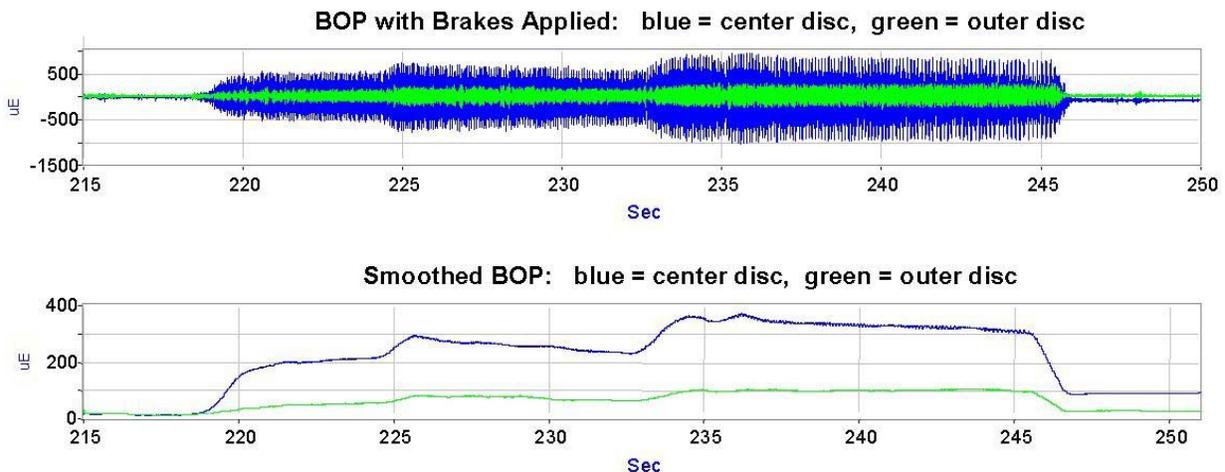
Figure 3.12. BOP Strain Recorded on Center and Outer WABTEC/SAB-WABCO Supplied Brake Discs During Braking Near MP E17 (File 051705_17.ABT) – May 17, 2005

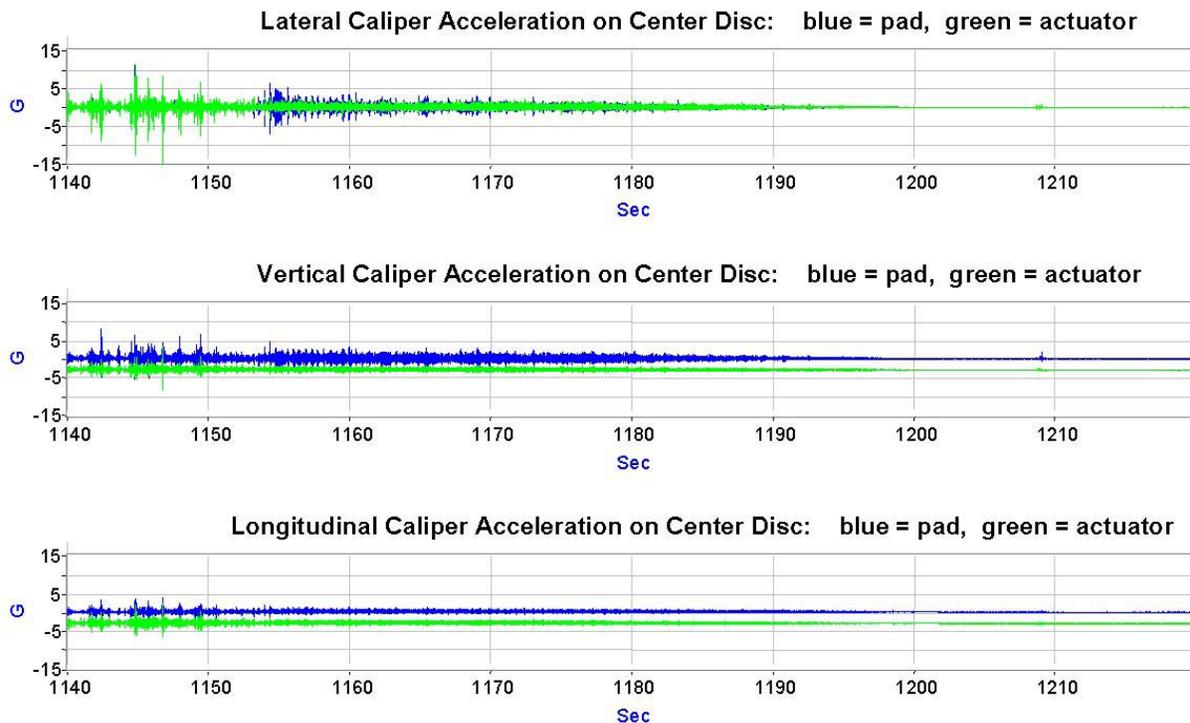
Figure 3.14. Accelerations Measured on Center Caliper During Normal Brake Application (File 051705_19.ABT) – May 17, 2005

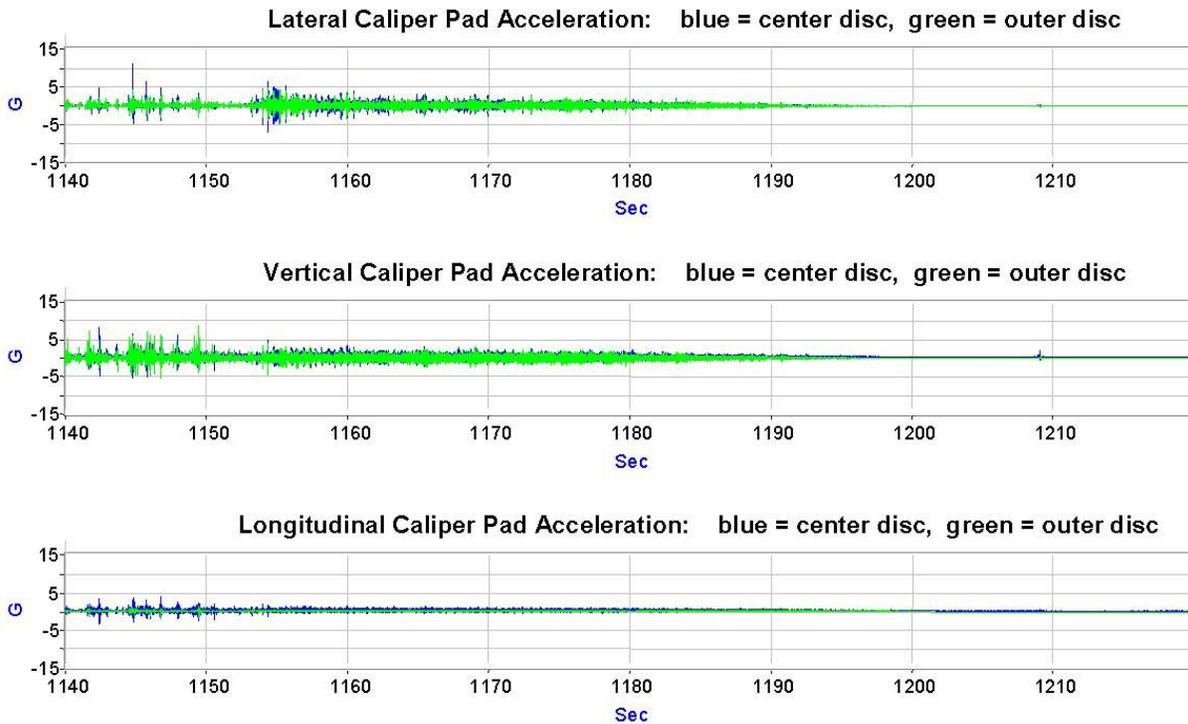
Figure 3.15. Accelerations Measured on Center and Outer Calipers Near Pads During Normal Brake Application (File 051705_19.ABT) – May 17, 2005

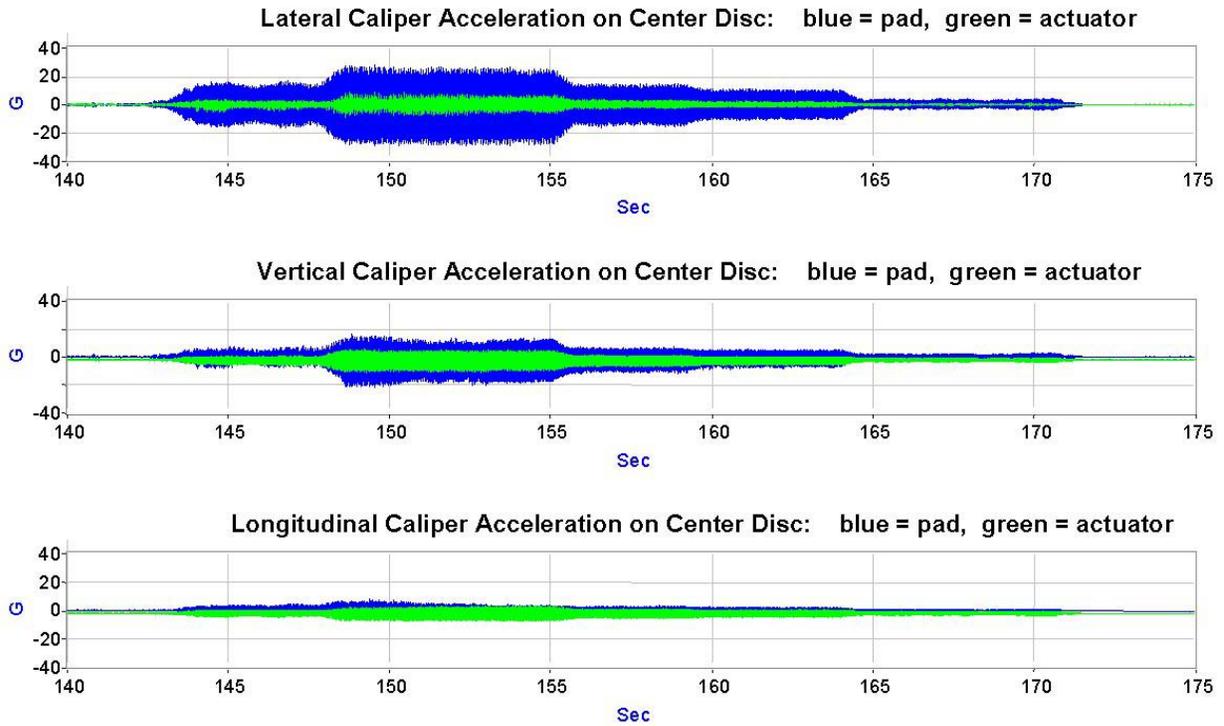
Figure 3.16. Accelerations Measured on Center Caliper During Brake Application with High BOP Strains (File 051705_19.ABT) – May 17, 2005

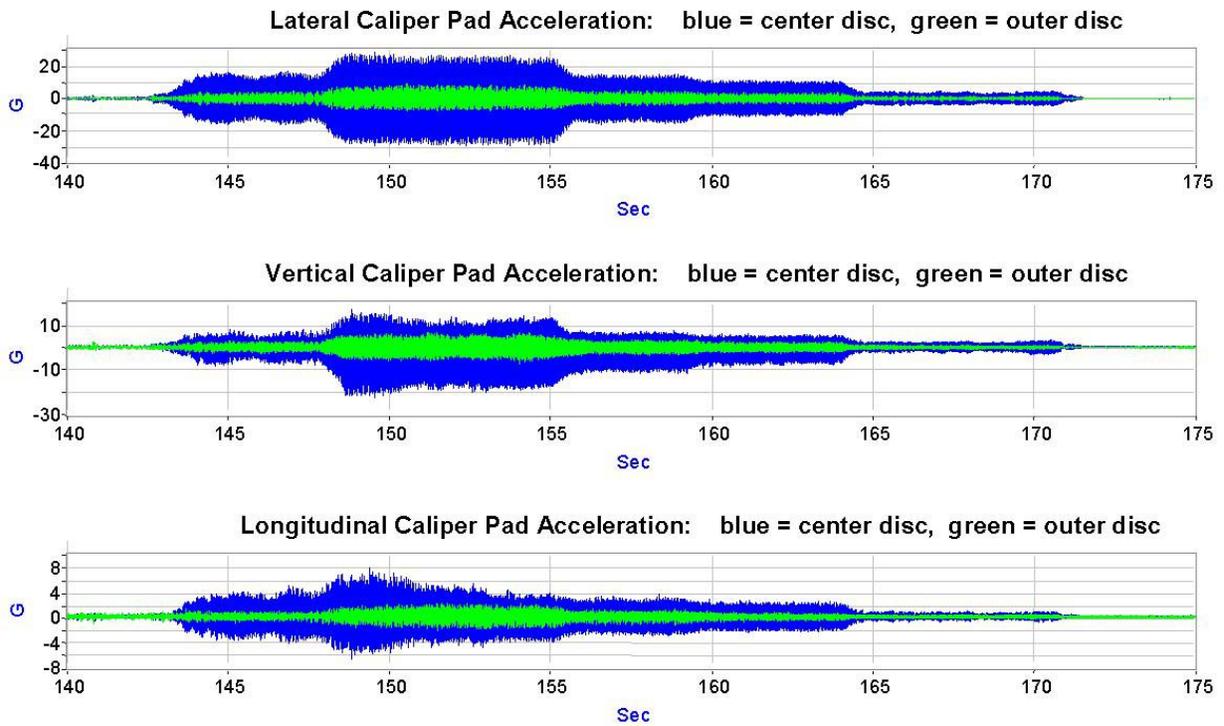
Figure 3.17. Accelerations Measured on Center and Outer Calipers Near Pads During Brake Application with High BOP Strains (File 051705_19.ABT) – May 17, 2005
