ENSCO PUB. NO. DOT-FR-05-07

Investigation of Cracks in
Acela Coach Car Brake Discs: Test and Analysis
Volume I - Final Report

November 2005

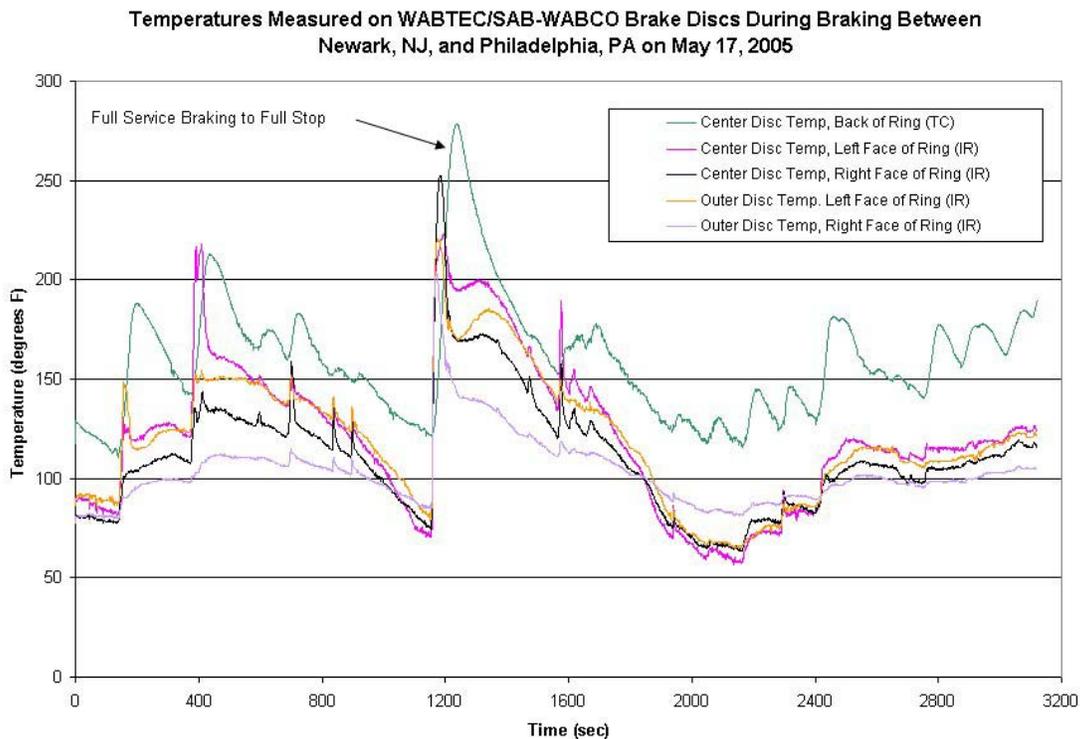
Figure 3.19. Temperature Measurements Made During Testing Between Newark, NJ, and Philadelphia, PA – May 17, 2005

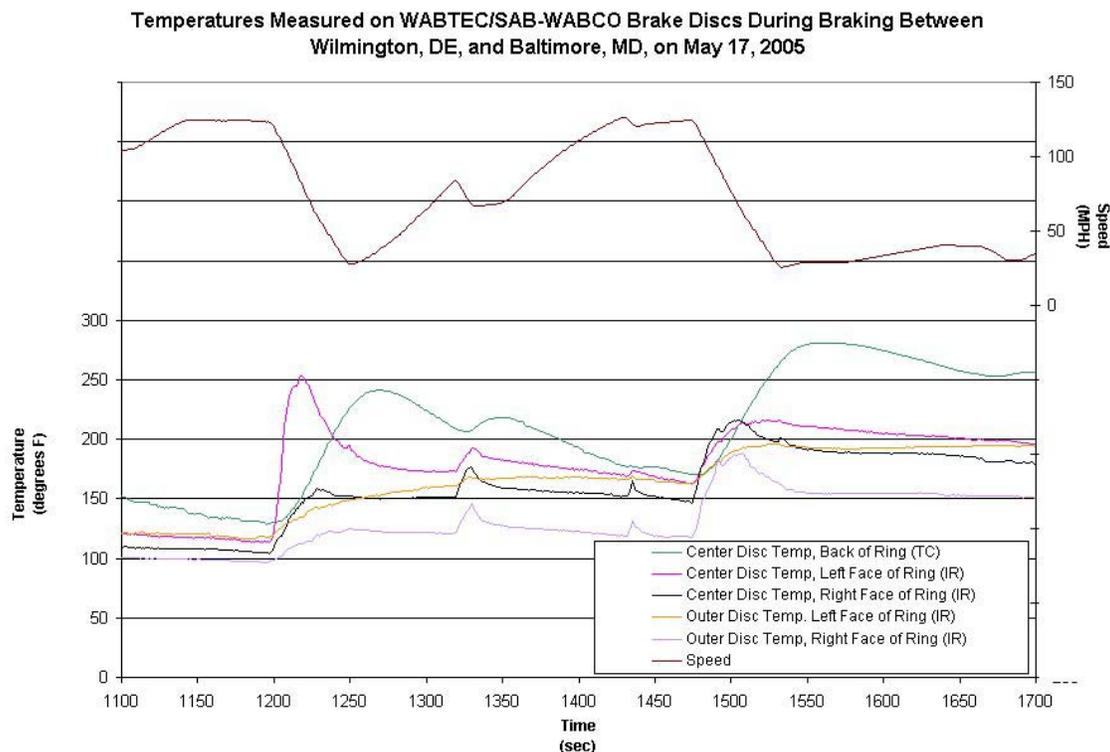
Figure 3.20. Extreme Temperature Measurements Made During Testing Between Wilmington, DE, and Baltimore, MD – May 17, 2005

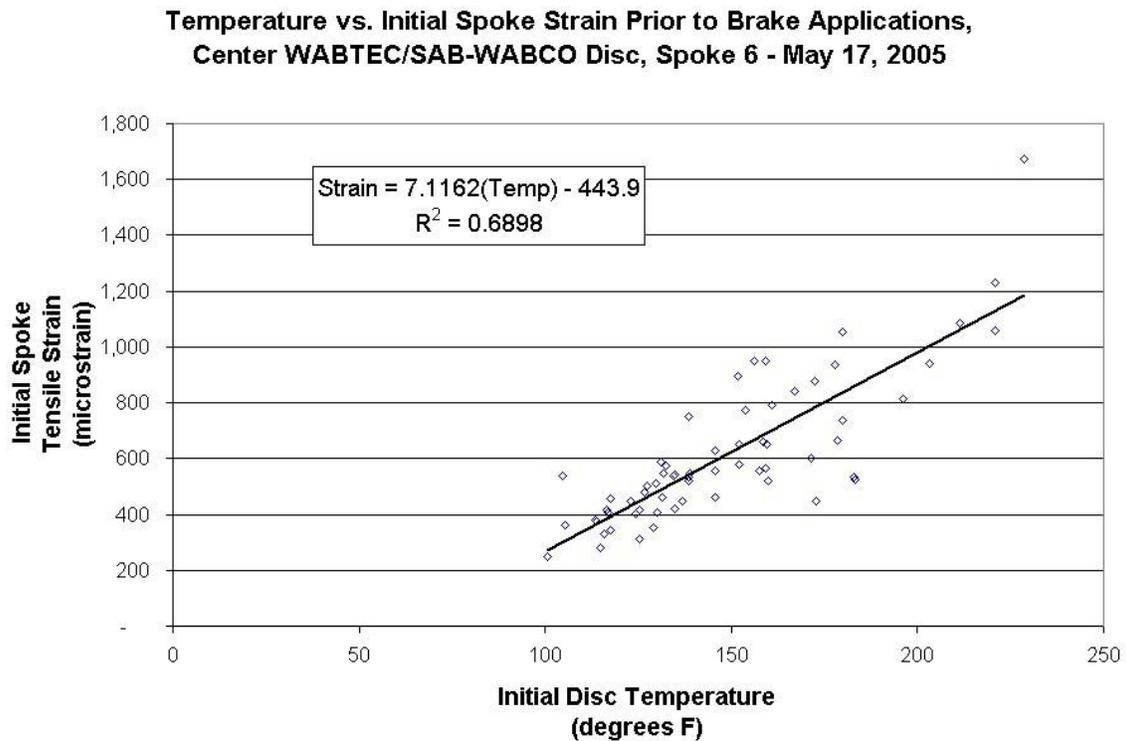
Figure 3.21. Brake Disc Temperature vs. Initial Spoke Tensile Strain Prior to Brake Applications, Center WABTEC/SAB-WABCO Supplied Disc, Spoke 6 – May 17, 2005

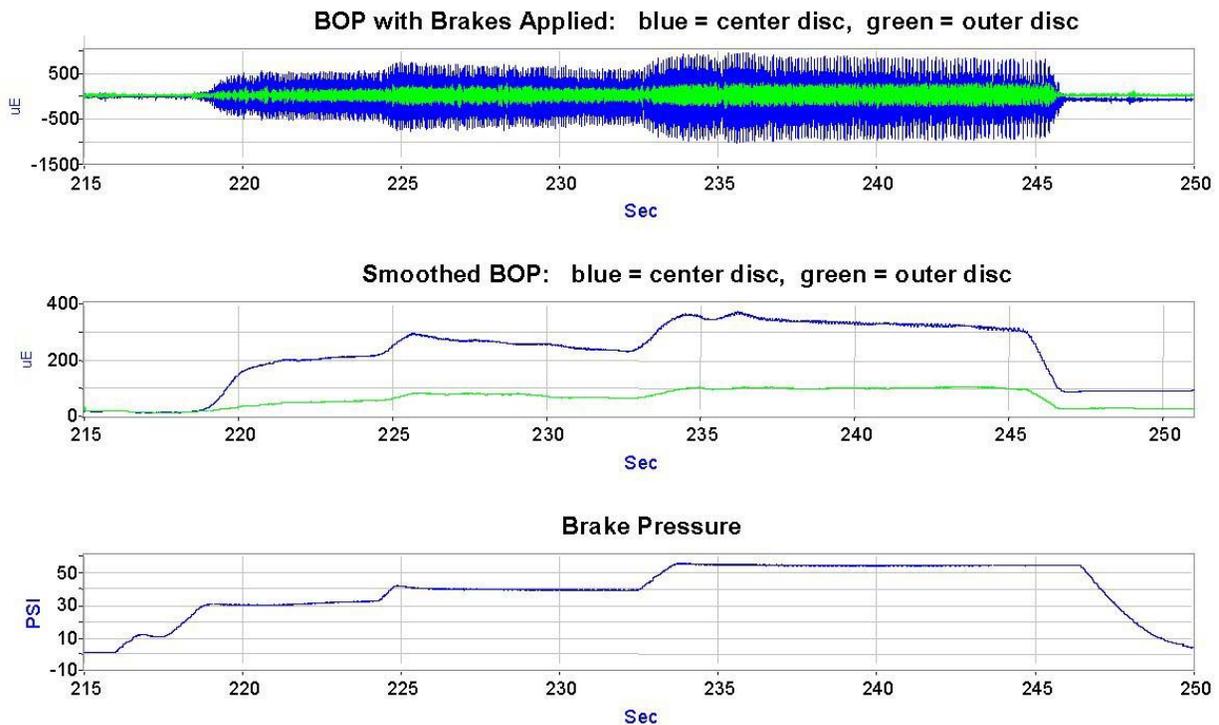
Figure 3.22. Brake Cylinder Pressure and BOP Strains Recorded on WABTEC/SAB-WABCO Supplied Brake Discs During Braking Near MP E17 (File 051705_17.ABT) – May 17, 2005

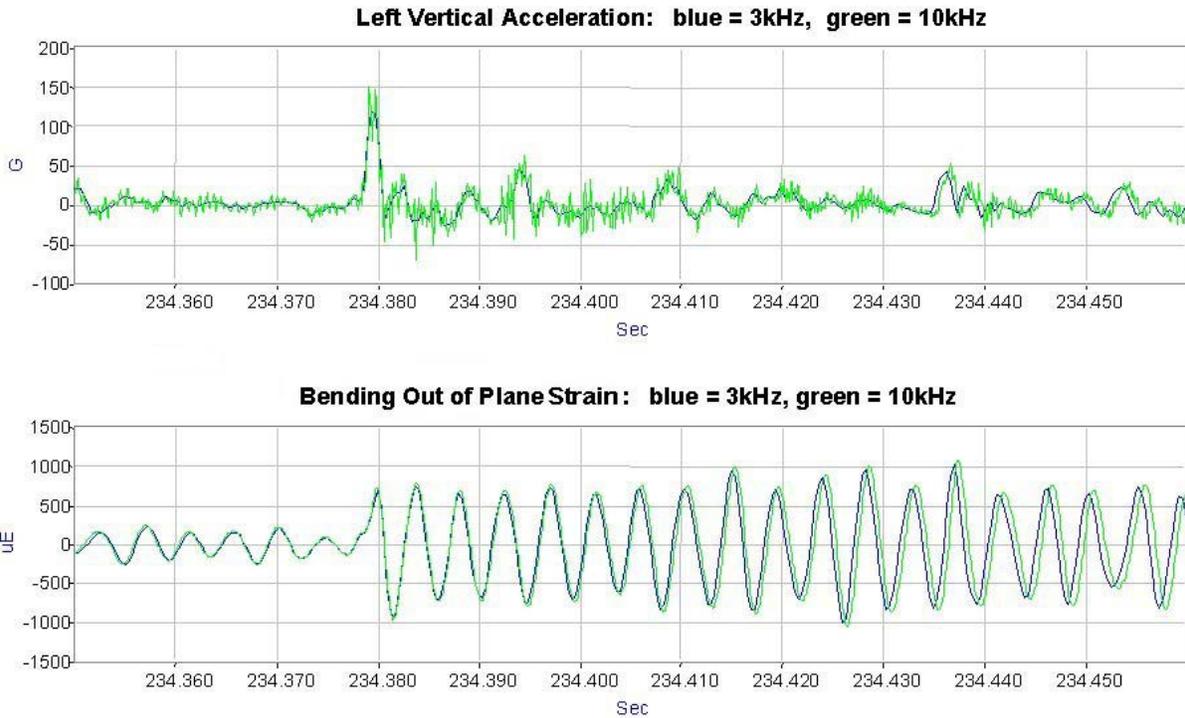
Figure 3.24. Comparison of Vertical Shock and BOP Strains Recorded with 3,000 Hz and 10,000 Hz Sampling Rates (Files 052605_18.AB2 [3,000 Hz Data] & File 052605_18.001 [10,000 Hz Data]) – May 26, 2005

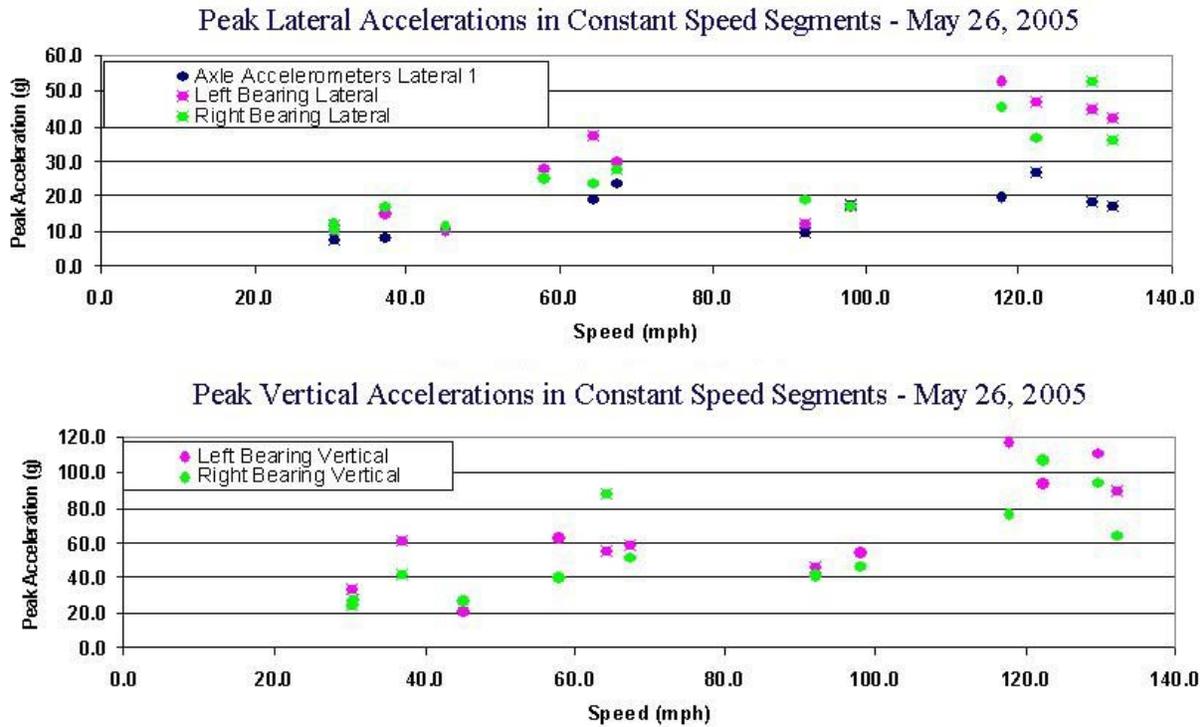
Figure 3.27. Peak Lateral and Vertical Accelerations Observed in Near-Constant Speed Segments as a Function of Speed – May 26, 2005

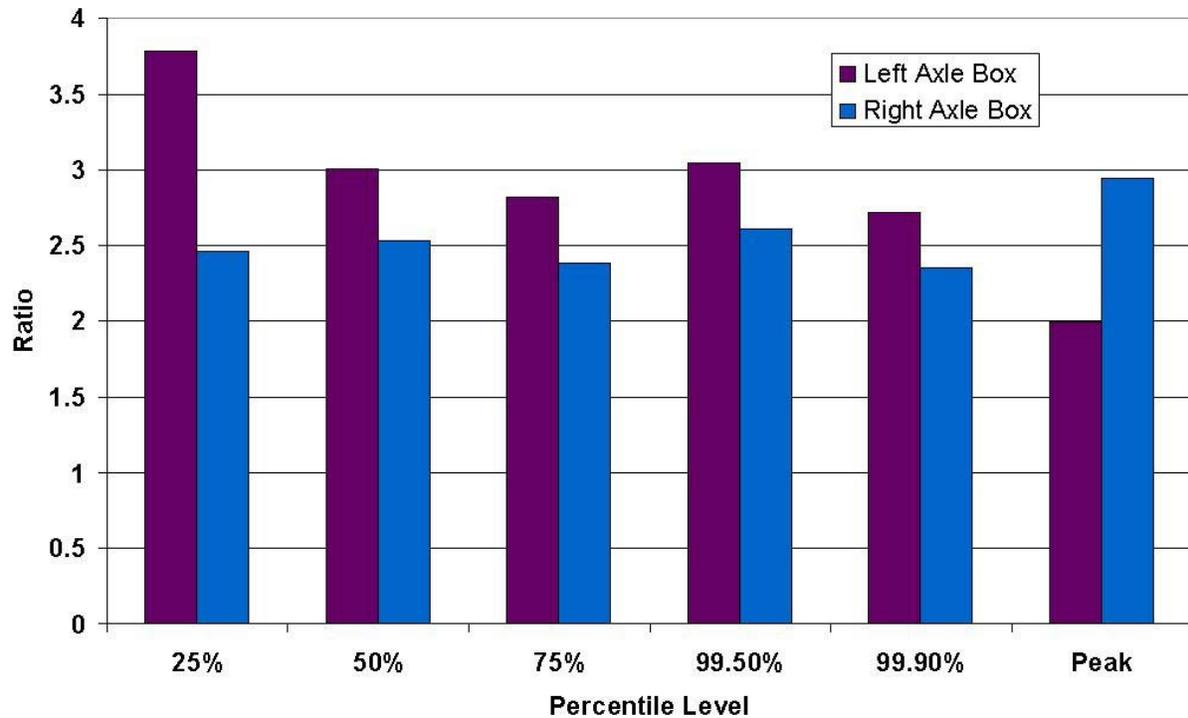
Figure 3.28. Vertical to Lateral Acceleration Ratios Determined for Data Collected in Near-Constant Speed Segments at 122 MPH – May 26, 2005

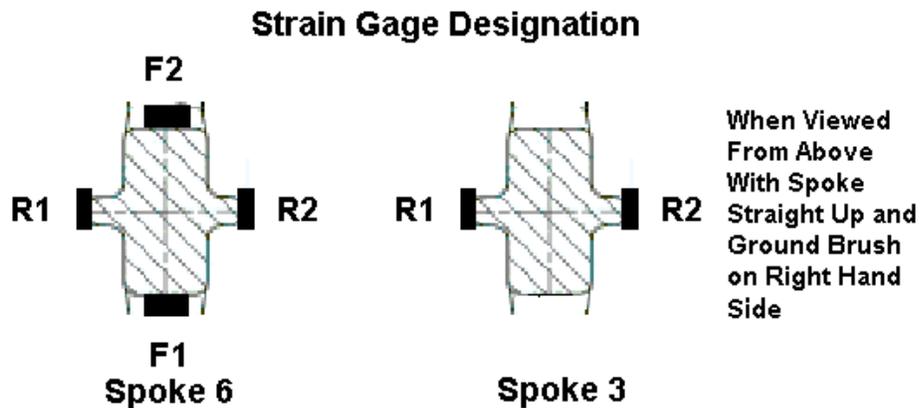
Figure 3.29. Designation of Strain Gages Used on Spoke 6 and Spoke 3 of Instrumented Center WABTEC/SAB-WABCO Supplied Disc During Phase 2 Testing

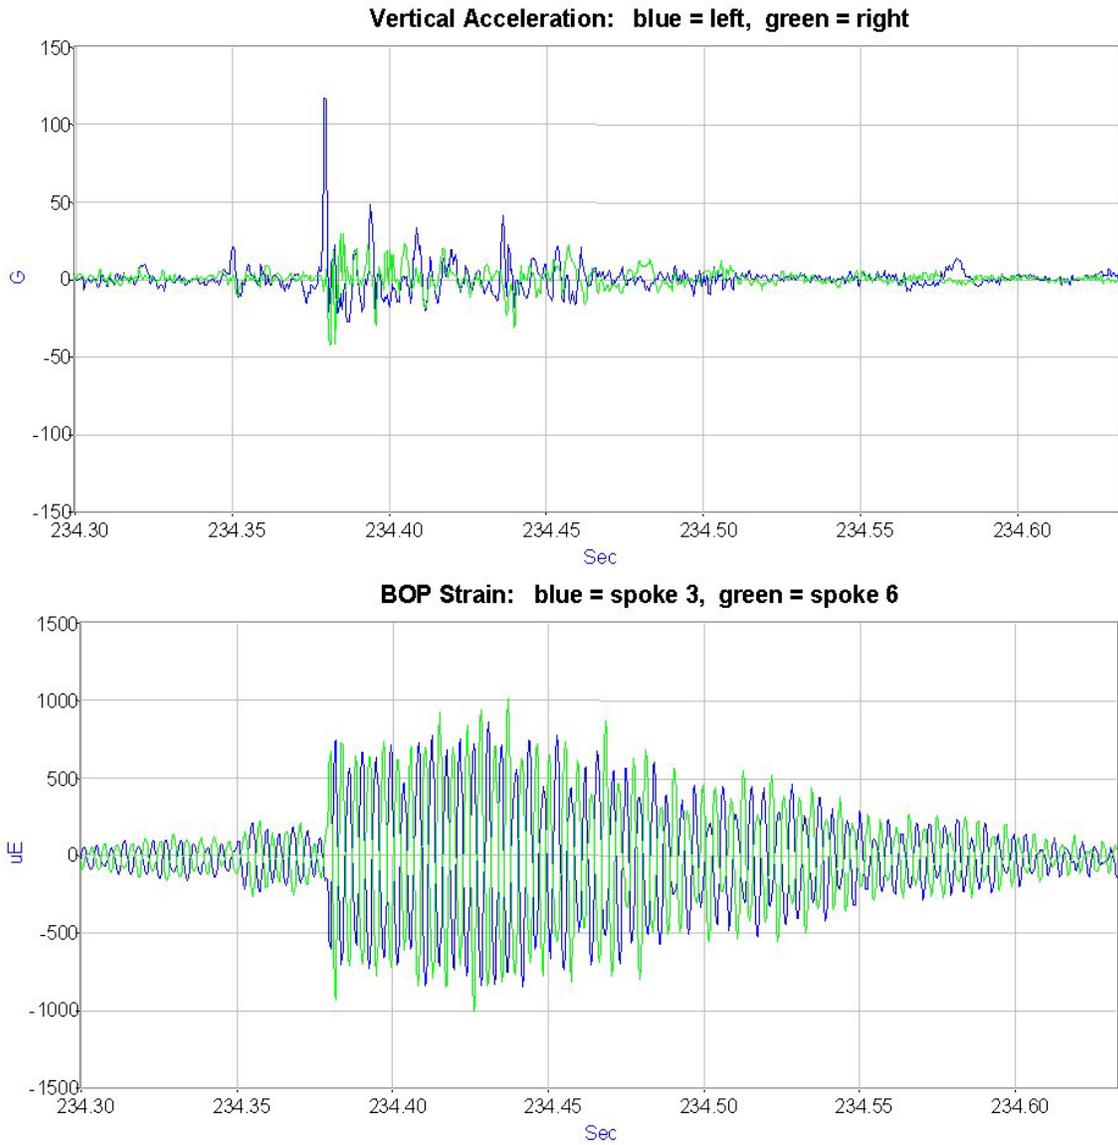
Figure 3.30. Vertical Shock and BOP Strains Recorded on Center WABTEC/SAB-WABCO Supplied Brake Disc During Phase 2 Testing (File 052605_18.AB2) – May 26, 2005

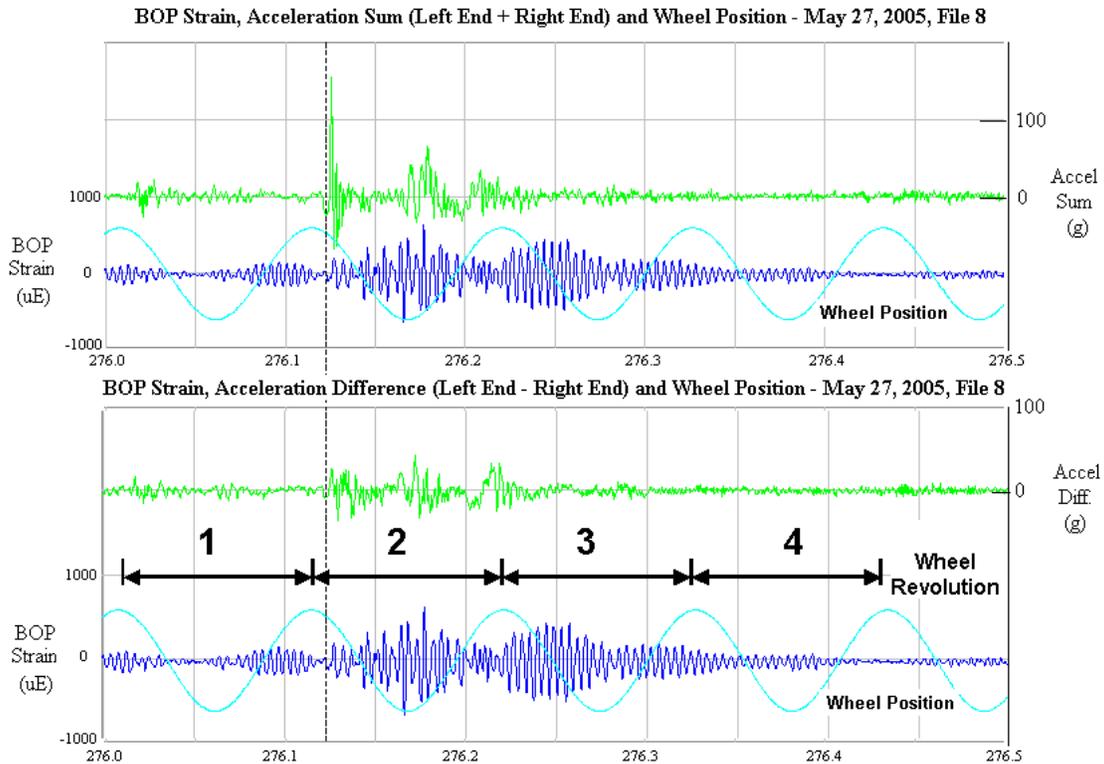
Figure 3.32. BOP Strains on WABTEC/SAB-WABCO Supplied Center Disc Resulting from Vertical Shocks on Both Ends of Test Axle (File 052705_08.AB2) – May 27, 2005

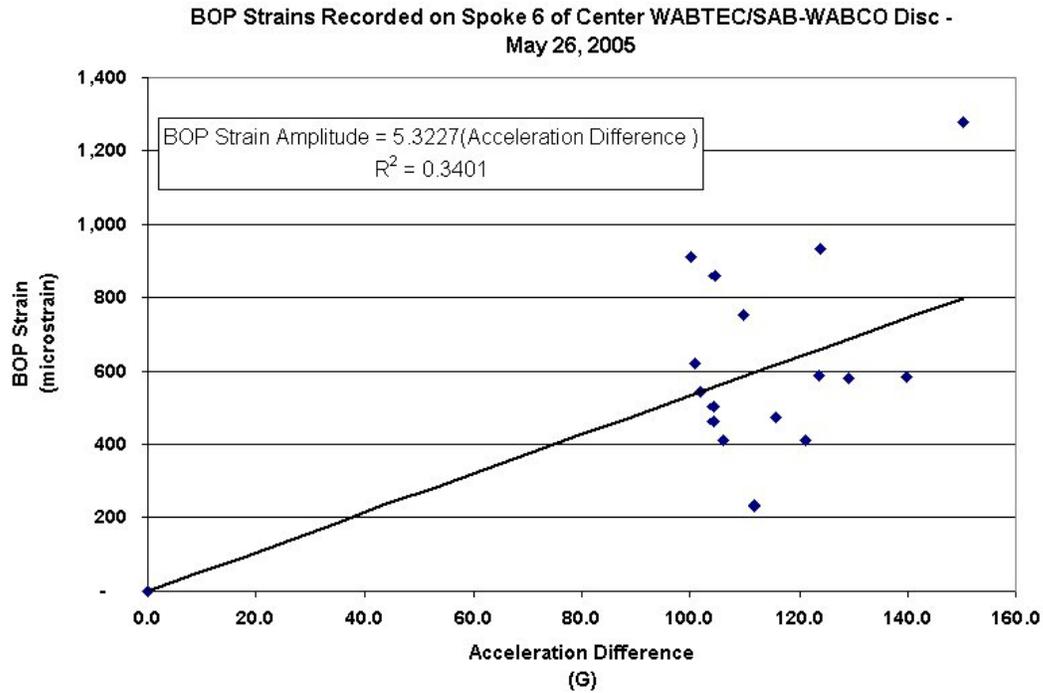
Figure 3.33. BOP Strains as a Function of Acceleration Differences Measured on May 26, 2005

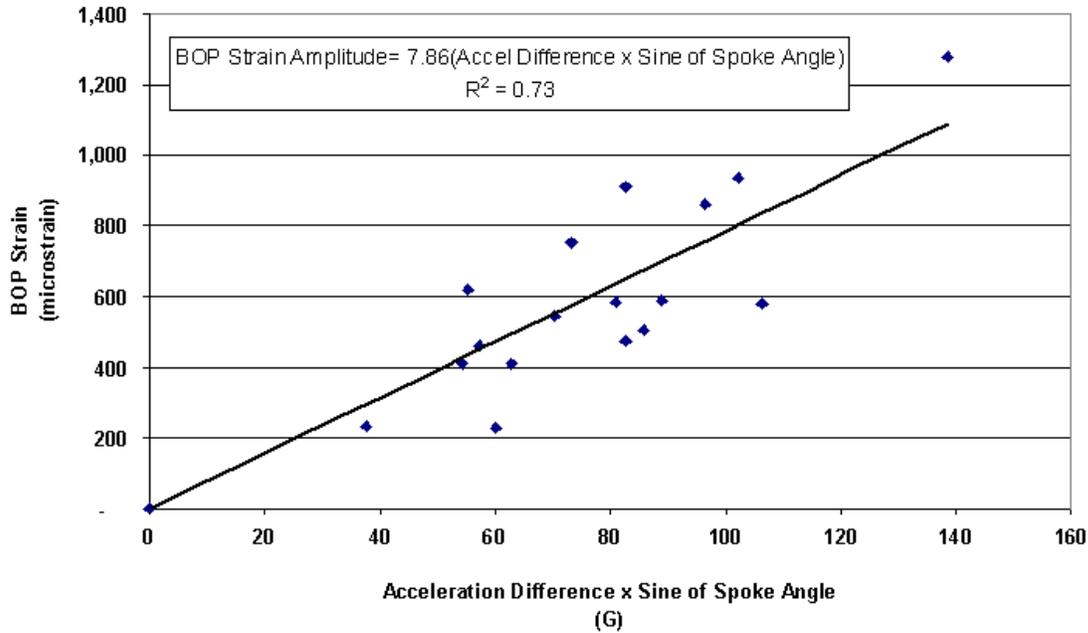
**Figure 3.34. Correlation of BOP Strain Amplitudes and Acceleration Differences
Based on Measurements Collected on May 26, 2005**

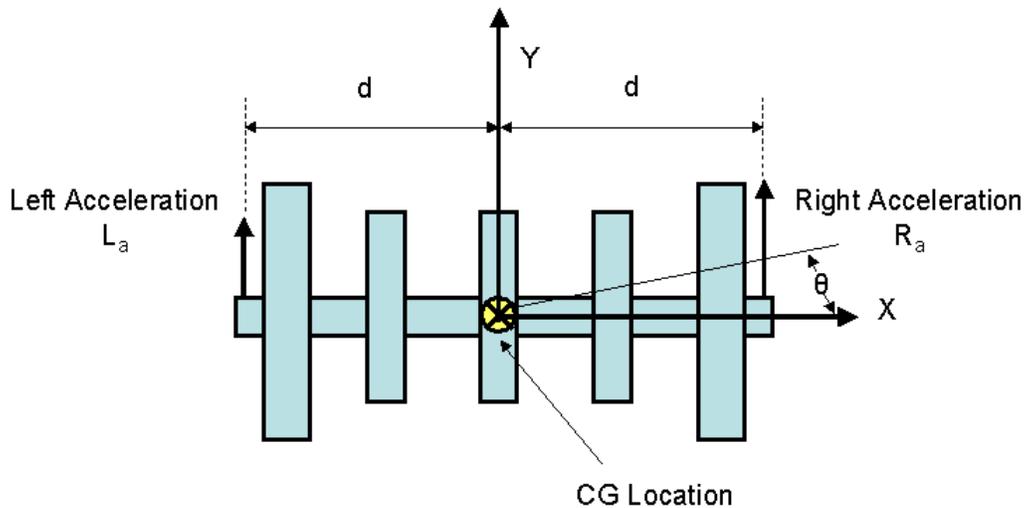
Figure 3.35. Definition of Wheelset Acceleration Terminology

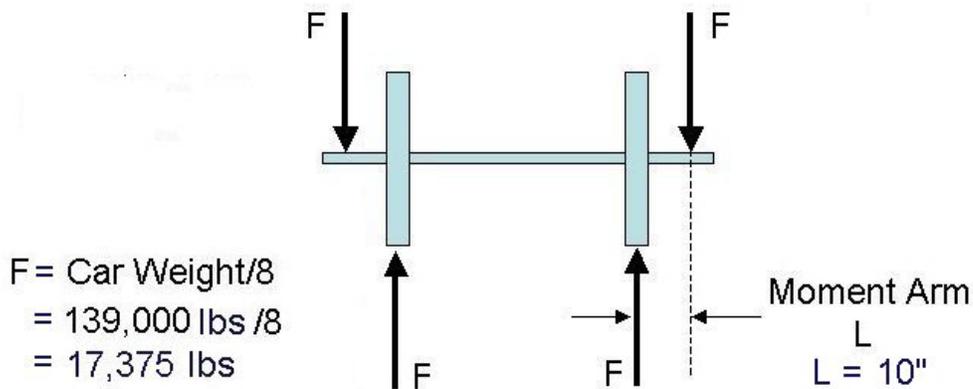
Figure 3.36. Bending Moments in Generic Wheelset

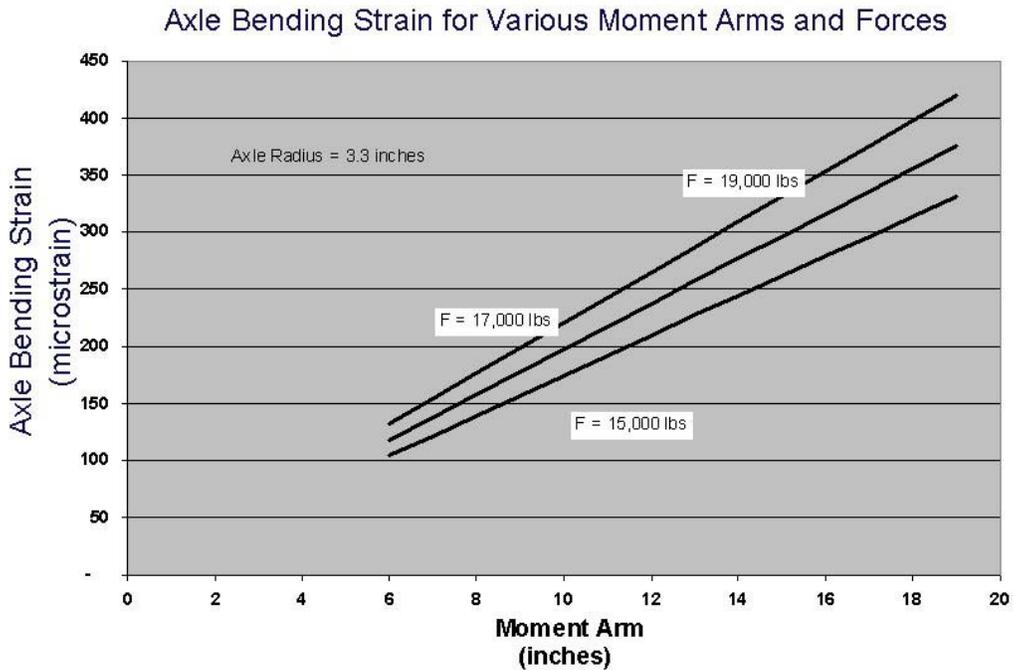
Figure 3.37. Axle Bending Strain as a Function of Bearing Force and Moment Arm

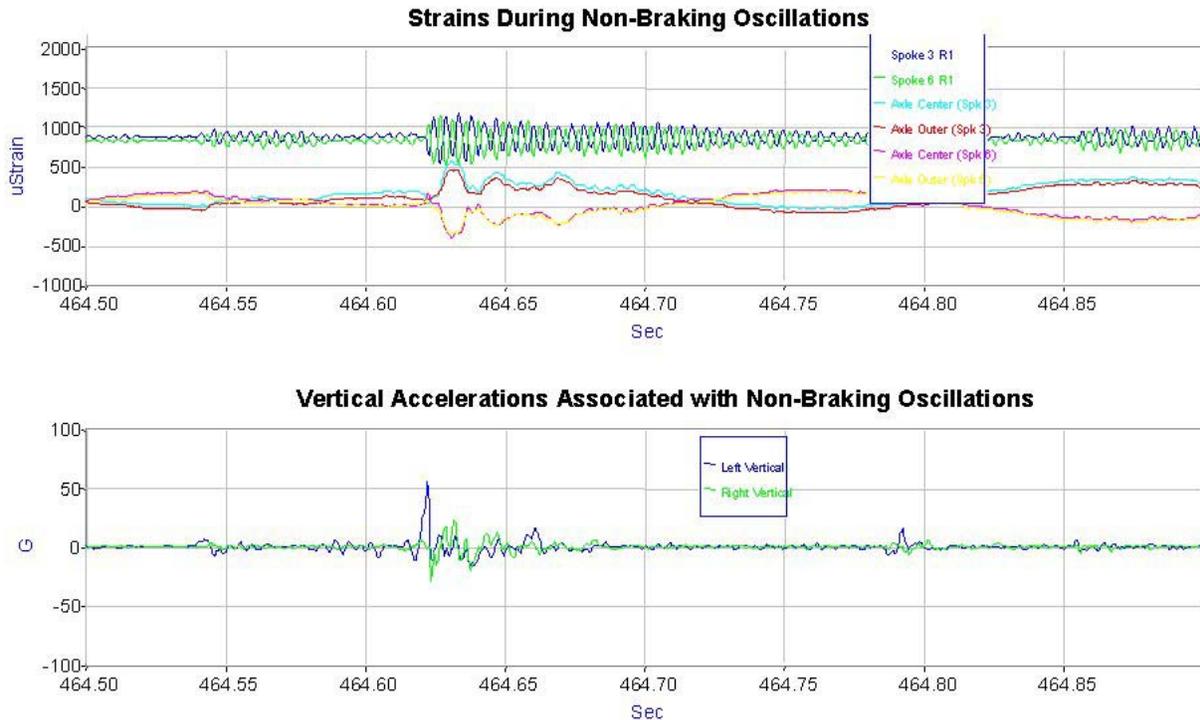
Figure 3.40. Axle Bending Strains Recorded During Response of WABTEC/SAB-WABCO Supplied Brake Disc to Vertical Impact (File 052605_18.AB2) – May 26, 2005

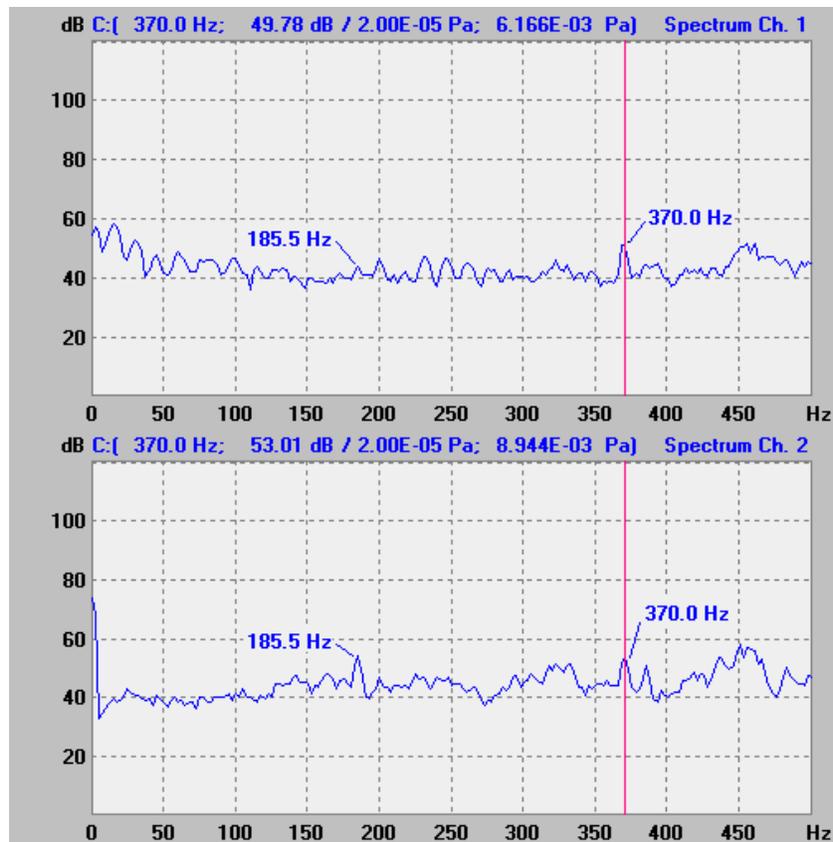
Figure 3.43. Analysis of Sound Recorded During Sustained Oscillations While Braking Near MP AB 179 – May 26, 2005

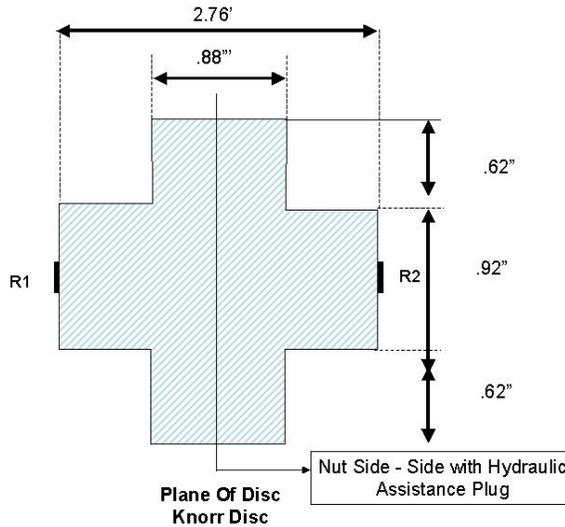
Figure 3.44. Strain Gage Location and Cross Section Associated with Spoke of Knorr Brake Disc

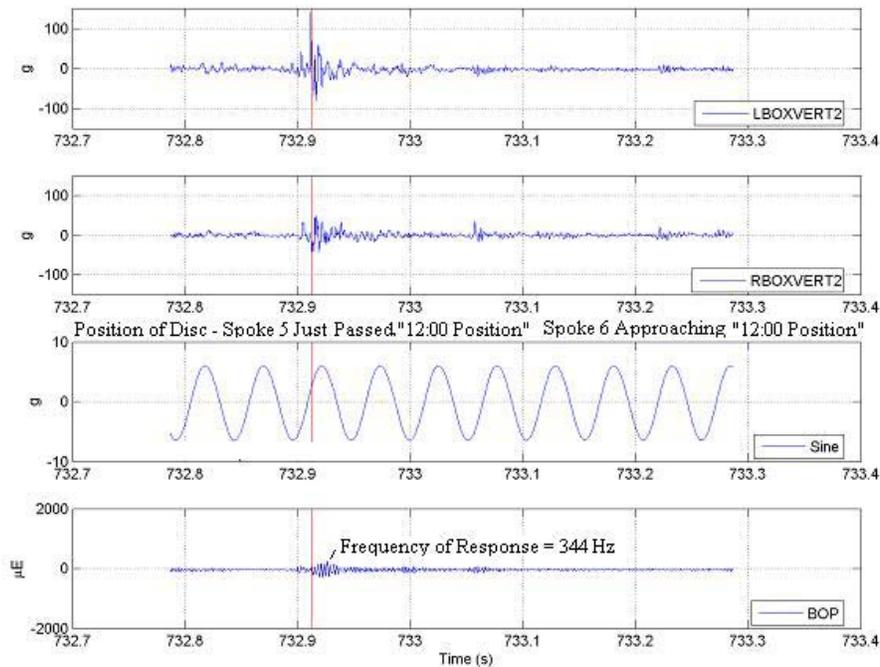
Figure 3.49. Vertical Shock and BOP Spoke Strain Response of Knorr Brake Disc Measured Near Lane Interlocking (File 061805_30.AB3) – June 18, 2005

NOTE: No Oscillations of Appreciable Amplitude Observed on Center Knorr Brake Disc

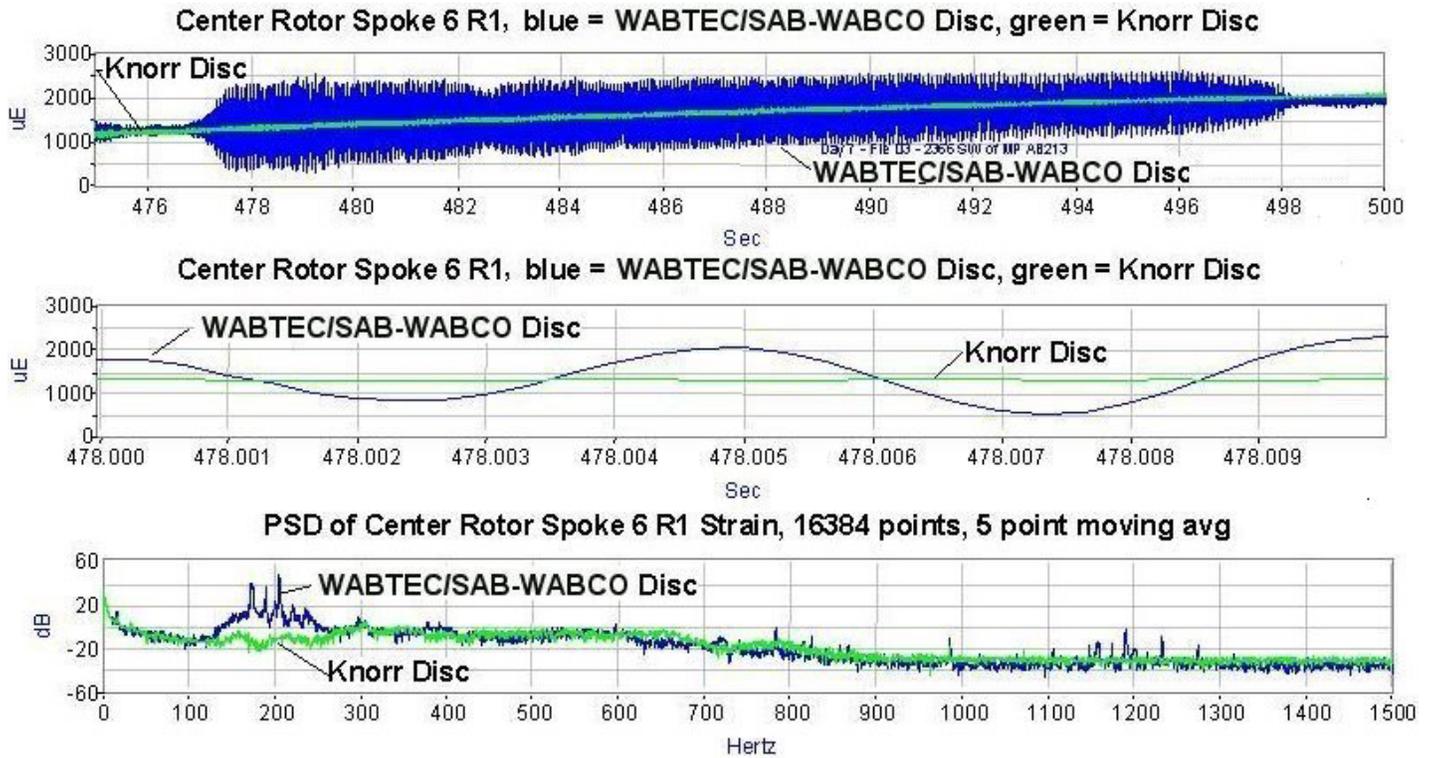
Figure 3.50. Comparison of WABTEC/SAB-WABCO Supplied Disc and Knorr Disc During a Brake Application From 116 MPH with Sustained Oscillations (File 061805_03.AB3) – June 18, 2005

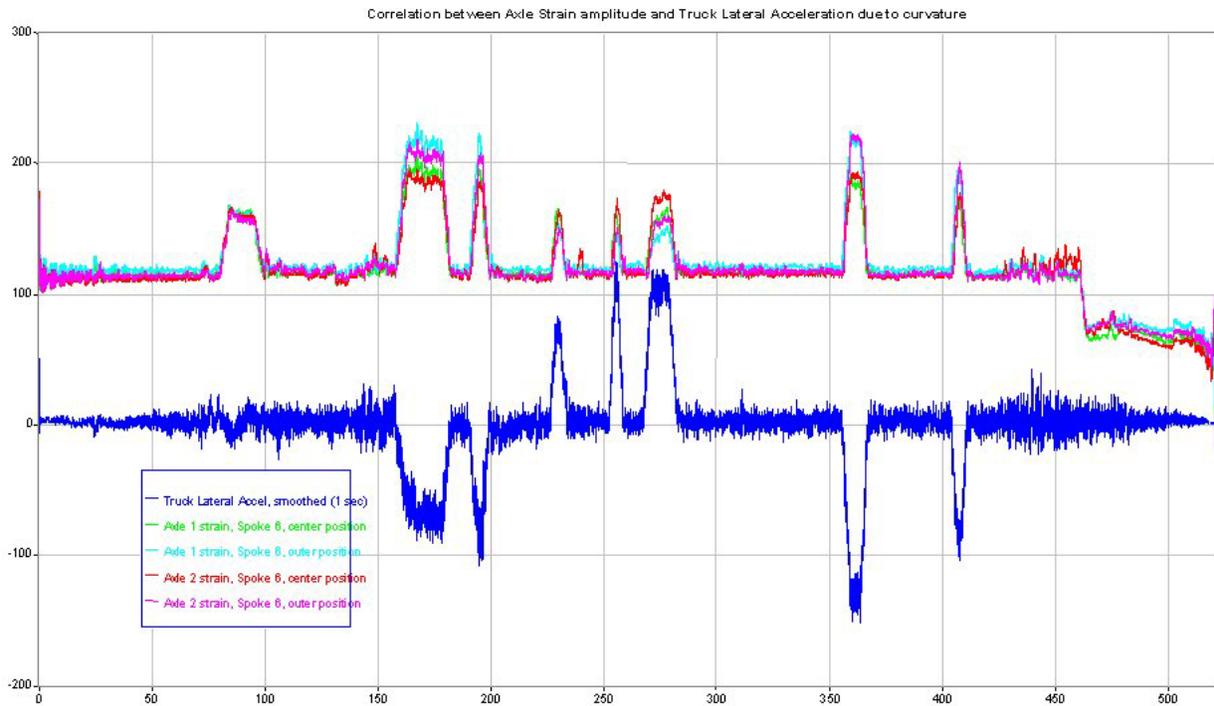
**Figure 3.52. Comparison of Truck Frame Lateral Accelerations and Axle Strains
(File 061805_03.AB3) – June 18, 2005**

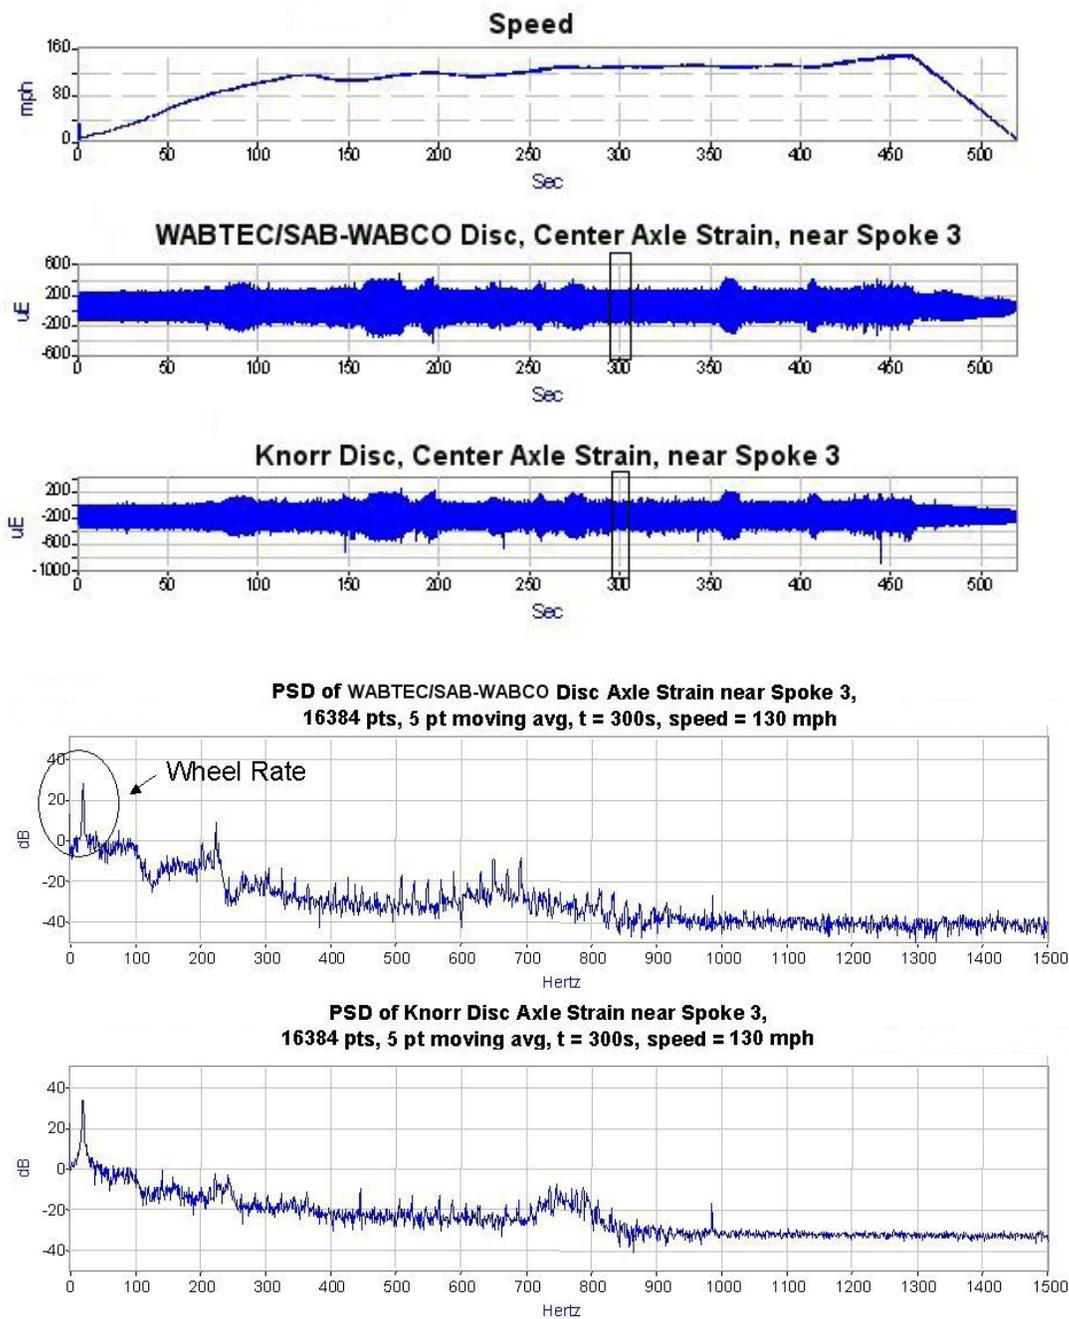
**Figure 3.53. PSD of Axle Strains Collected Over Tangent Section of Track
(File 061805_03.AB3) – June 18, 2005**

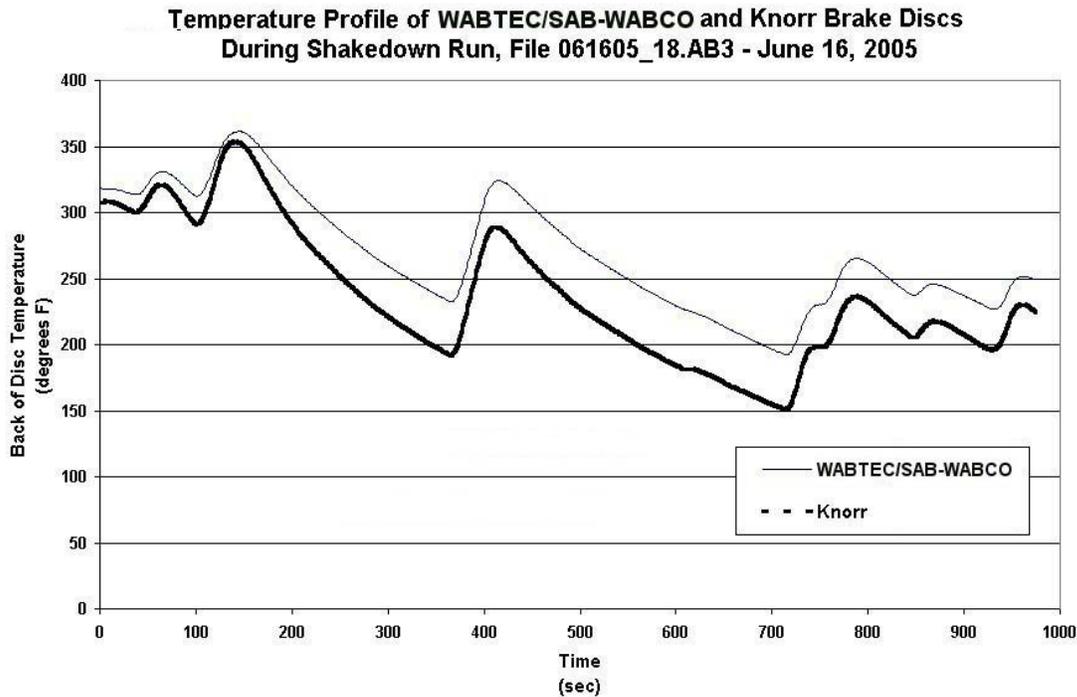
Figure 3.55. Temperature Profiles from Back of WABTEC/SAB-WABCO Supplied and Knorr Brake Discs During Shakedown Run (File 061605_18.AB3) – June 16, 2005

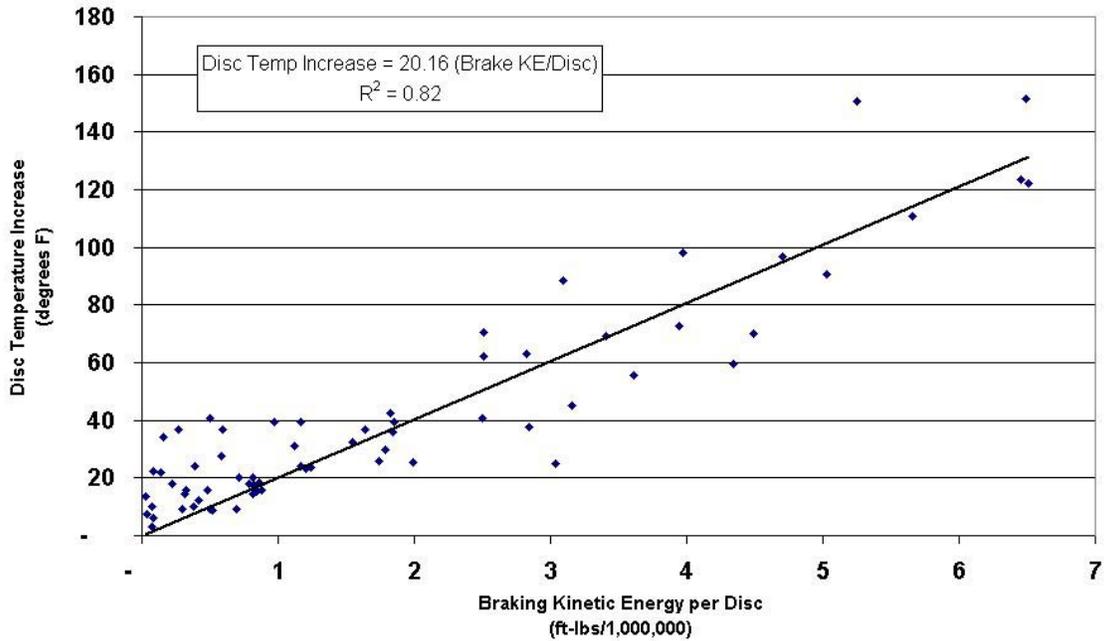
**Disc Temperature Change vs. Braking Kinetic Energy/Disc
Knorr Disc - June 18, 2005**

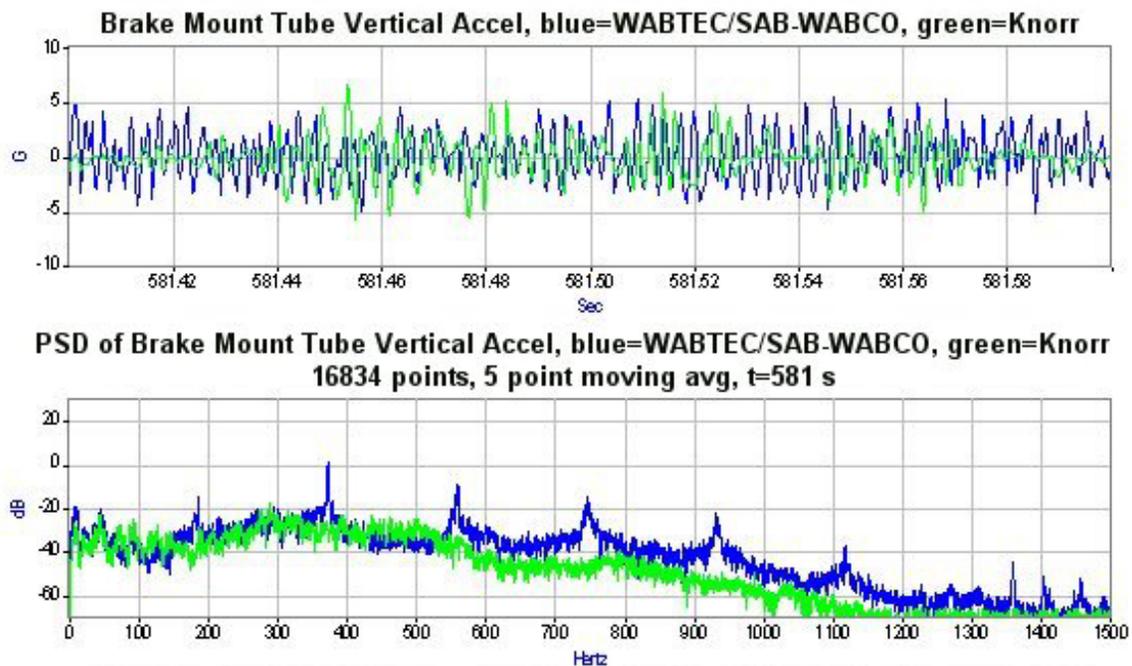
Figure 3.57. Time History and PSD of Brake Mounting Tube Vertical Accelerations During Sustained Oscillations While Braking (File 061805_24.AB3) – June 18, 2005

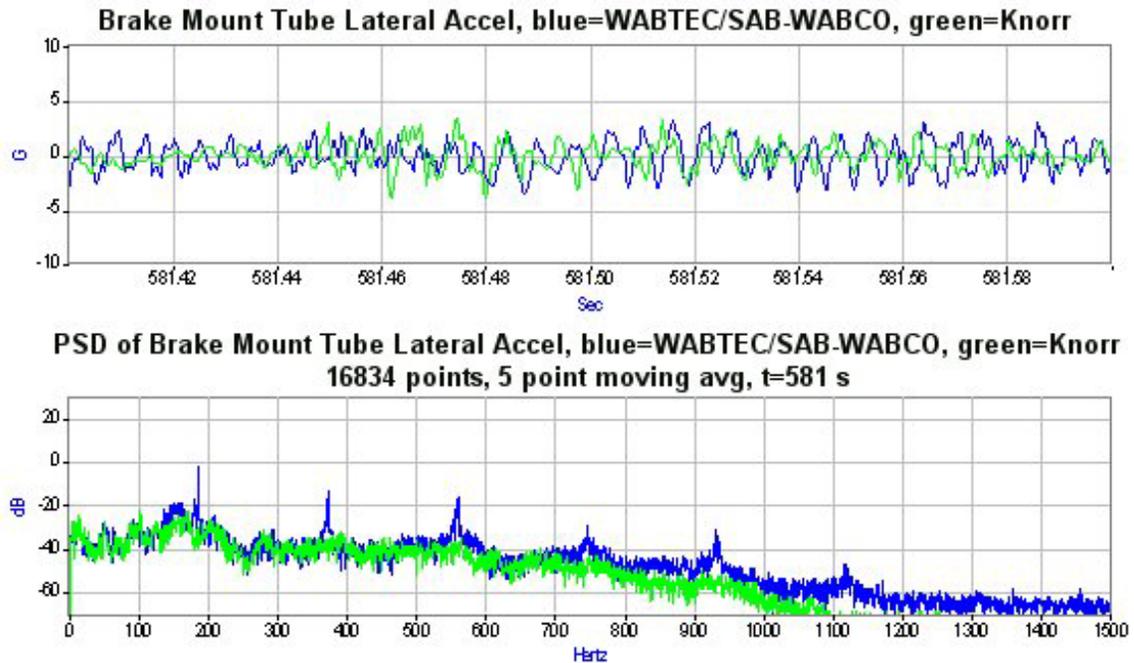
Figure 3.58. Time History and PSD of Brake Mounting Tube Lateral Accelerations During Sustained Oscillations While Braking (File 061805_24.AB3) – June 18, 2005

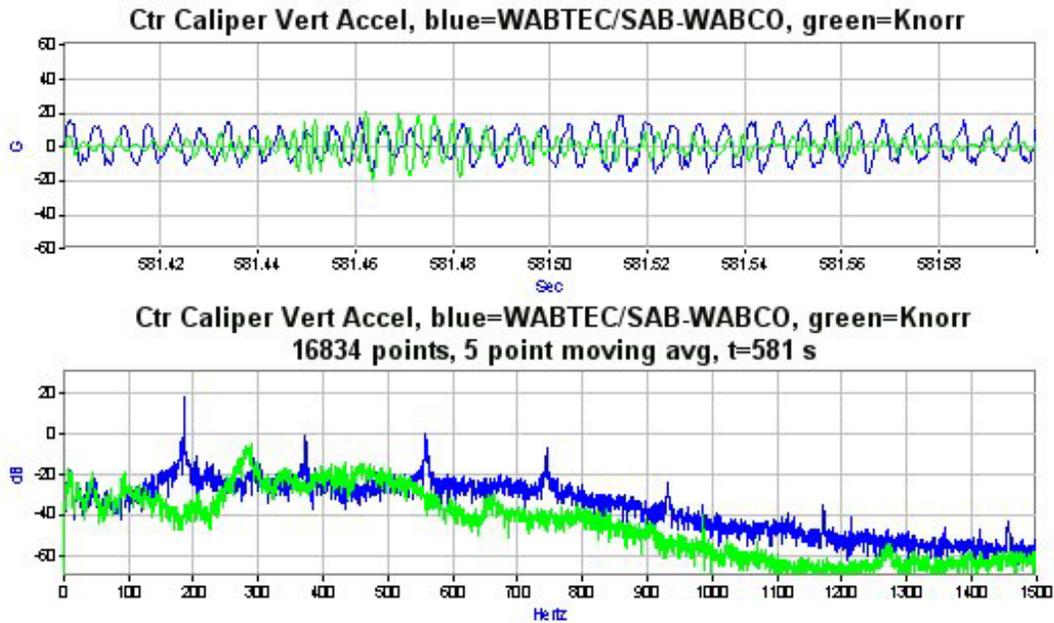
Figure 3.59. Time History and PSD of Brake Caliper Pad Vertical Accelerations During Sustained Oscillations While Braking (File 061805_24.AB3) – June 18, 2005

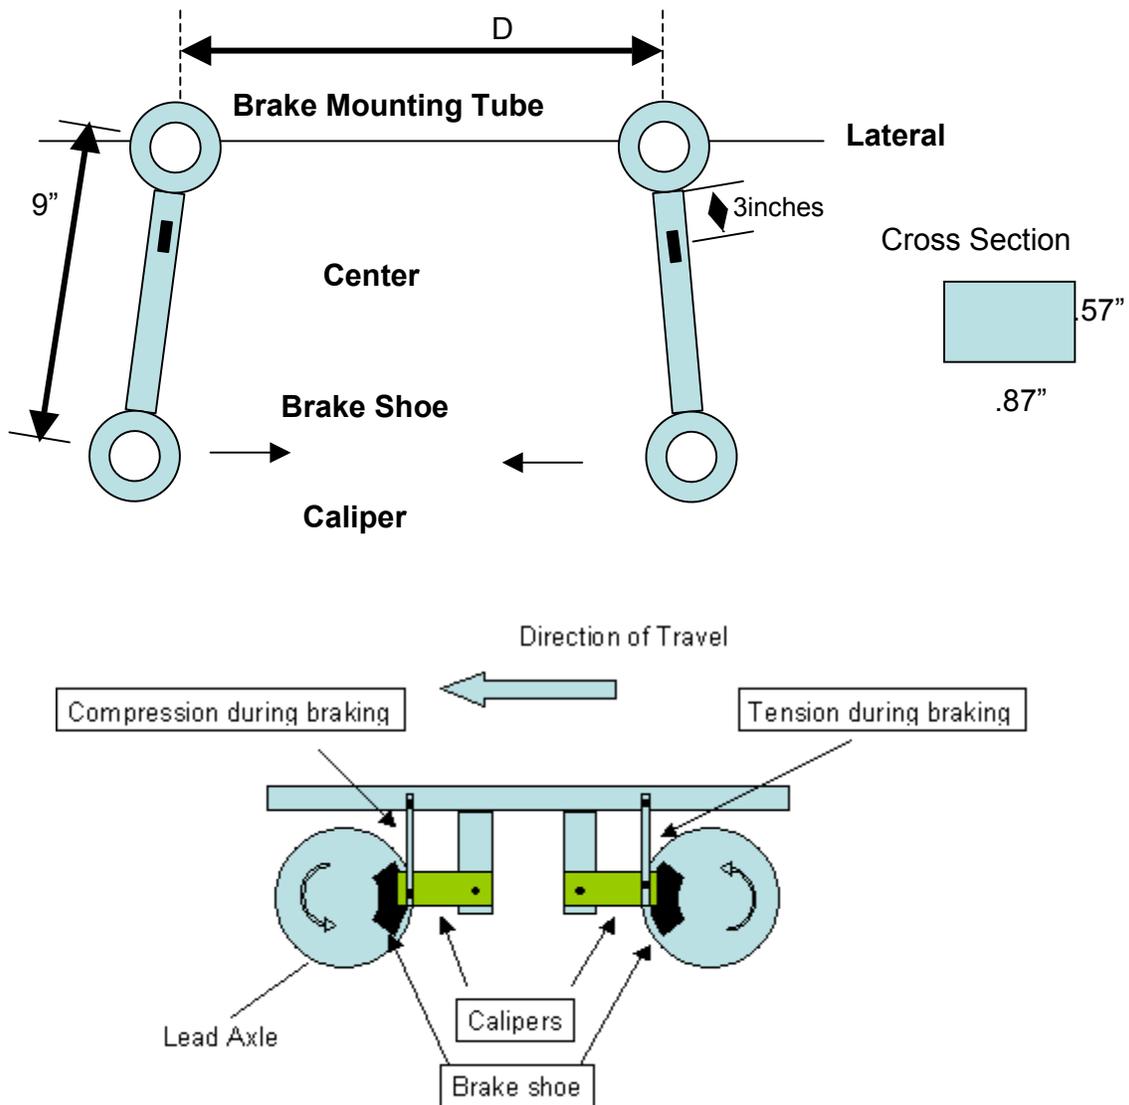
Figure 3.61. Illustration of Instrumented Brake Links and Locations Within Truck
