ENSCO PUB. NO. DOT-FR-05-07

Investigation of Cracks in
Acela Coach Car Brake Discs: Test and Analysis
Volume I - Final Report

November 2005

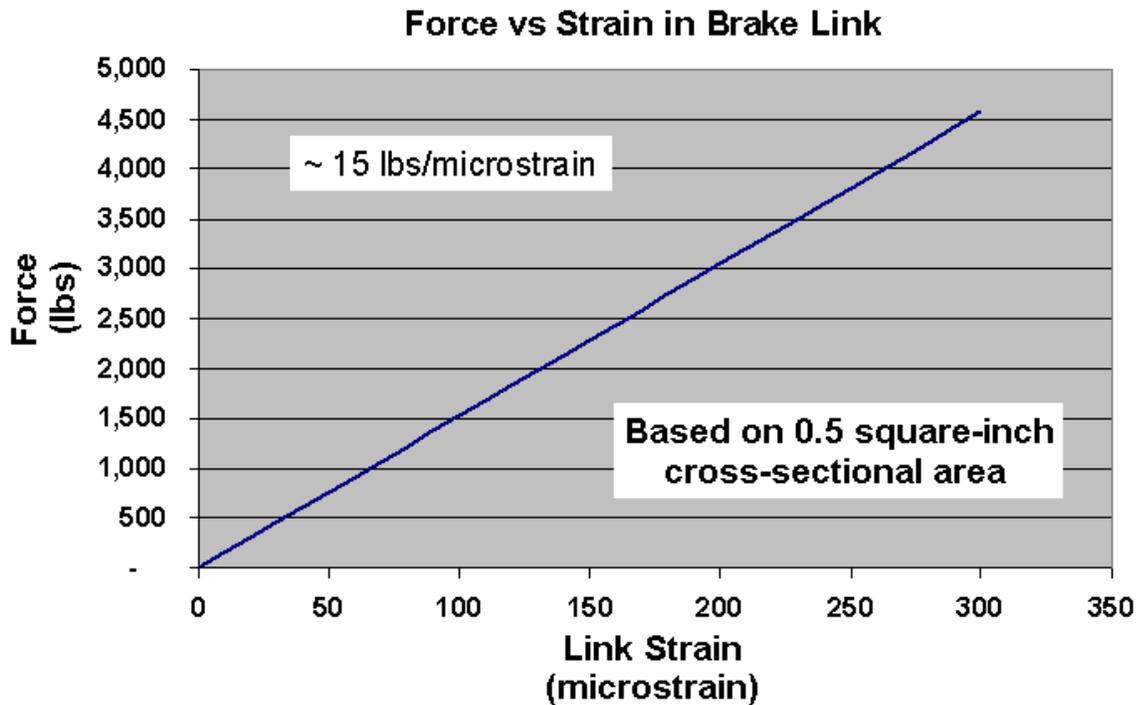
Figure 3.62. Brake Link Strain Level - Force Relationship

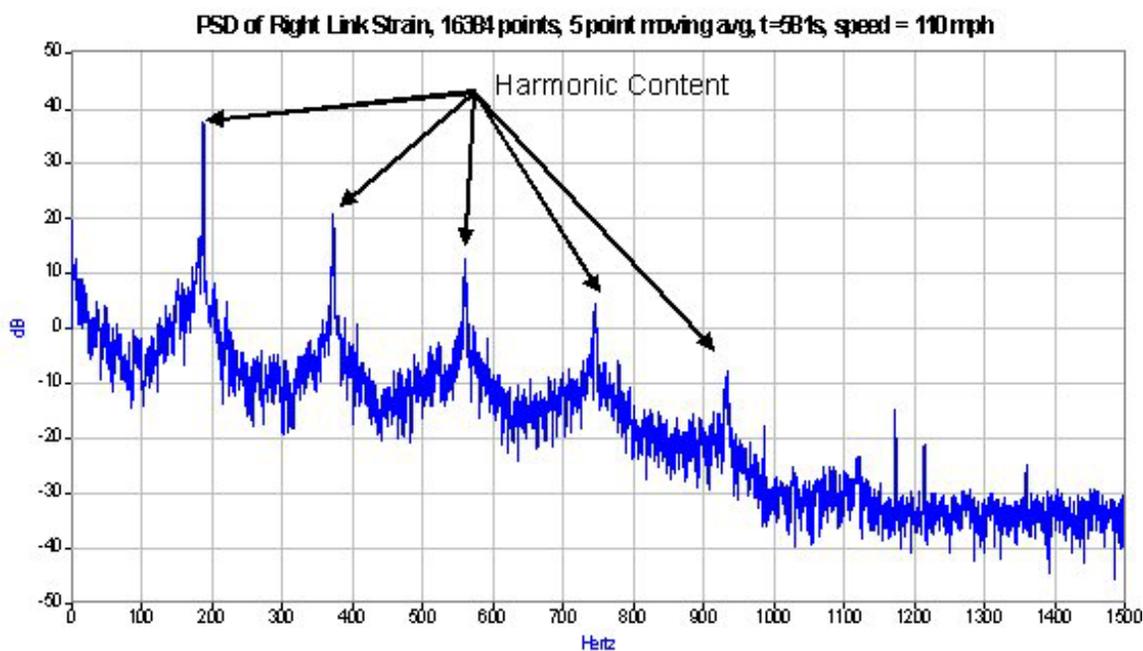
Figure 3.63. Frequency Spectrum of Strains Recorded on Caliper Link During Sustained Oscillations While Braking (File 061805_24.AB3) – June 18, 2005

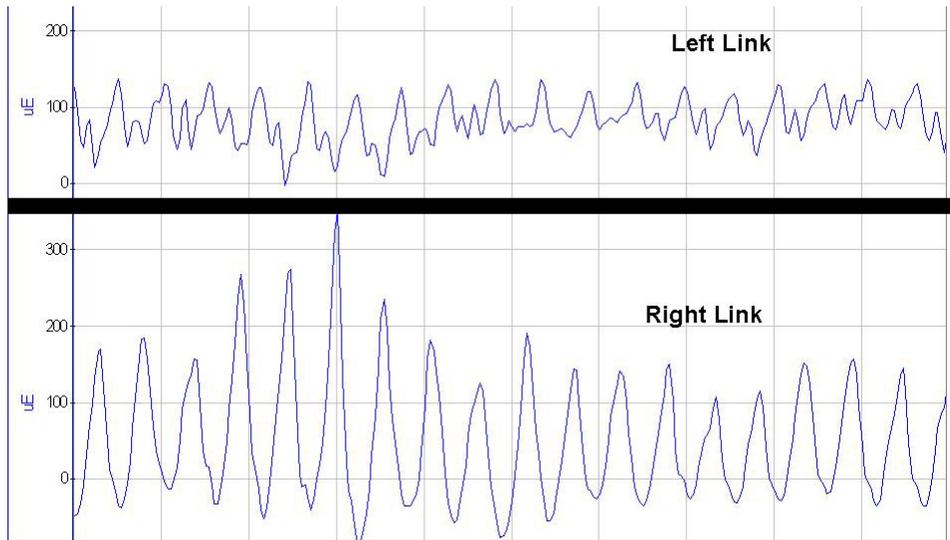
Figure 3.64. Strains Recorded on Caliper Links During Sustained Oscillations of WABTEC/SAB-WABCO Supplied Brake Disc While Braking (File 061805_24.AB3) – June 18, 2005

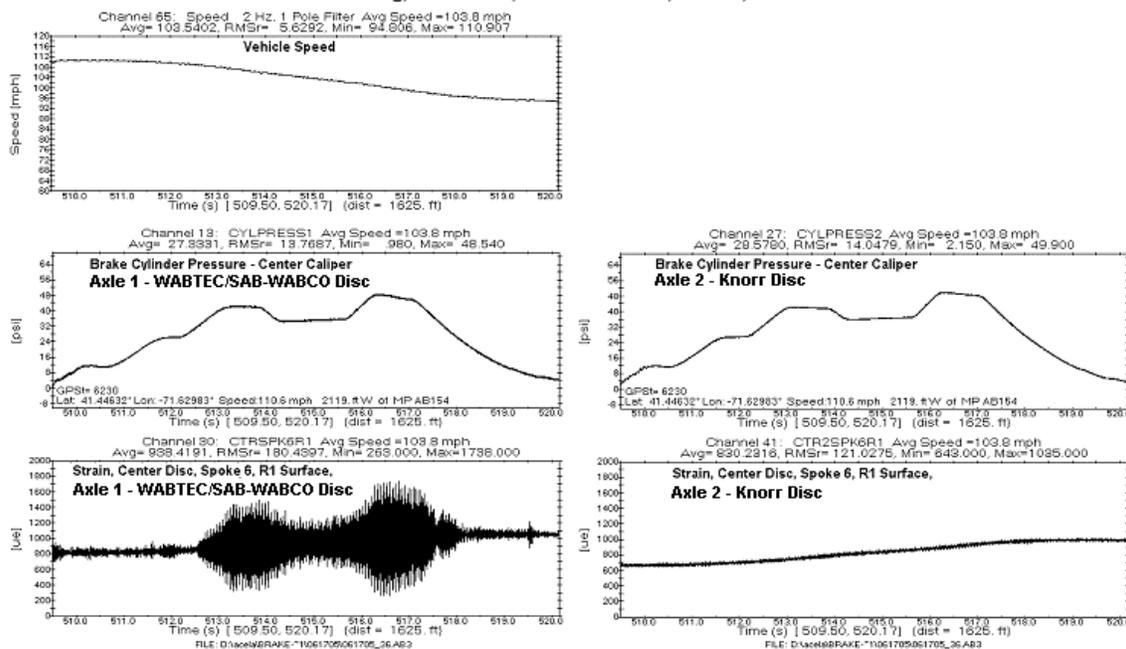
Figure 3.65. Brake Cylinder Pressure and Strains Recorded on Side of WABTEC/SAB-WABCO Supplied and Knorr Brake Disc Spokes During Short Case of Sustained Oscillations (File 061705_36.AB3) – June 17, 2005

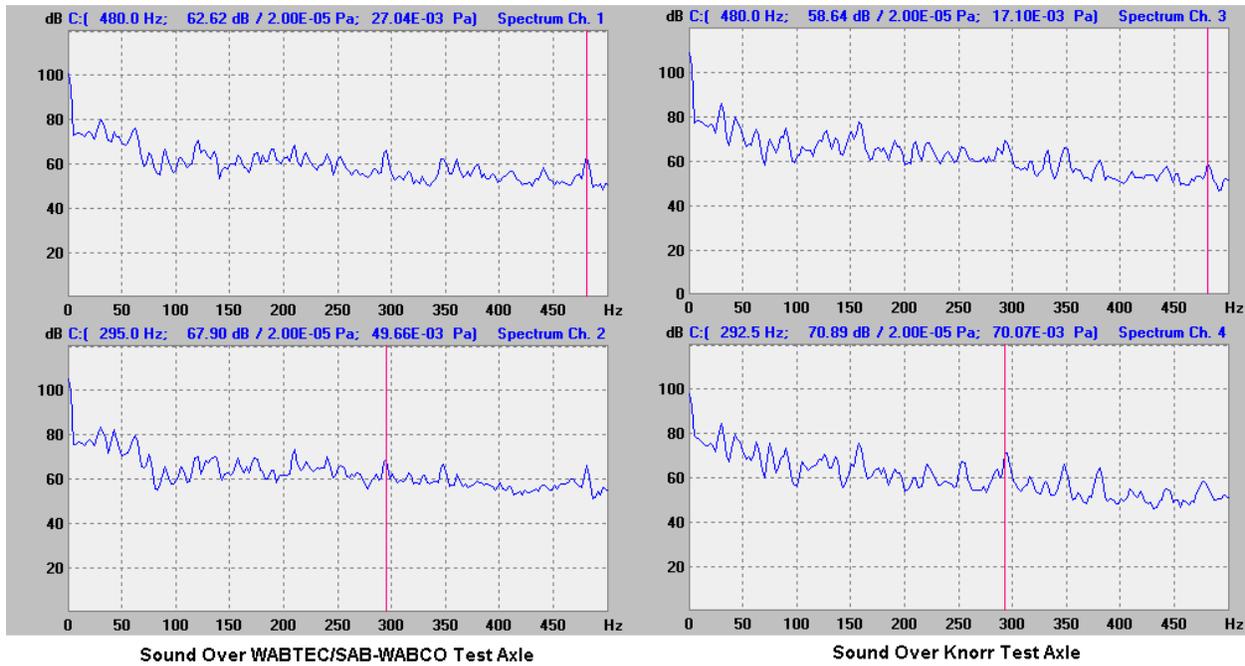
Figure 3.67. Analysis of Sound Recorded Over Both Test Axles During Mild Case of Sustained Oscillations on WABTEC/SAB-WABCO Supplied Disc During Braking Near MP AB 179 – June 17, 2005

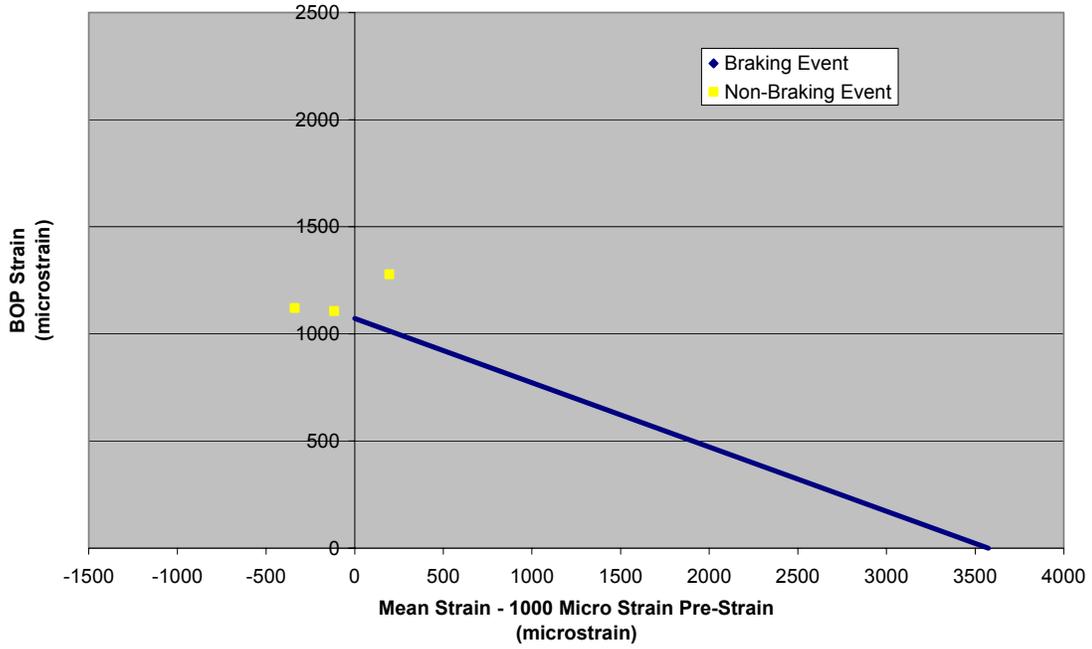
**Mean Strain vs. Alternating Strain, Outer WABTEC/SAB-WABCO Disc,
Spoke 6 - May 16, 2005**

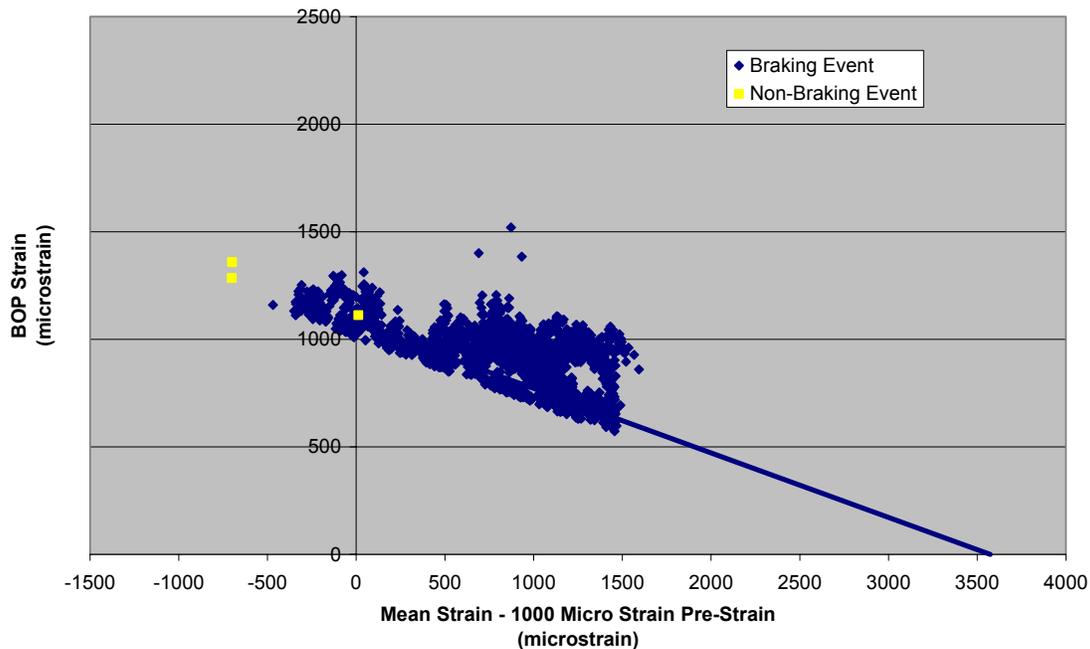
Figure 3.73. Mean Strain vs. Alternating Strain, Center WABTEC/SAB-WABCO Supplied
Brake Disc, Spokes 6 and 3 – June 18, 2005

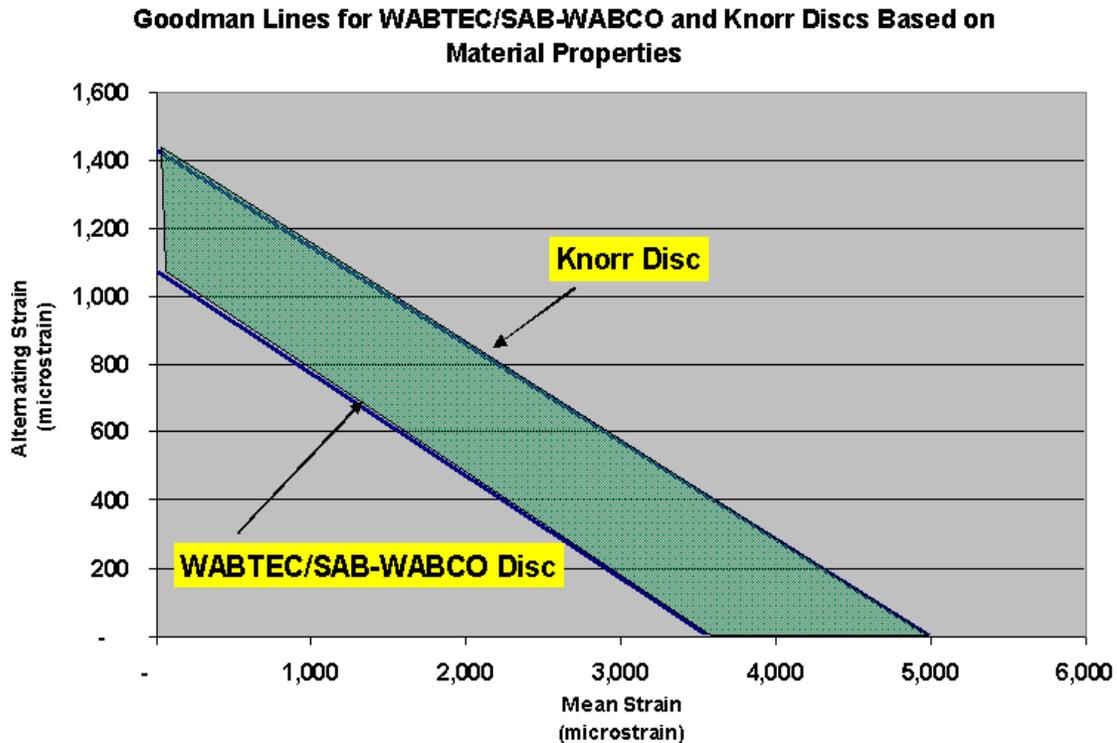
Figure 3.74. Comparison of Goodman Lines for WABTEC/SAB-WABCO Supplied and Knorr Brake Discs

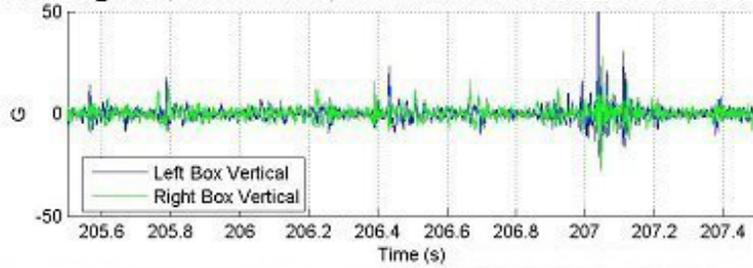
File 061705_10.AB3, Location = 206.5 s, Truck Frame Accelerations W/ABTEC/SAB-WABCO Test Axle
