**Federal Railroad
Administration**

1997 Railroad Employee Fatalities: A Comprehensive Study

Date: June 18, 2001

Subject: **1997 Railroad Employee Fatalities: A Comprehensive Study**

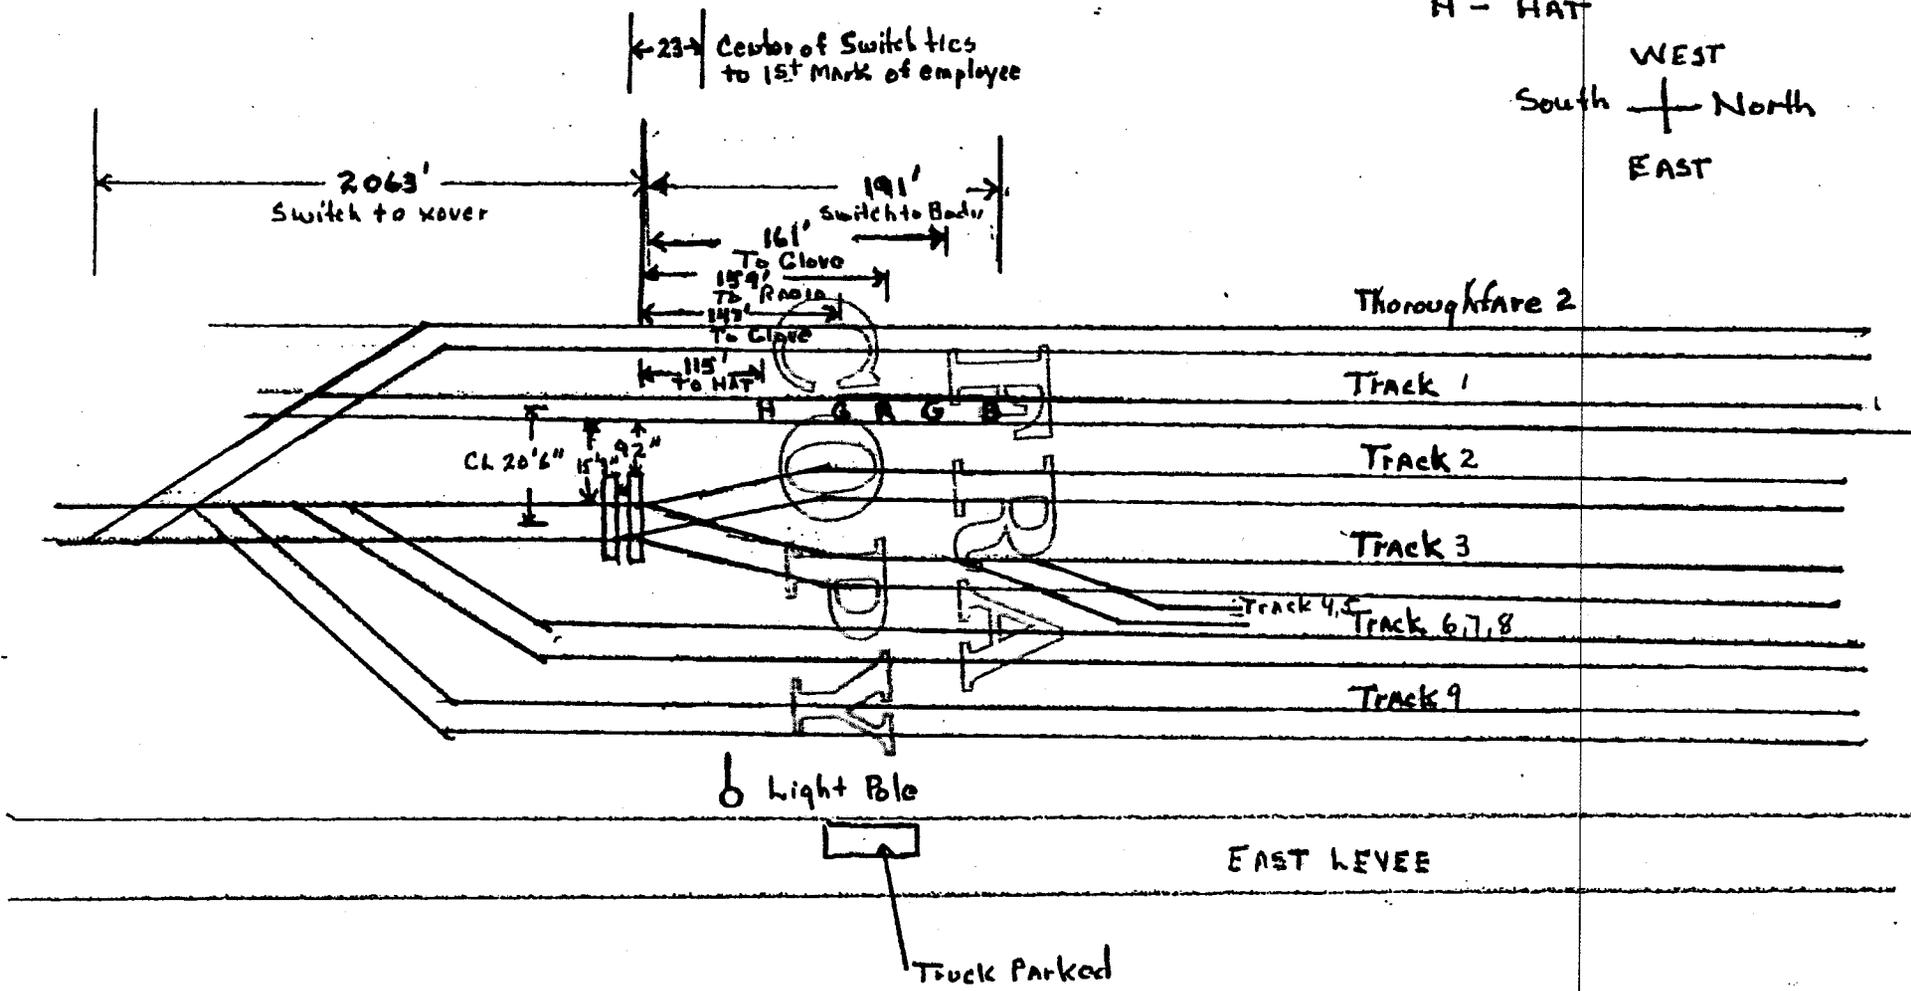
The Carman was wearing layered clothing with a stocking-type cap and a hooded sweatshirt at the time of the accident. His outer clothing was dark in color. It is unknown if the stocking cap and hooded sweatshirt he was wearing at the time had reduced his ability to hear. He also had gloves and a radio with him. His gloves and radio were found in the gage of the track north of the point of impact. His transected body was found approximately 191 feet north of the switch to Tracks Nos. 2 and 3. His upper torso was found in the gage of Track No. 1, while his lower portion was found outside the gage of the east rail.

Evidence observed on Locomotive NW 6143 of Train No. M-98 indicated that it had passed over the Carman's body. The Engineer was operating from the control stand from the west side of the south unit (NW 8067). The locomotive consist was moving northward onto Track No. 1 to couple to its train. The Conductor was controlling the northward movement of the locomotives from the cab of Locomotive NW 6143; he was seated on the west side. The Conductor's view of the track in the direction of movement was hampered by the long hood end of Locomotive NW 6143.

- B - Body
- G - Glove
- R - Radio
- G - Glove
- H - HAT

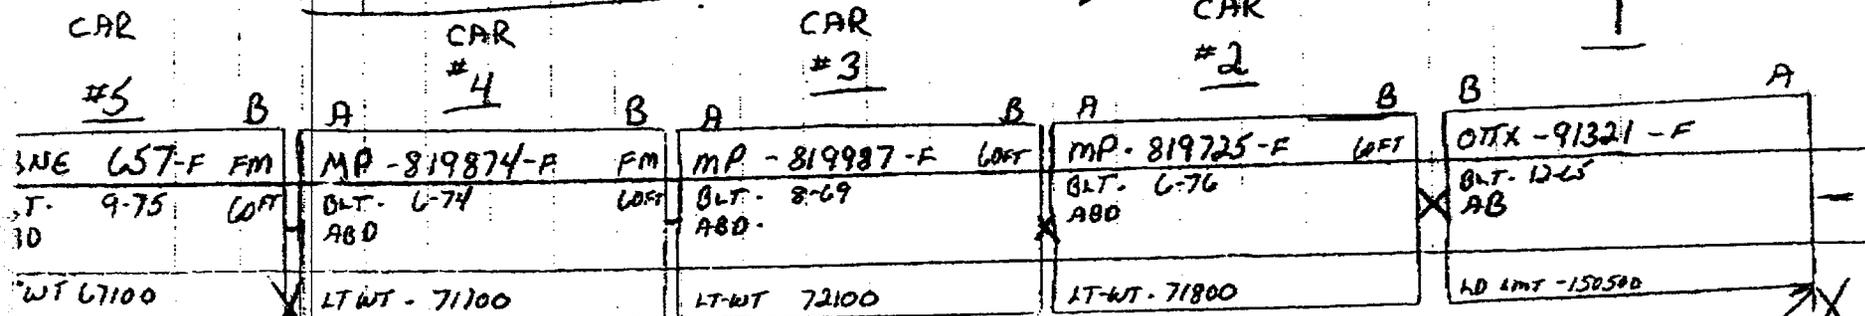
MOVEMENT OF TRAIN
WEST INTO #7 TRACK

INJURED
Employee
Found

POINT OF
CONTACT

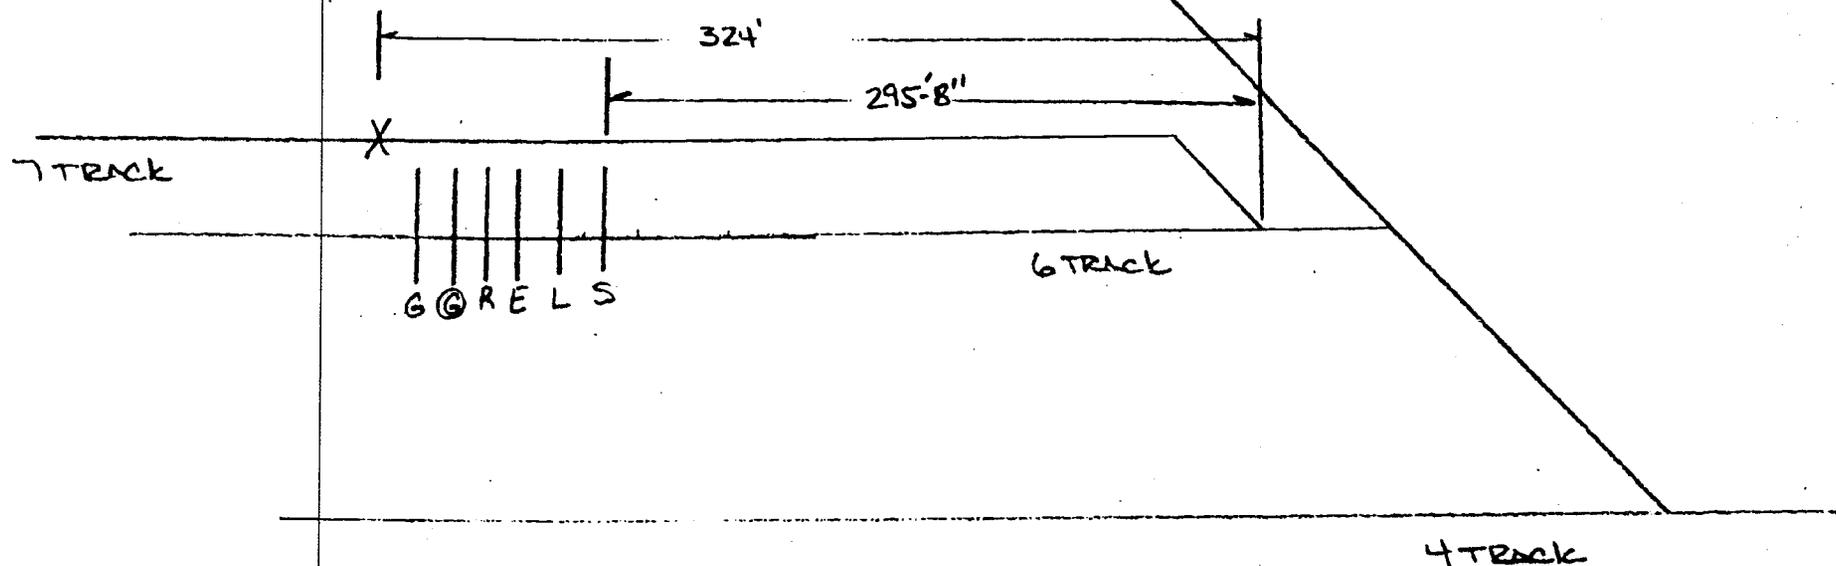
- G = GLOVE — 141" FROM REST - Laying AGAINST NR.
 ⊙ = GLASSES — 151" FROM REST - 14" FROM BASE OF NR EDGE OF TIE
 R = RADIO — 159" FROM REST - 29" FROM BASE OF NR
 E = EYE LENSE — 217" FROM REST - 5" FROM BASE OF NR
 L = LANTERN — 276" FROM REST - 34" FROM BASE OF NR
 S = SWITCH LIST - 345" FROM REST - 71" FROM BASE OF NR

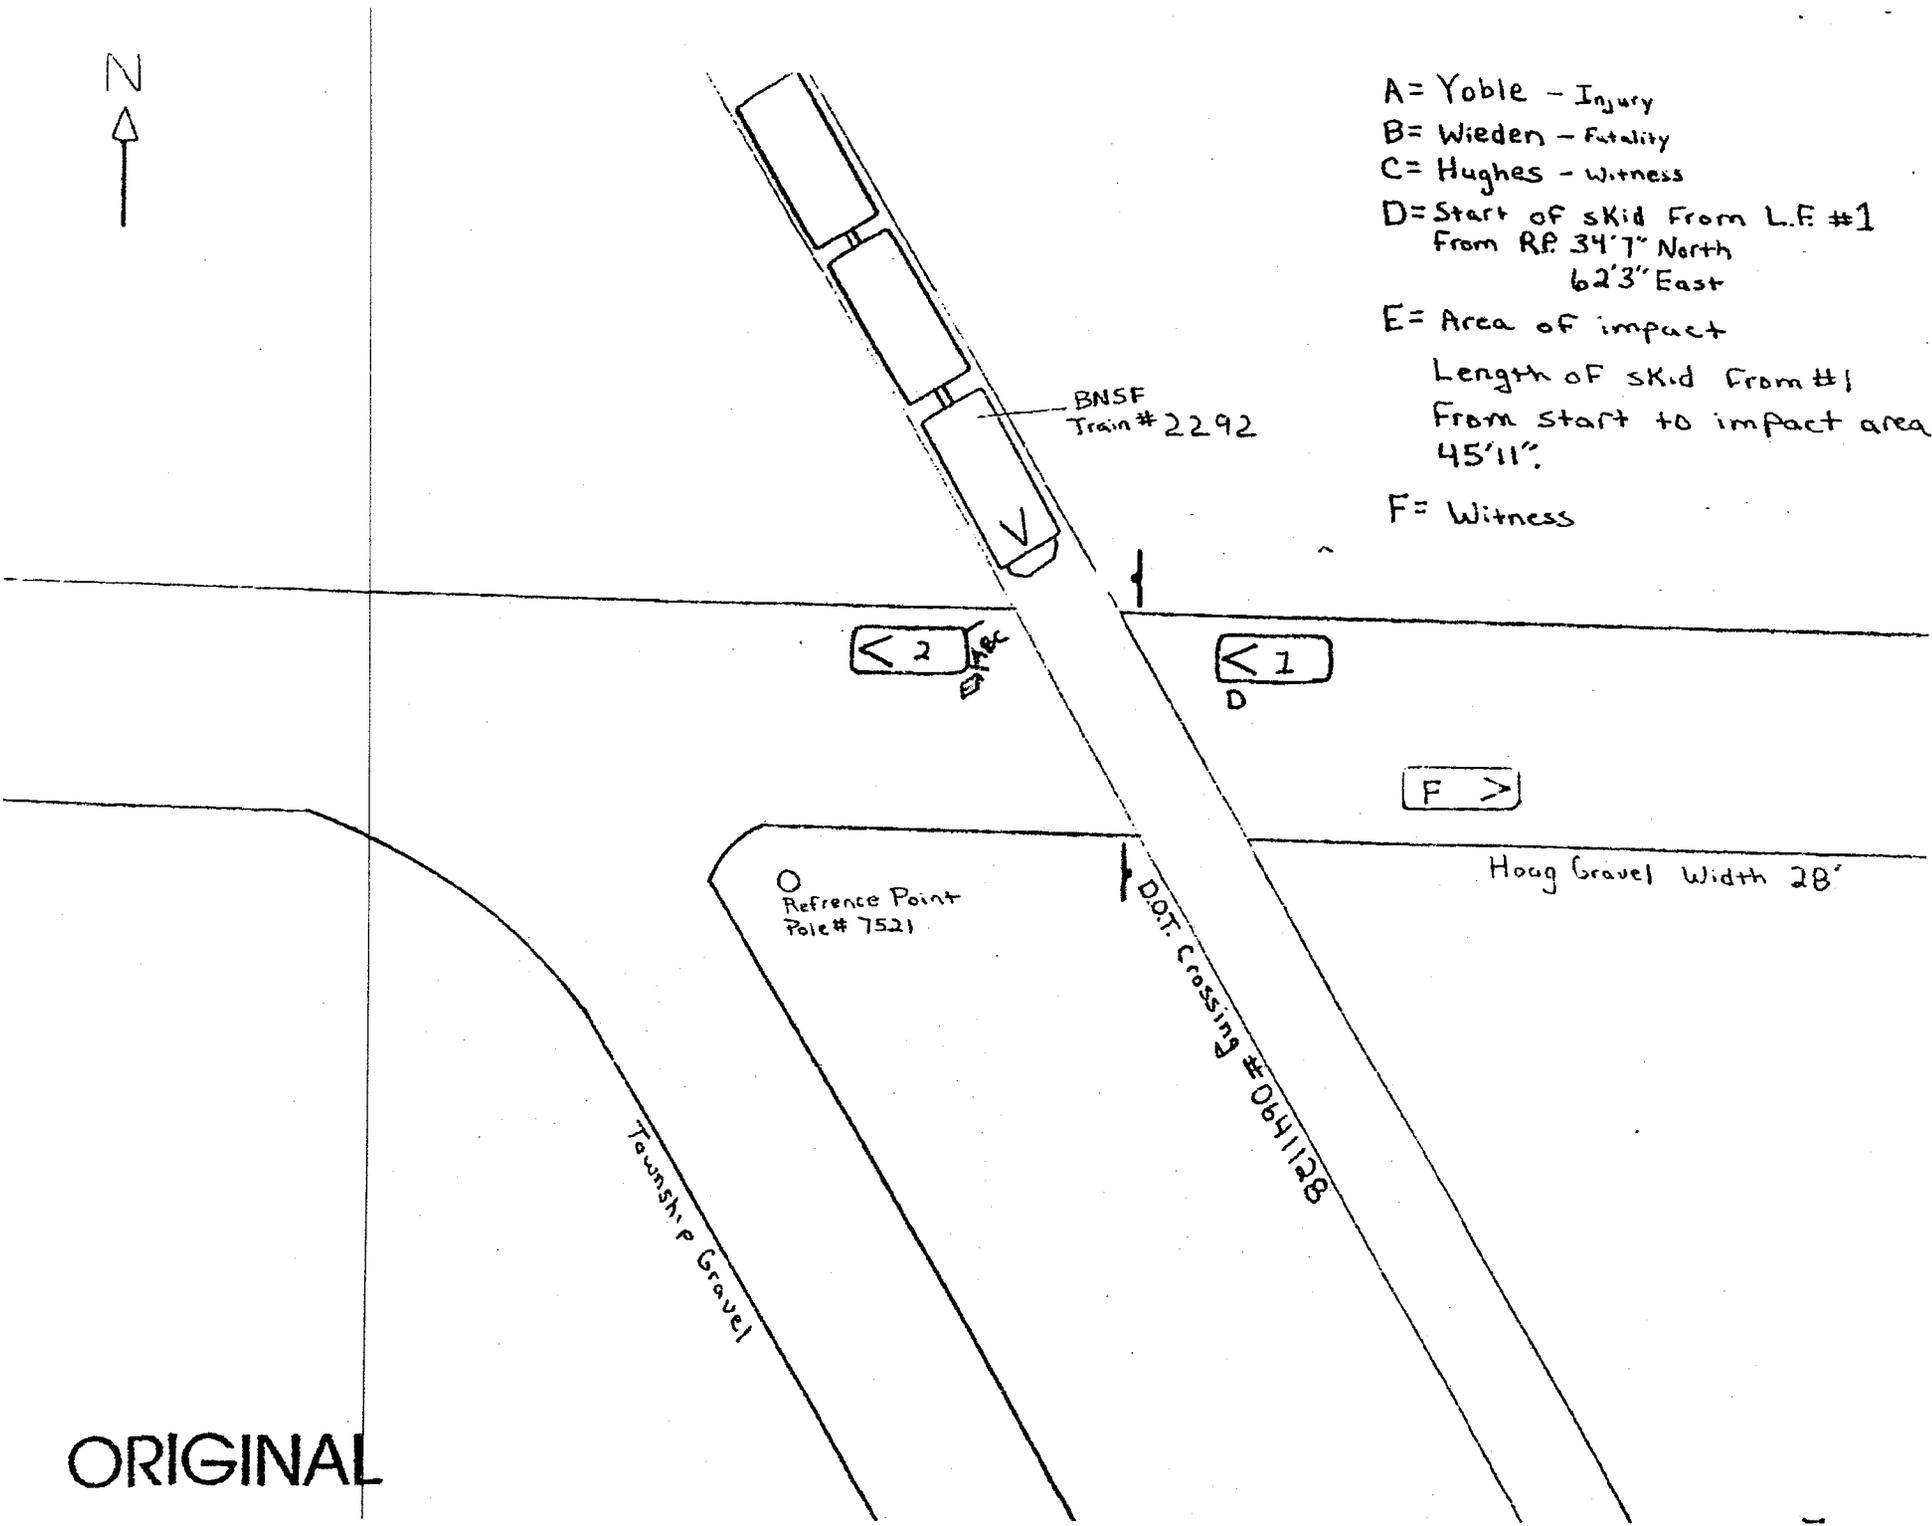
- A = Yoble - Injury
- B = Wieden - Fatality
- C = Hughes - witness
- D = Start of skid From L.F. #1
From RP. 34'7" North
62'3" East
- E = Area of impact
Length of skid From #1
From start to impact area
45'11"
- F = Witness

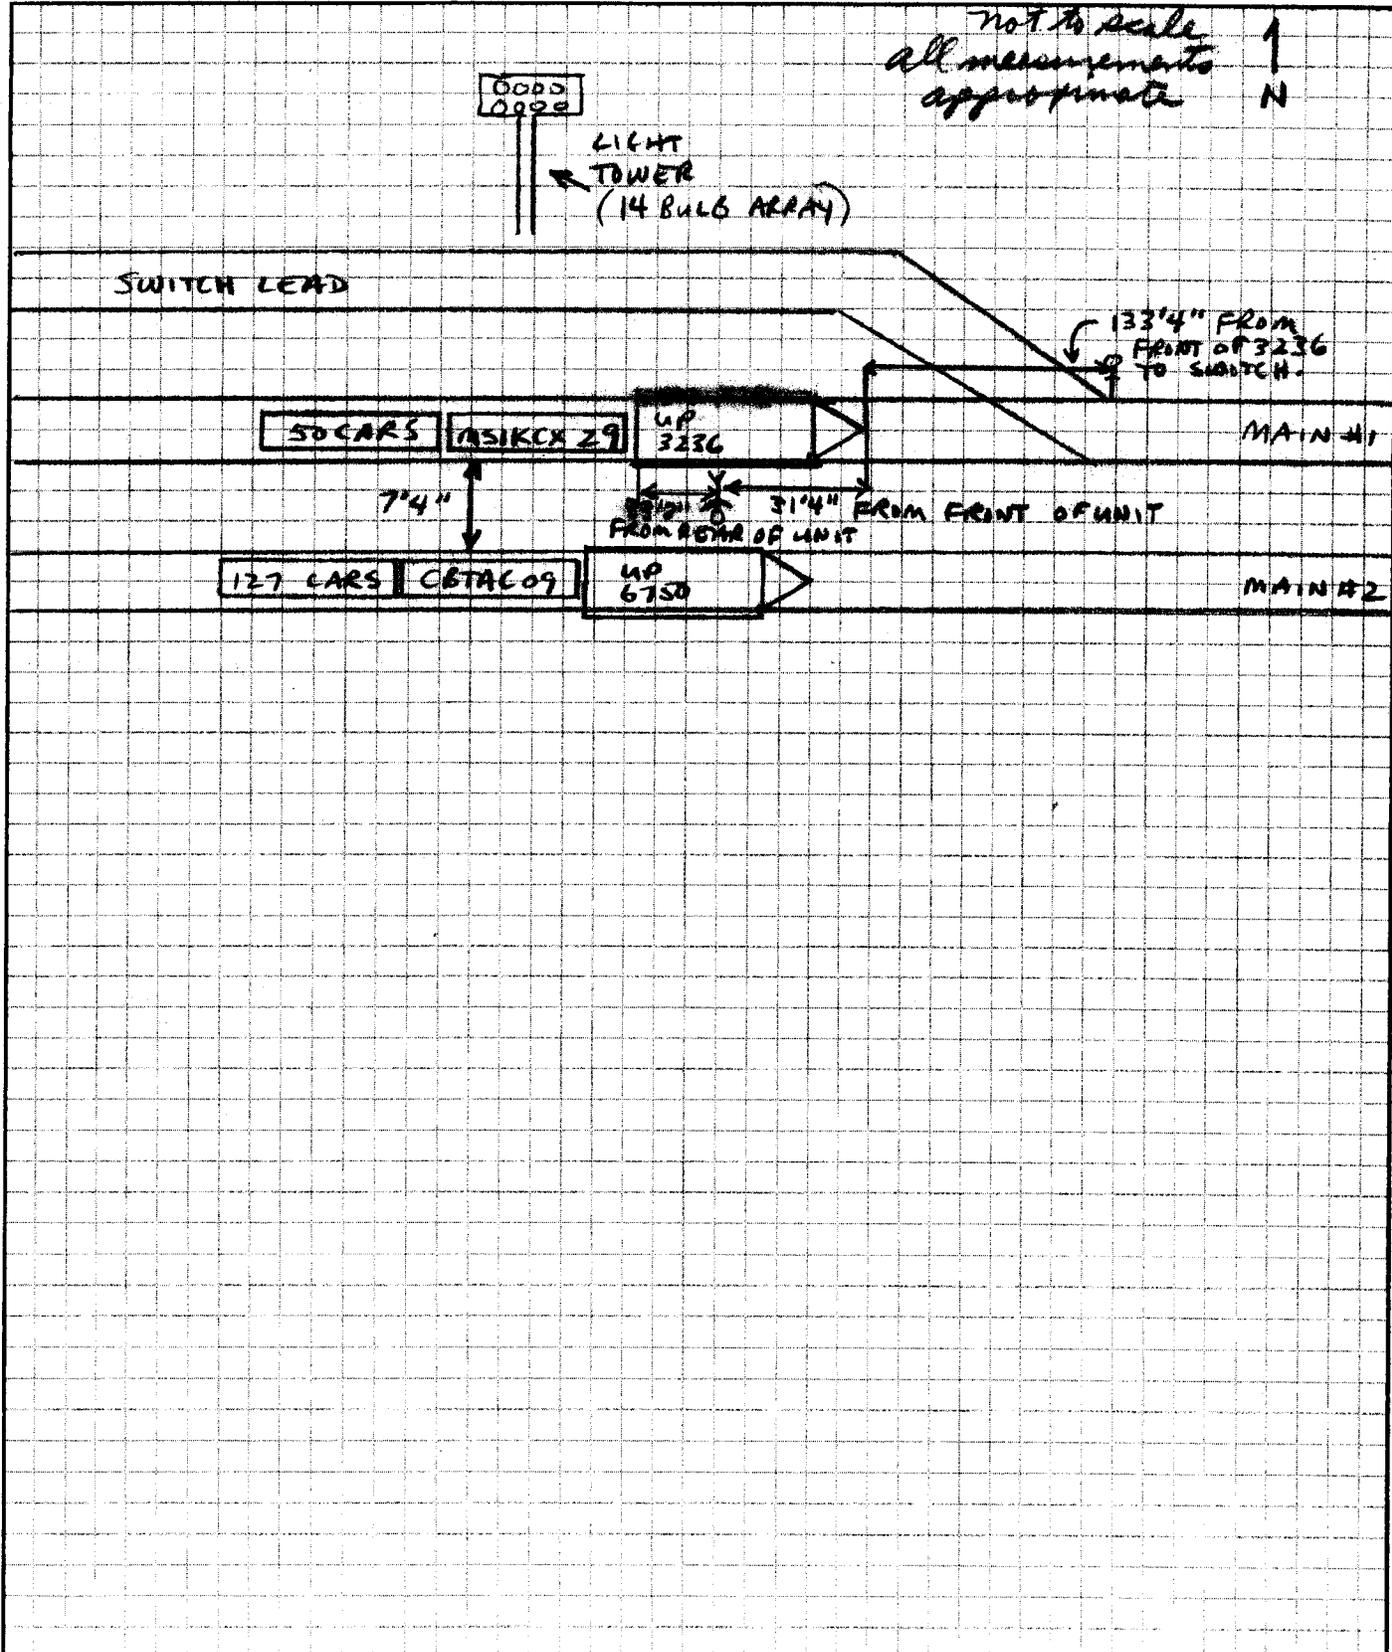
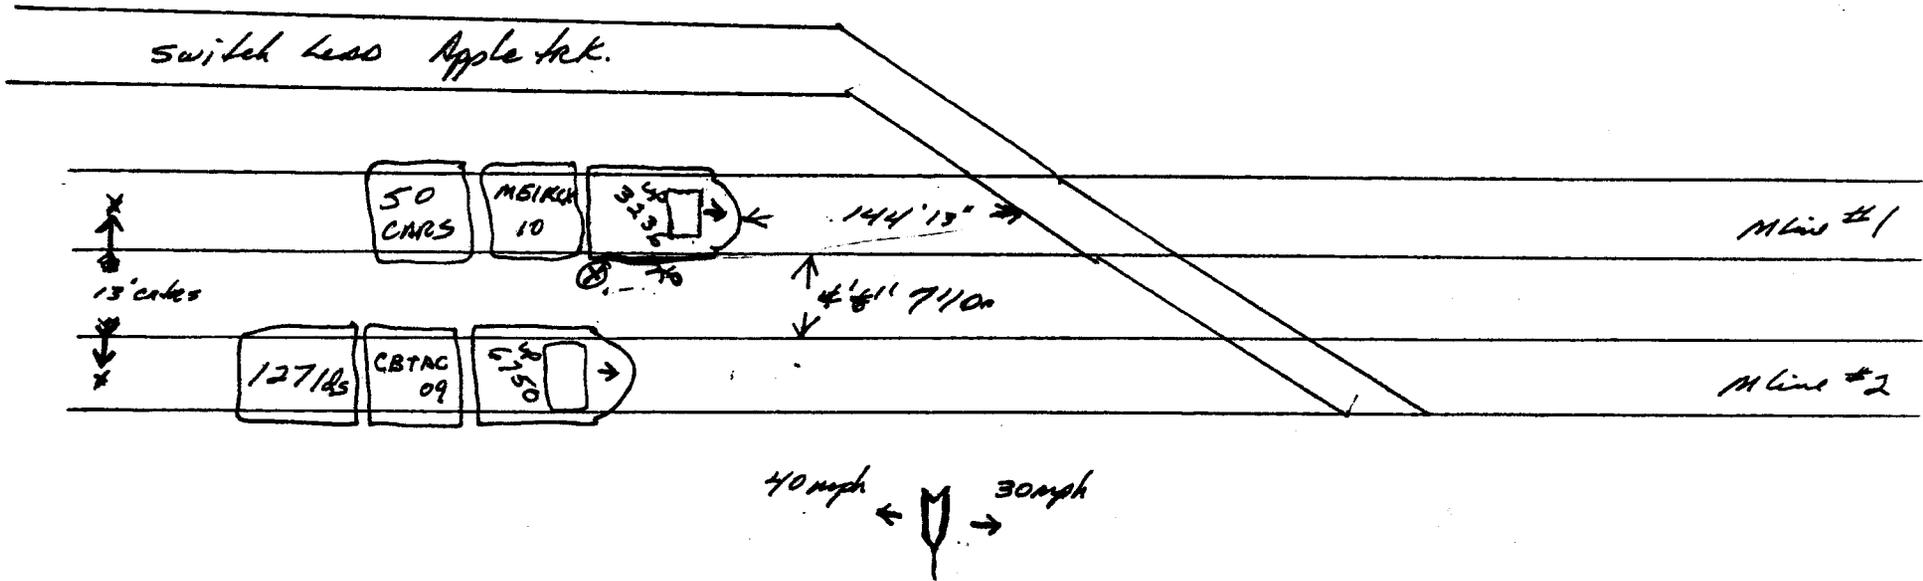
Diagram by TW BARNETT Date 12-12-97

⊗ Point of impact

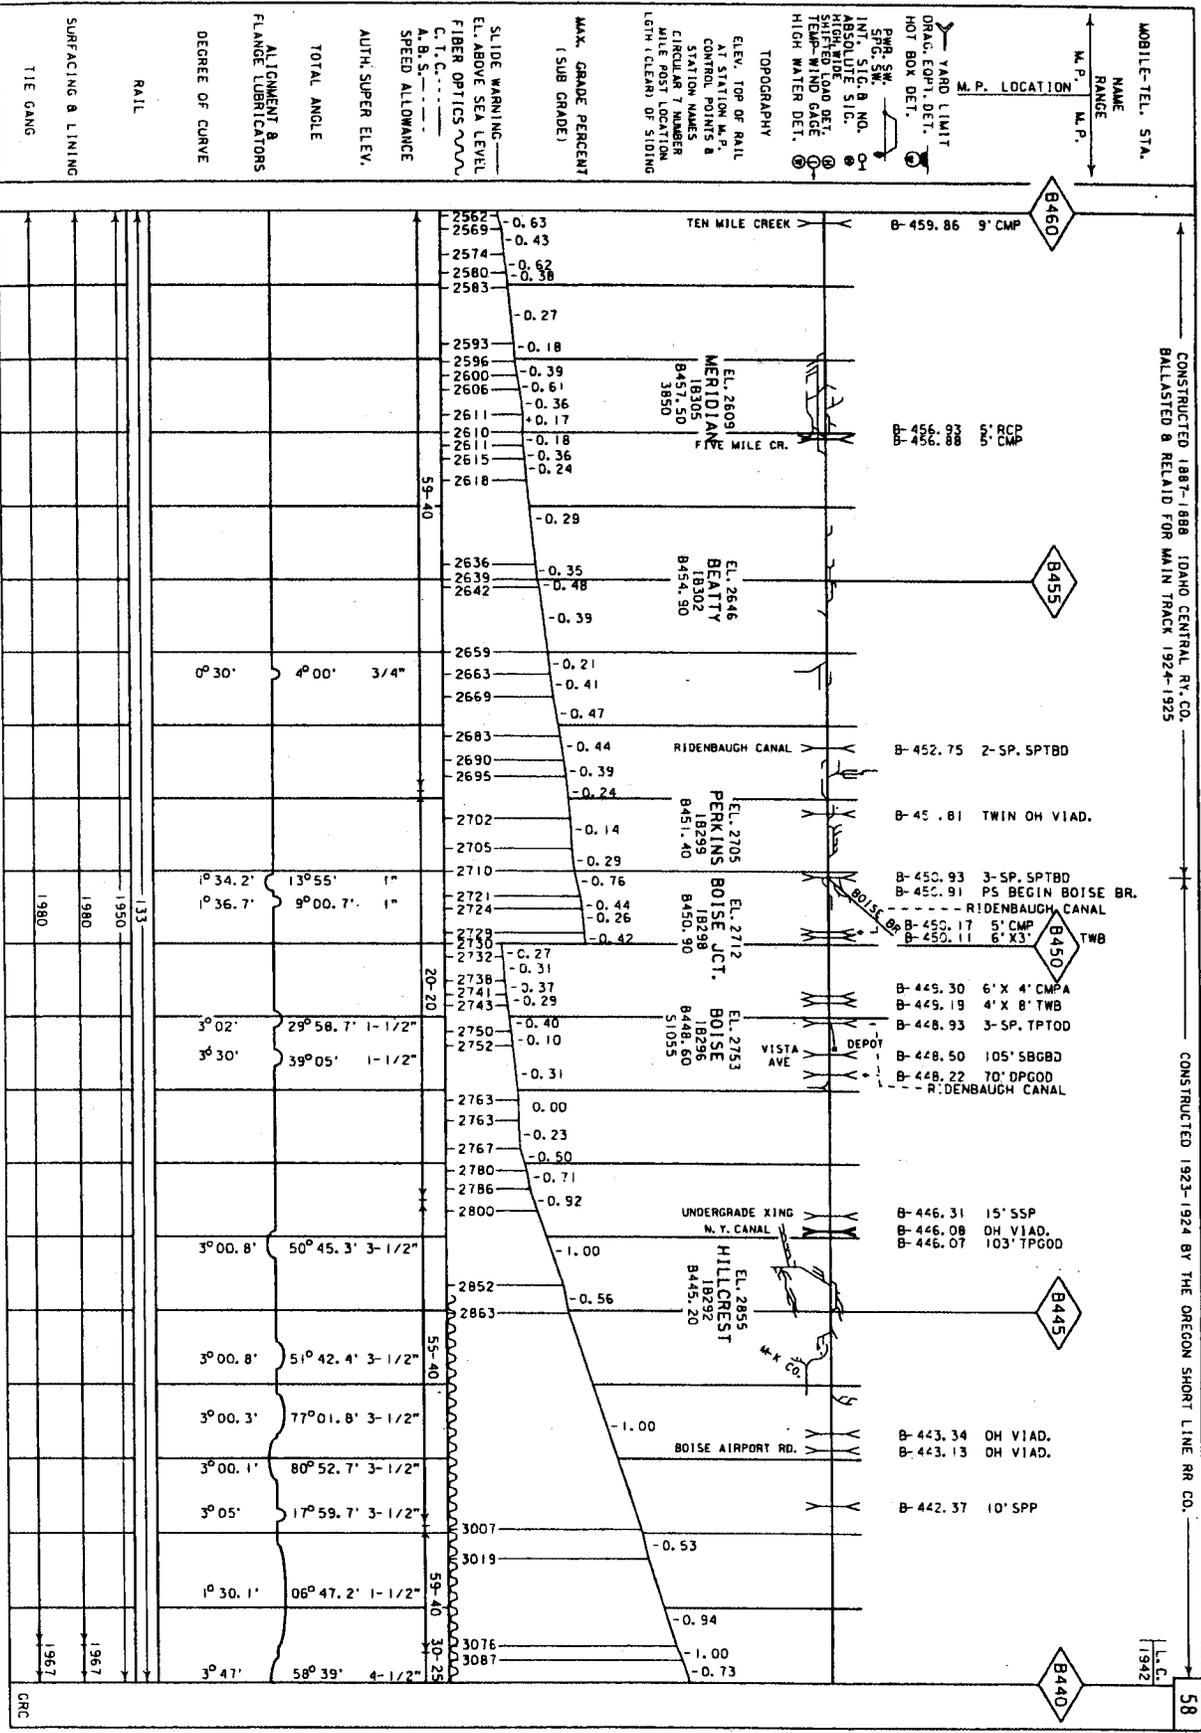
IDAHO DIVISION
BOISE CUT-OFF

The Brakeman began walking the train and observed the Conductor lying between the rails under an empty wood chip car approximately two car lengths east of the switch. He notified the Engineer that the Conductor was hurt and asked the Engineer to call an ambulance. The Engineer turned his radio to a road channel and pressed the emergency button. The Dispatcher responded immediately. The Engineer then informed the Dispatcher of the accident and requested an ambulance and the police department.

The footing in the accident area was a slightly raised, ballasted track bed. The tracks were clean of any material that would create a tripping hazard. There was no snow, and the ground was dry. The footwear which the Conductor was wearing at the time of the accident was examined, and nothing was found that could have caused or contributed to the cause of the accident.

Following the investigation, UP's Portland Service Unit issued Accident Prevention Alert No. 26, which reviewed possible causes of the fatality, applicable safety rules when closing an angle cock, and precautionary procedures for working around moving equipment. The railroad also conducted safety meetings with all employees to discuss the accident.
