# Federal Railroad Administration Hazmat Seminar Reno, NV

June 25-27, 2013

# Tank Car Forensics

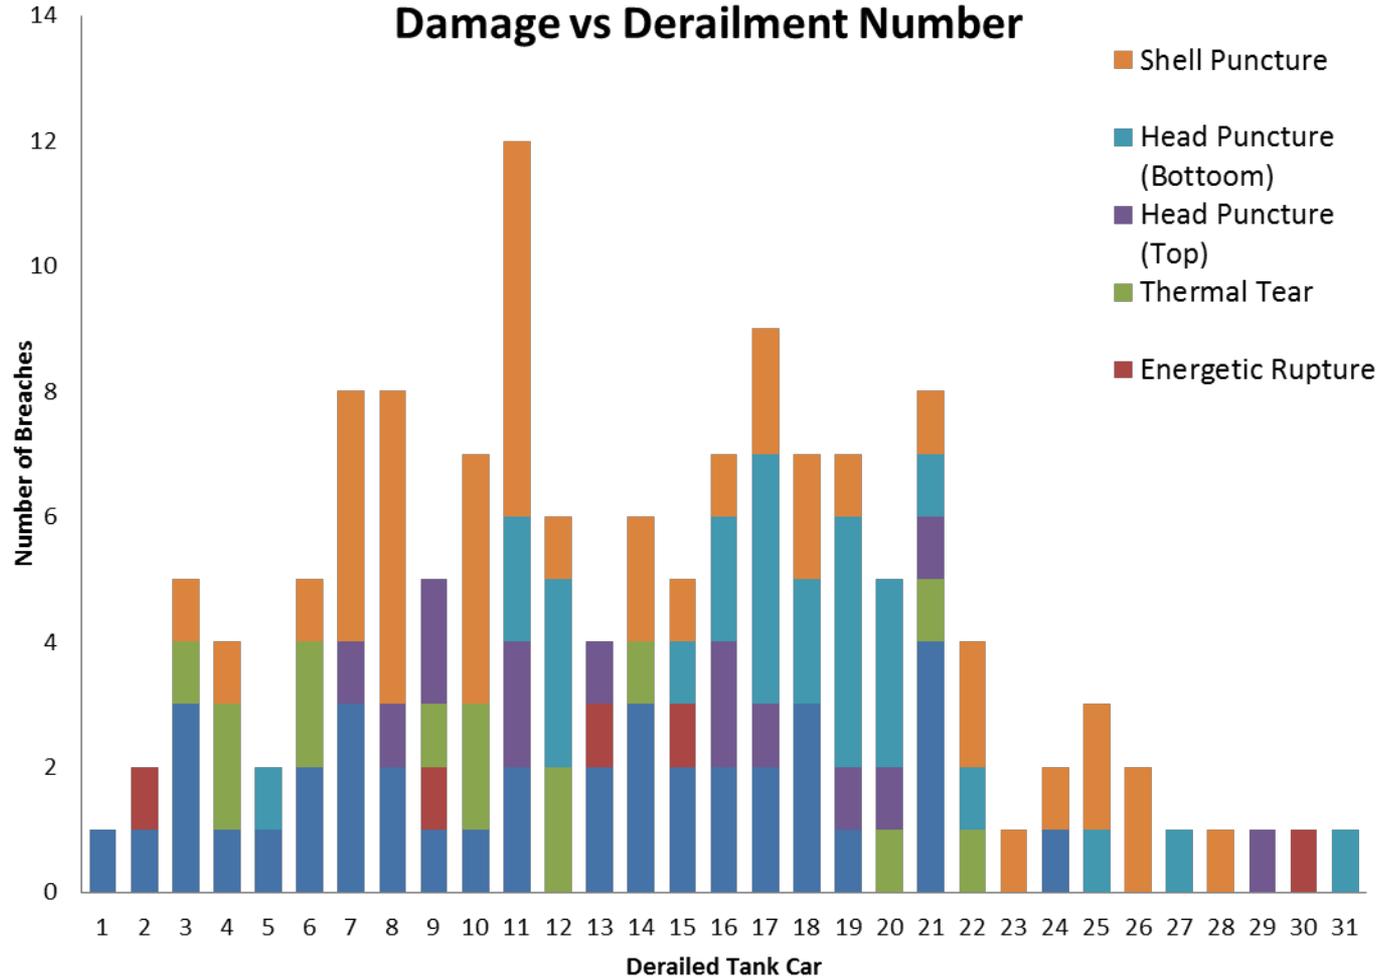
Damage vs Derailment Number

Damage	Number of Incidents	Occasions of only damage
Top Fittings	34	16
Bottom Outlet Valve	5	1
Thermal Tear	14	13
Energetic Rupture	5	5
Top Head Puncture	14	6
Bottom Head Puncture	27	19
Shell Puncture	42	12
Total Volume Lost	2,161,807 gallons	-----

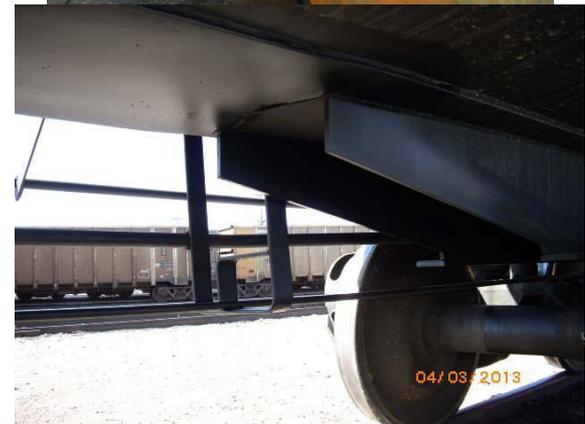
ACF300 Underframe

A-end inboard draft sill

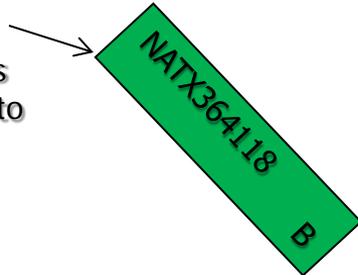
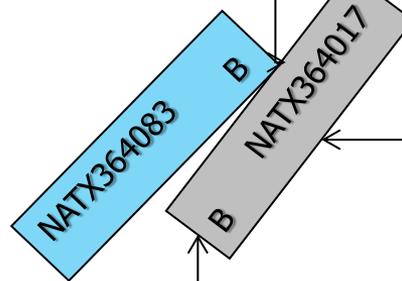
Head of 083 slides into  
the inboard termination  
of the draft sill

017 rotates 90°  
clockwise exposing  
the draft sill to 083

Broken coupler

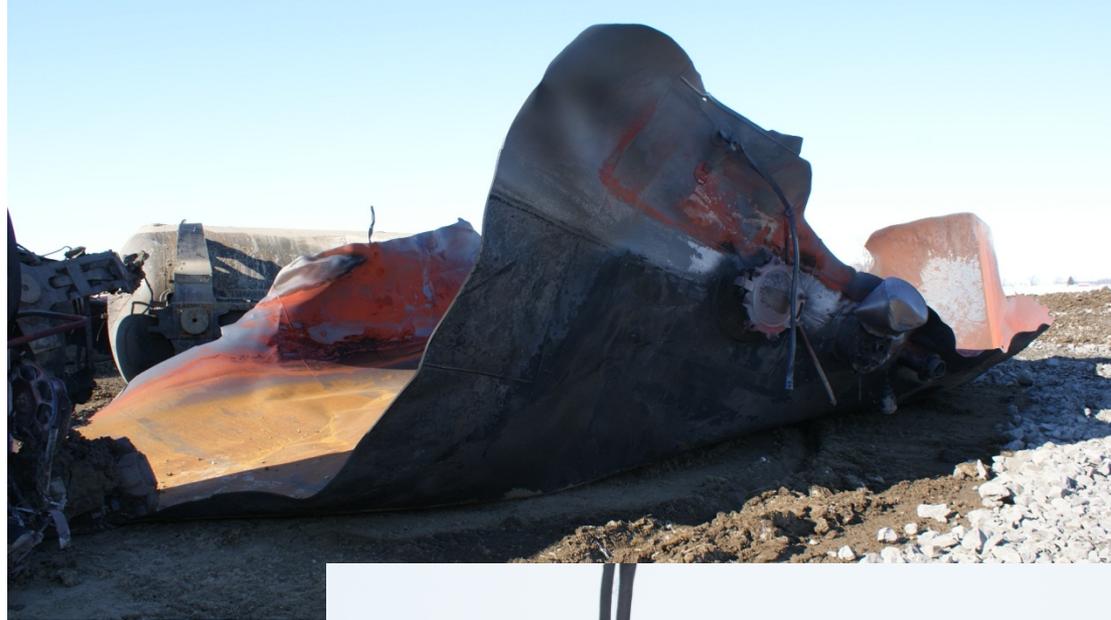
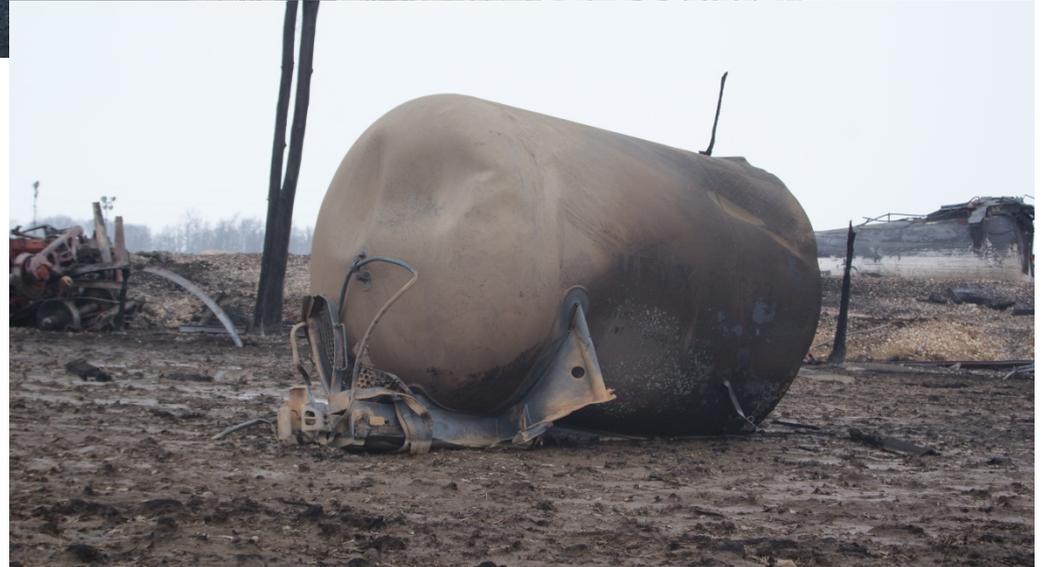
# Arcadia, OH

- Large explosions resulting in classic tank destruction (BLEVEs) occurred in two derailments
  - Arcadia (3)
  - Plevna (2)
- Large explosion with limited tank damage (thermal tears) occurred in five derailments
  - Arcadia (2)
  - Tiskilwa (3)
  - Columbus (2)
  - Plevna (6)
  - New Brighton (1)
- Birk (1995) found that in cases where a fissure (tear) are similar in length to the tank diameter the resulting release and fireball was virtually identical to a BLEVE.

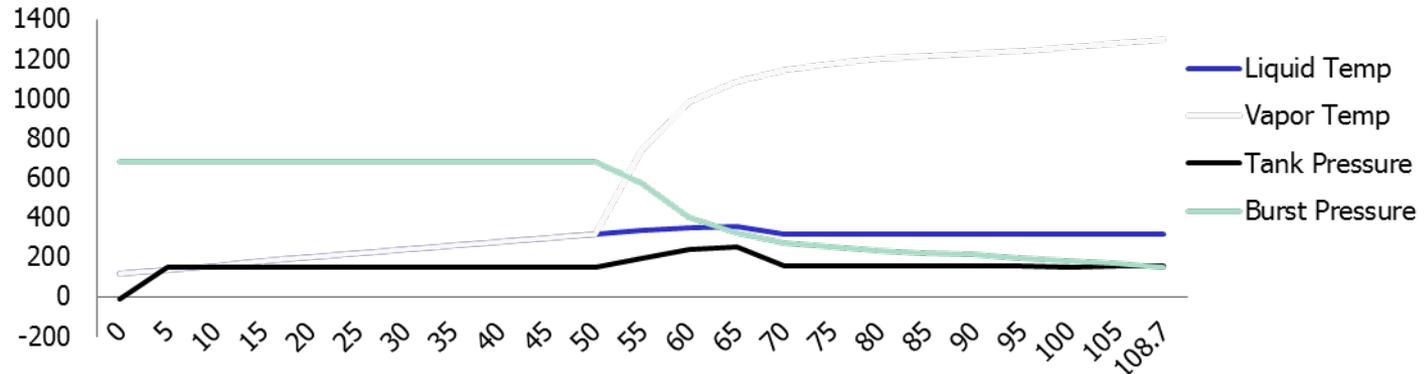
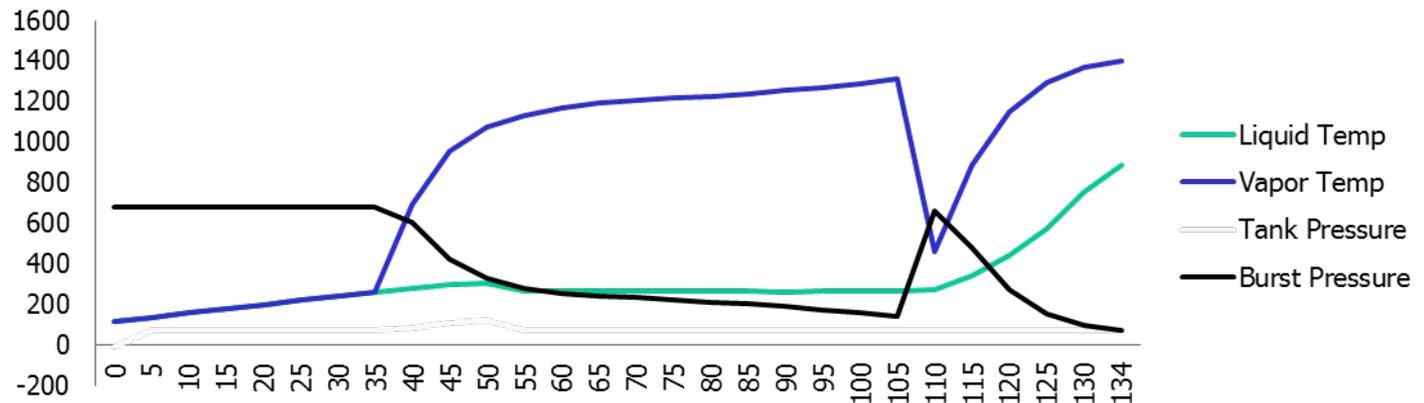
## AFFTAC Simulation (165 psig STD)

- Video from Columbus – rupture at ~34 min
- Anecdotally, all ruptures within one hour.

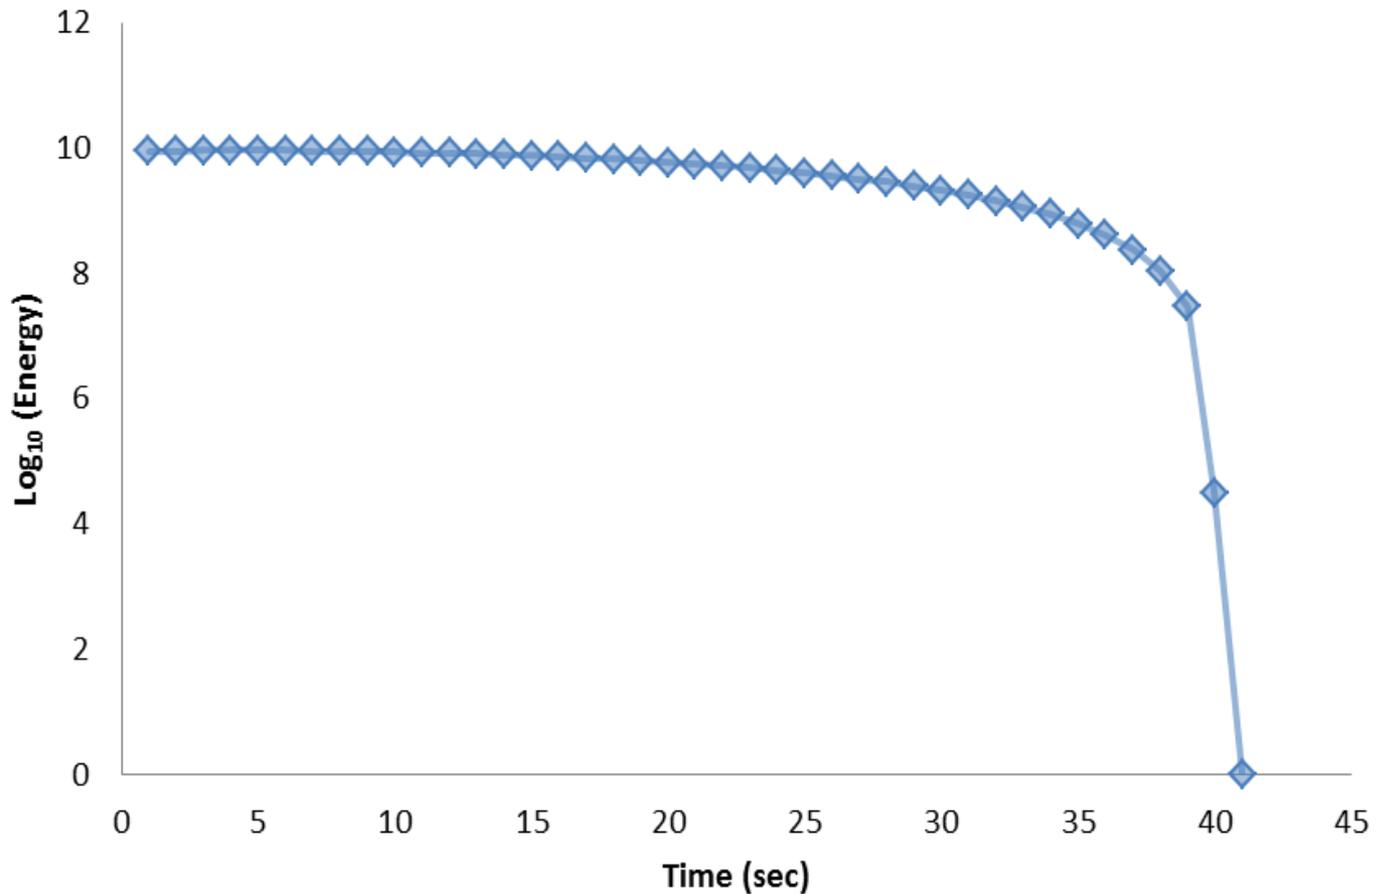
Log of the kinetic energy of train behind ATW140155  
(last car derailed)

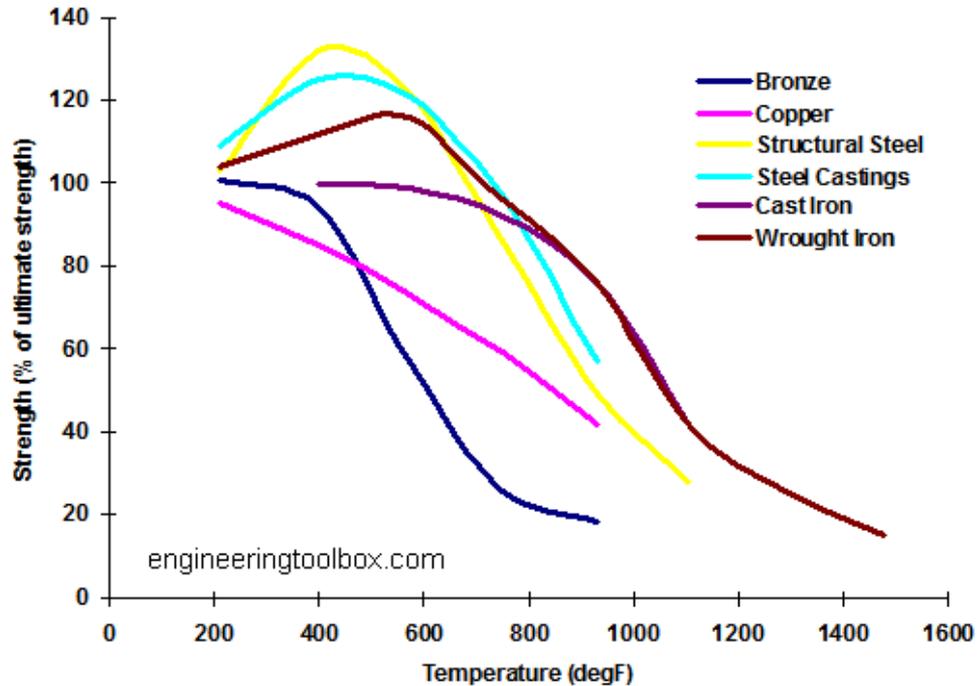
# Analysis of ruptures

Car Number	Thickness at fracture	Material	Tensile strength	Diameter	STD Pressure
UTLX211623	0.180"	TC-128	81,000 psi	120"	165 psig
UTLX204101	0.213"	TC-128	81,000 psi	120"	165 psig
GATX263706	0.144"	TC-128	81,000 psi	120"	75 psig
